Appendices

Appendix 1: Land Use – Historical Photos

Appendix 2: Groundwater/Flow– Supplemental Tables

Appendix 3: Surface Water Hydrology – Supplemental Data Tables

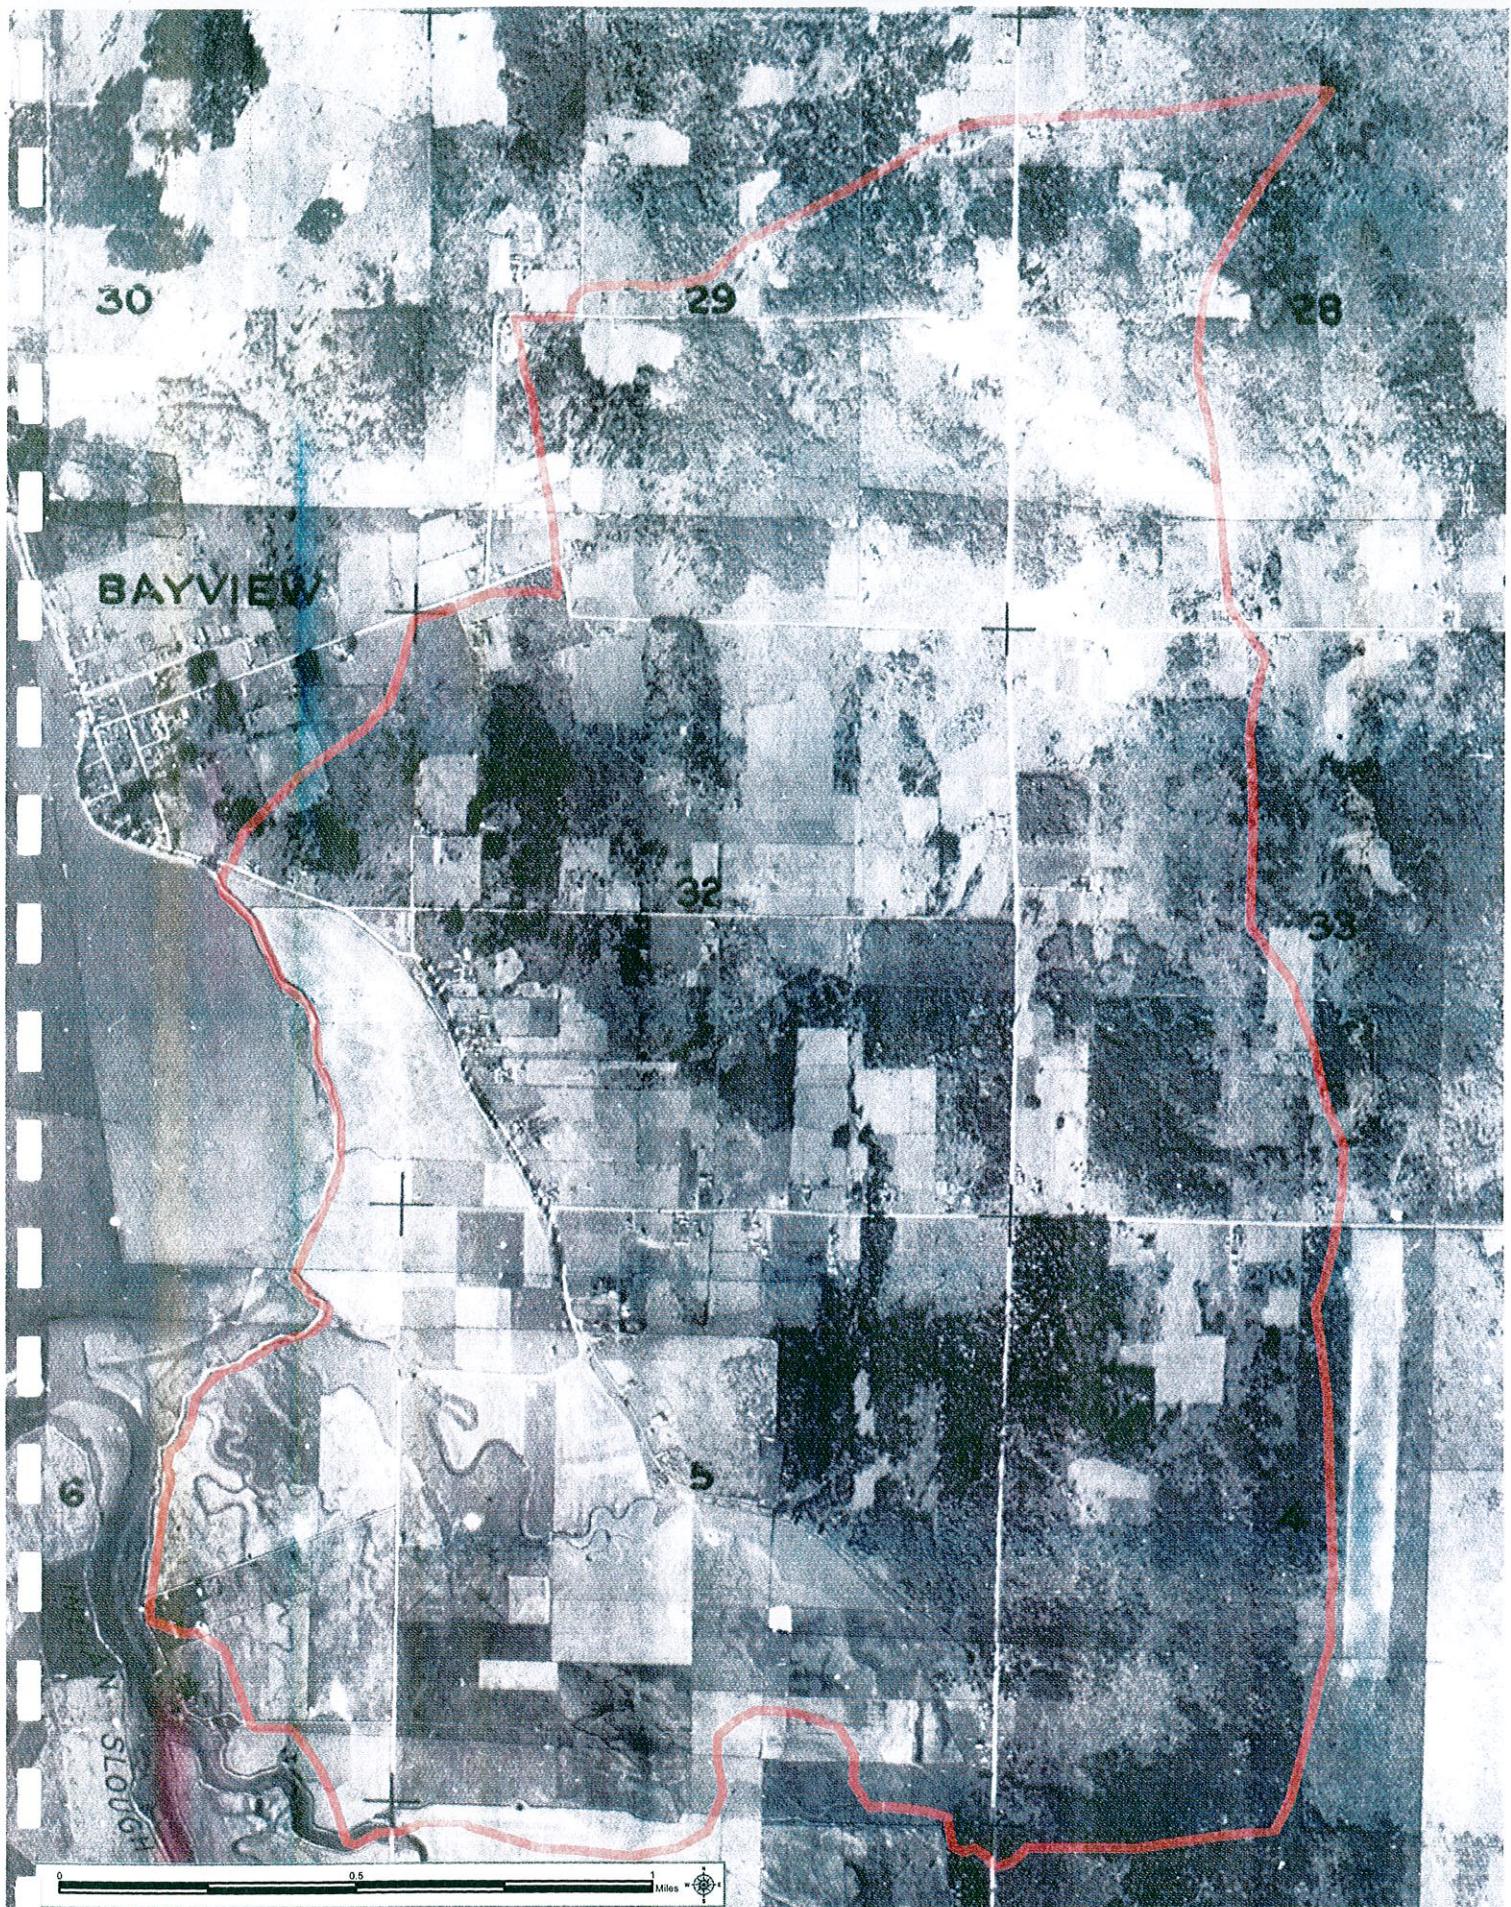
Historic Photo 1 No Name Watershed Boundary (in red) overlaid on 1937 image (source: US War Department via Skagit County GIS).

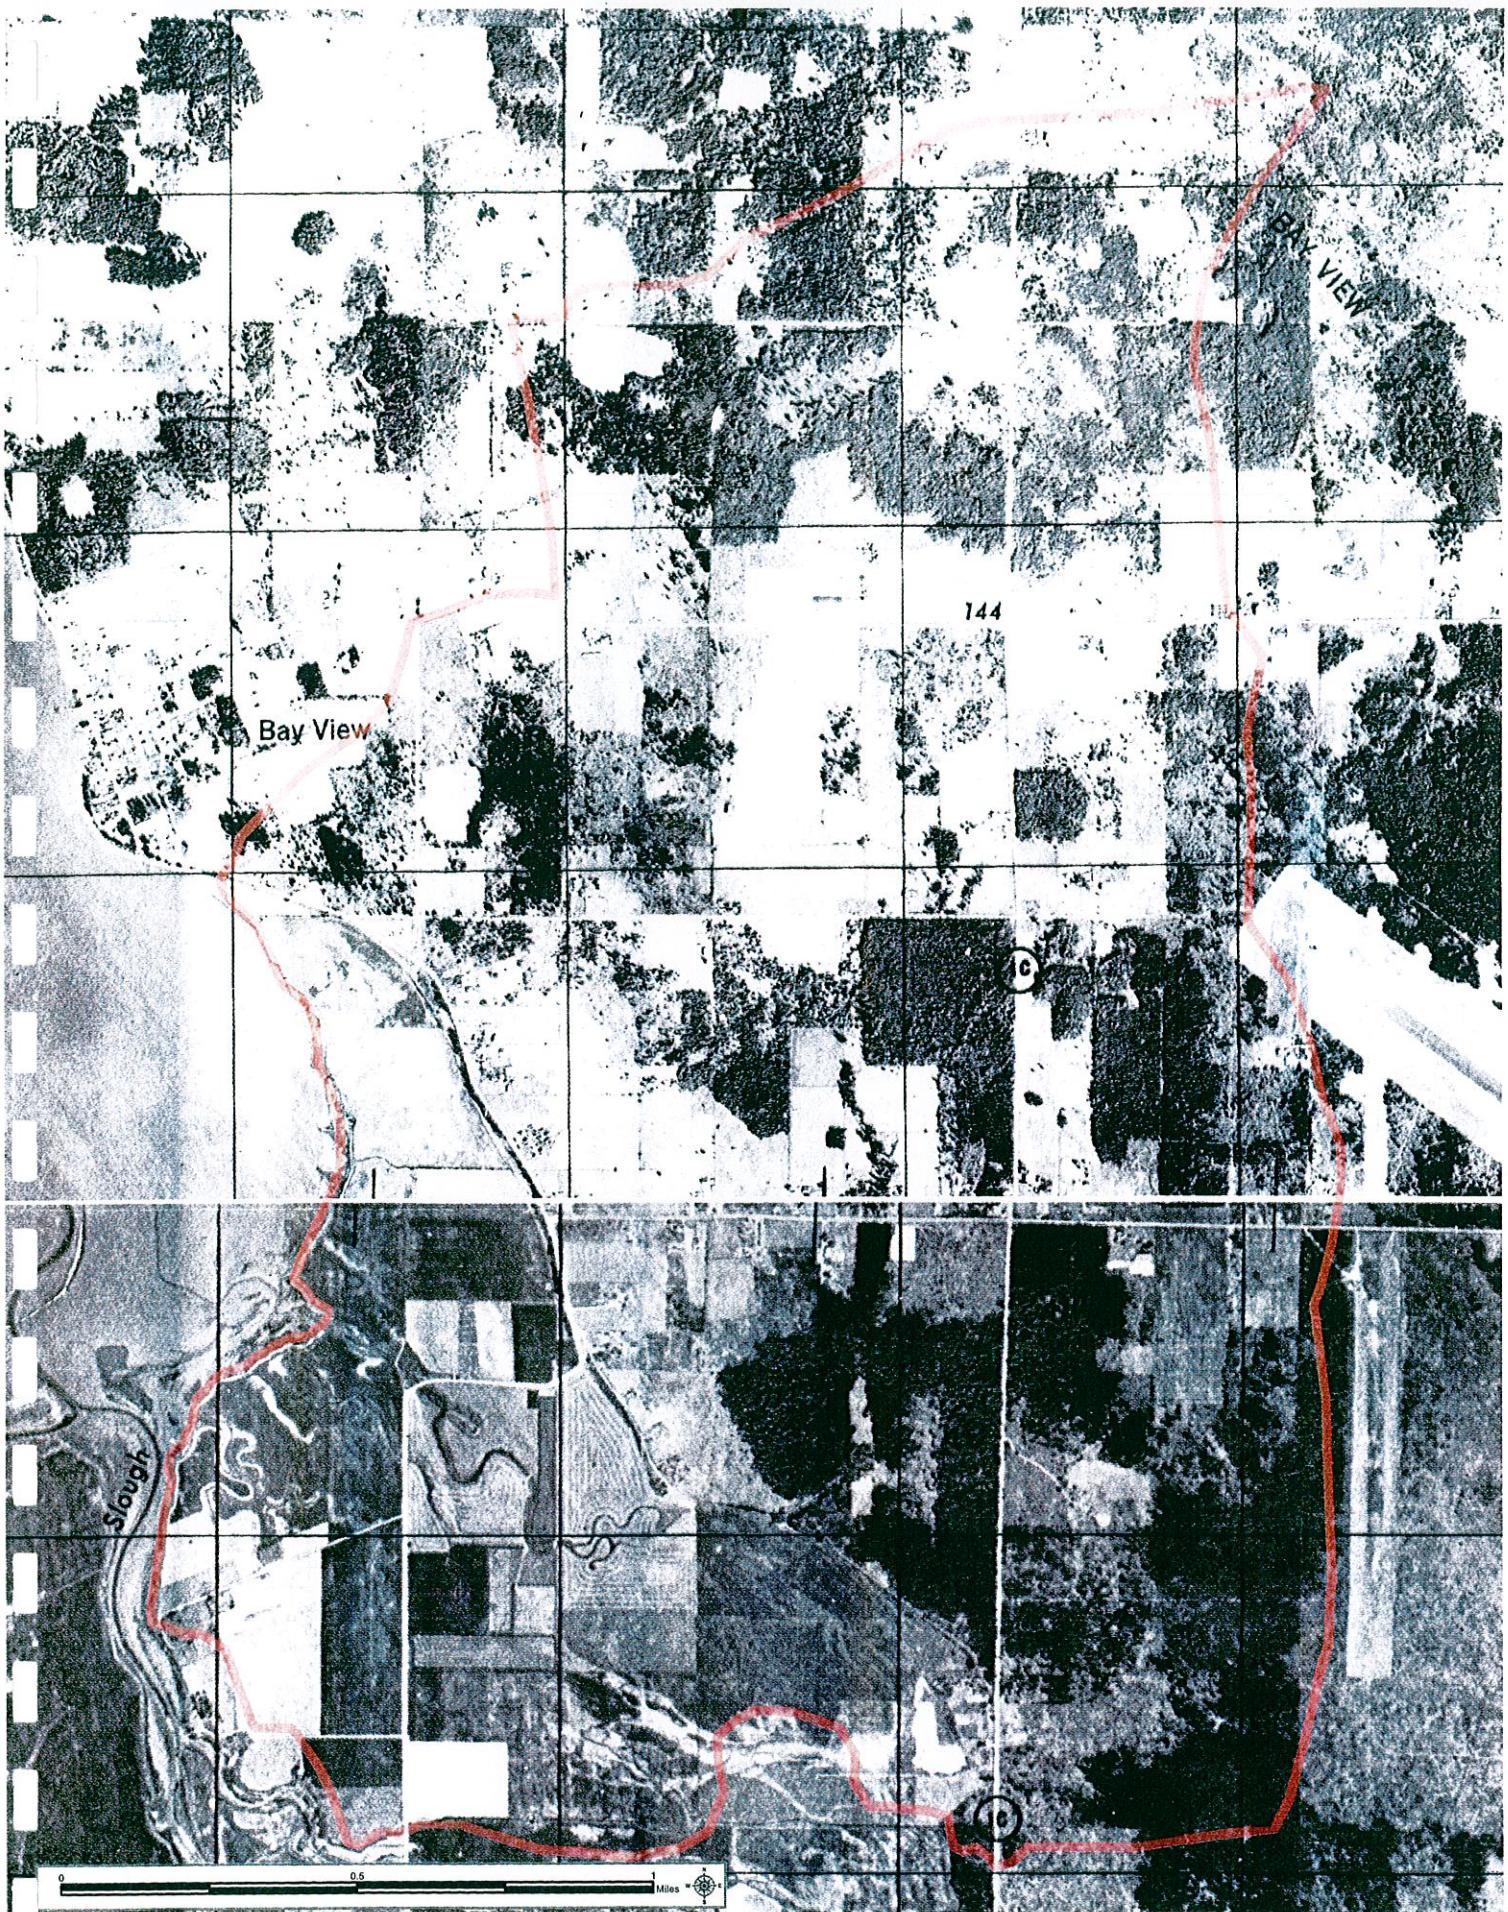
Historic Photo 2 No Name Watershed Boundary (in red) overlaid on 1941-1943 mosaic mage (source: COE).

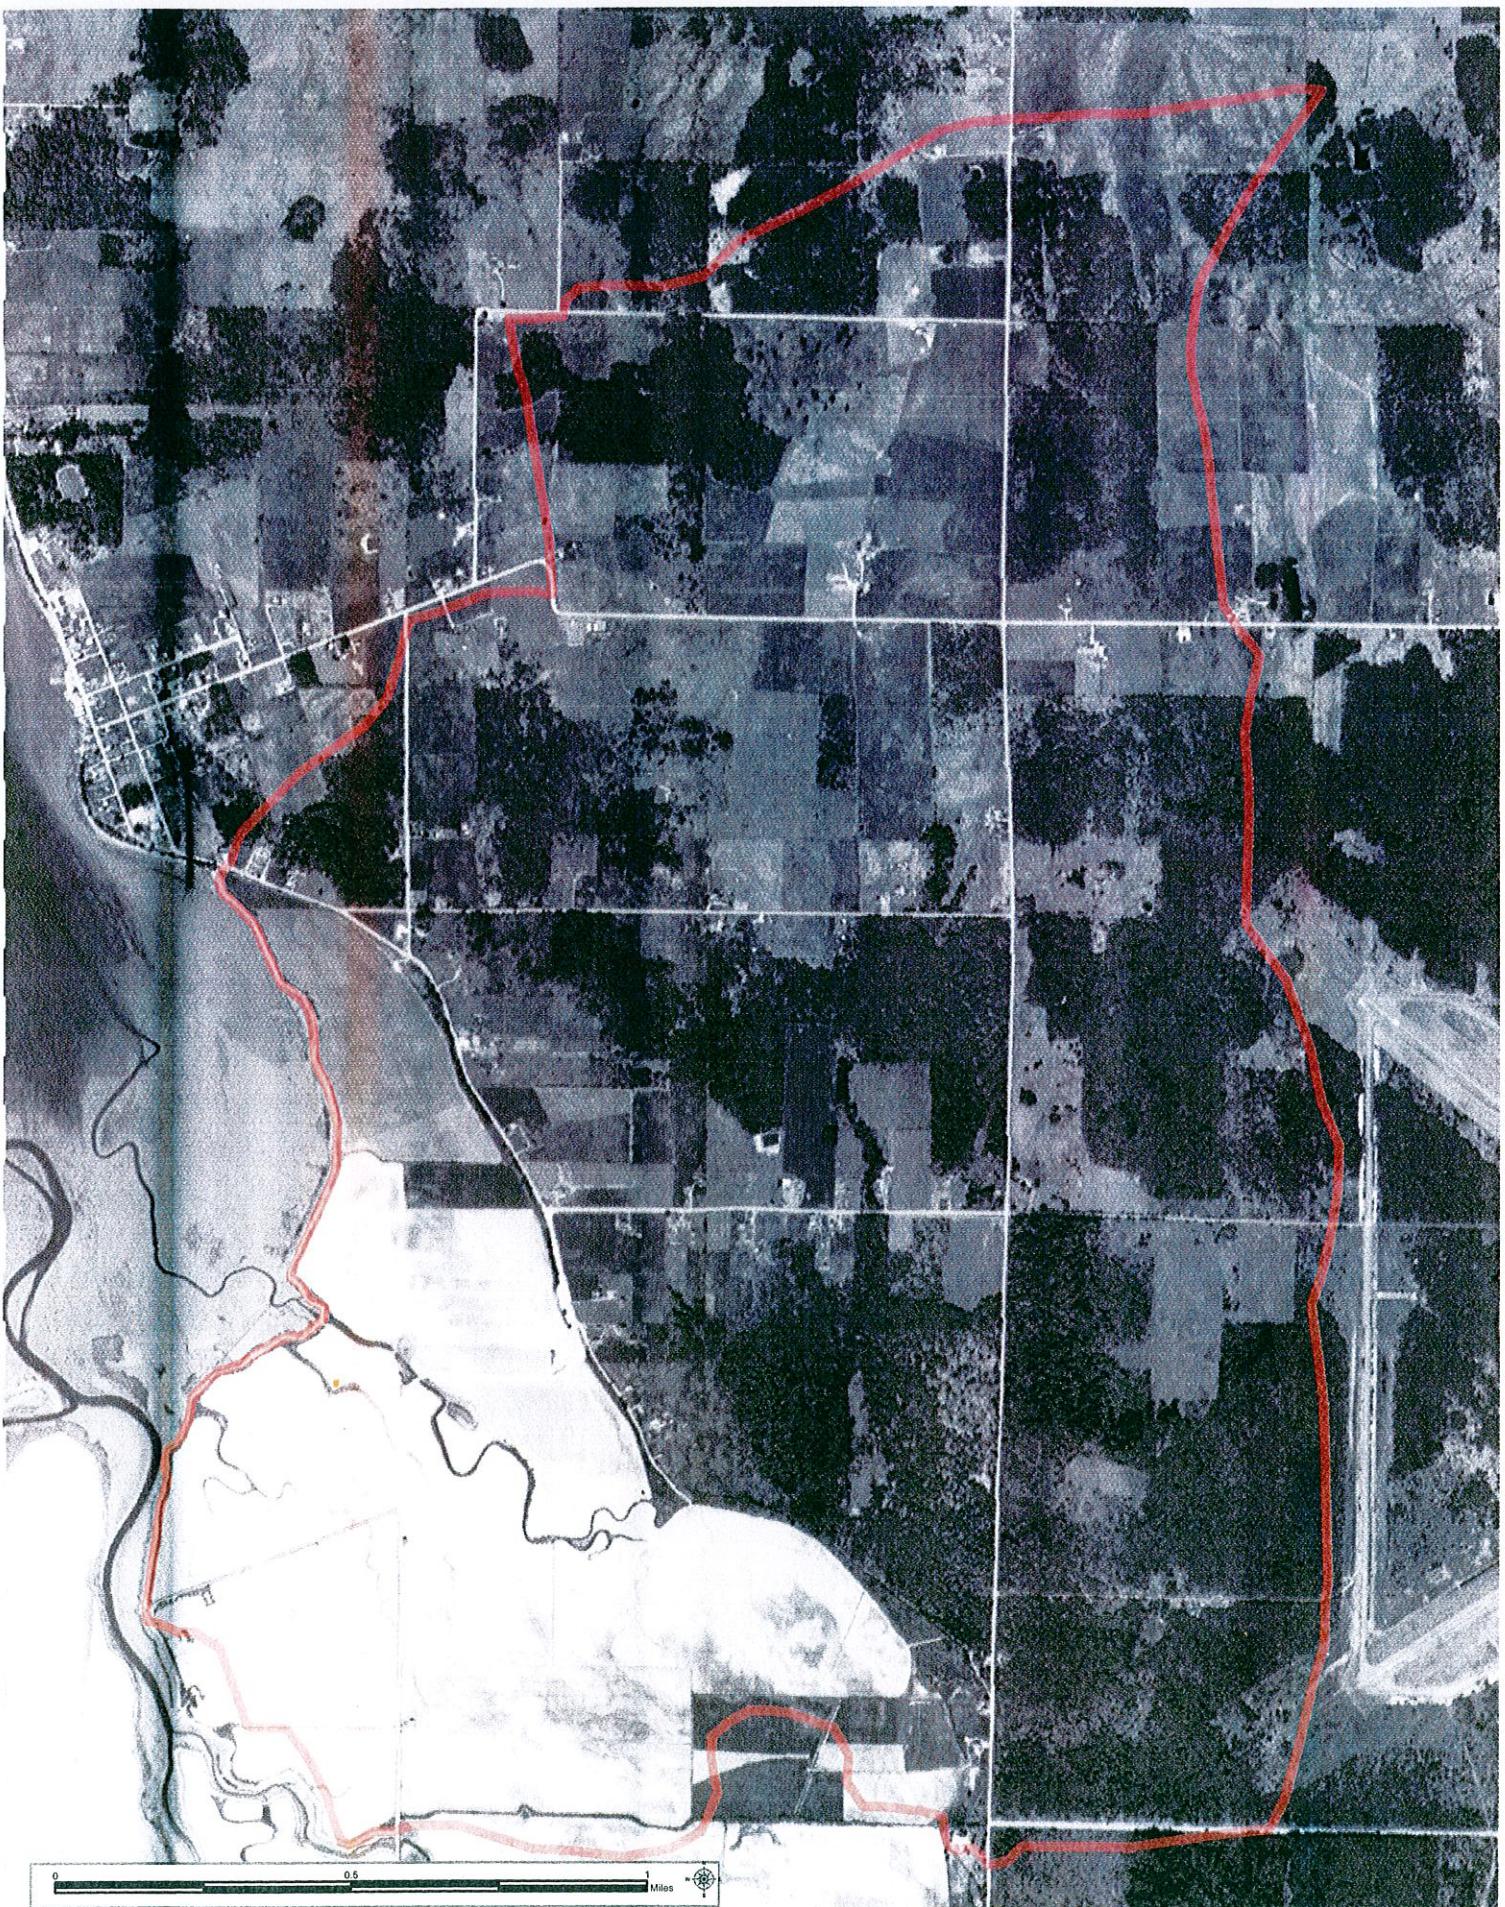
Historic Photo 3 No Name Watershed Boundary (in red) overlaid on 1966 image (source: US Department of Agriculture).
