# Skagit Stream Team Water Quality Report

*Citizen Monitoring Summary for Samish Bay, Padilla Bay,  
Ace of Hearts, Gages Slough, Trumpeter Basin,  
Kulshan Creek and Nookachamps Creek*

# 2017 - 2018 Annual Water Quality Report

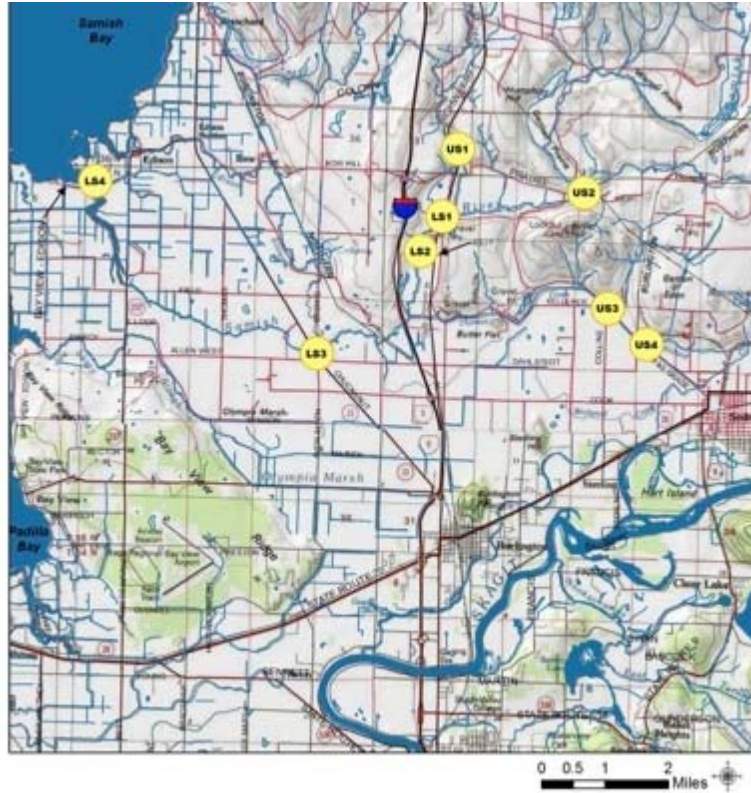
Figure 1. Map of Samish Sites

US1	Friday Creek @ Pomona Grange Park	N48°33'55.02 W122°20'49.49
US2	Swede Creek @ Grip Rd	N48°33'17.75 W122°17'16.23
US3	Thomas Creek @ F&S Grade Rd	N48°31'42.93 W122°16'44.69
US4	Willard Creek @ 8274 F & S Grade Rd	N48°31'13.65 W122°15'58.07
LS1	Hwy 99 Bridge over Samish River	N48°31'32.58 W122°20'24.78
LS2	Samish River @ Jolly Road	N48°32'25.47 W122°20'36.36
LS3	Chuckanut Bridge over Samish River	N48°31'0.69 W122°22'43.29
LS4	Mouth of the Samish River (boat dock)	N48°19'11 W122°19'47

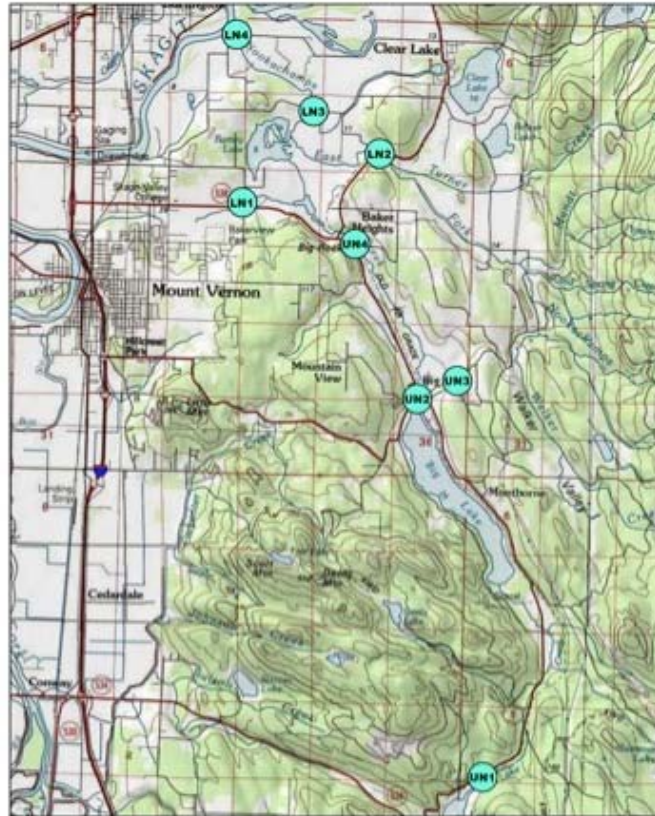
Figure 2. Map of Nookachamps Creek Sites

UN1	Lake McMurray Estates	N48°19'37 W122°13'10
UN2	Big Lake Outflow	N48°23'57 W122°14'24
UN3	Otter Pond Road	N4824'10 W122°13'44
UN4	Knapp Road	N4825'43 W122°15'32
LN1	SR 538 and N Waugh Road	N48°26'10.14 W122°17'29.88
LN2	SR 9 and Babcock	N48°26'45.56 W122°15'8.65
LN3	Swan Road	N48°27'13.79 W122°16'17.84
LN4	Francis Road	N48°28'5.47 W122°17'38.72

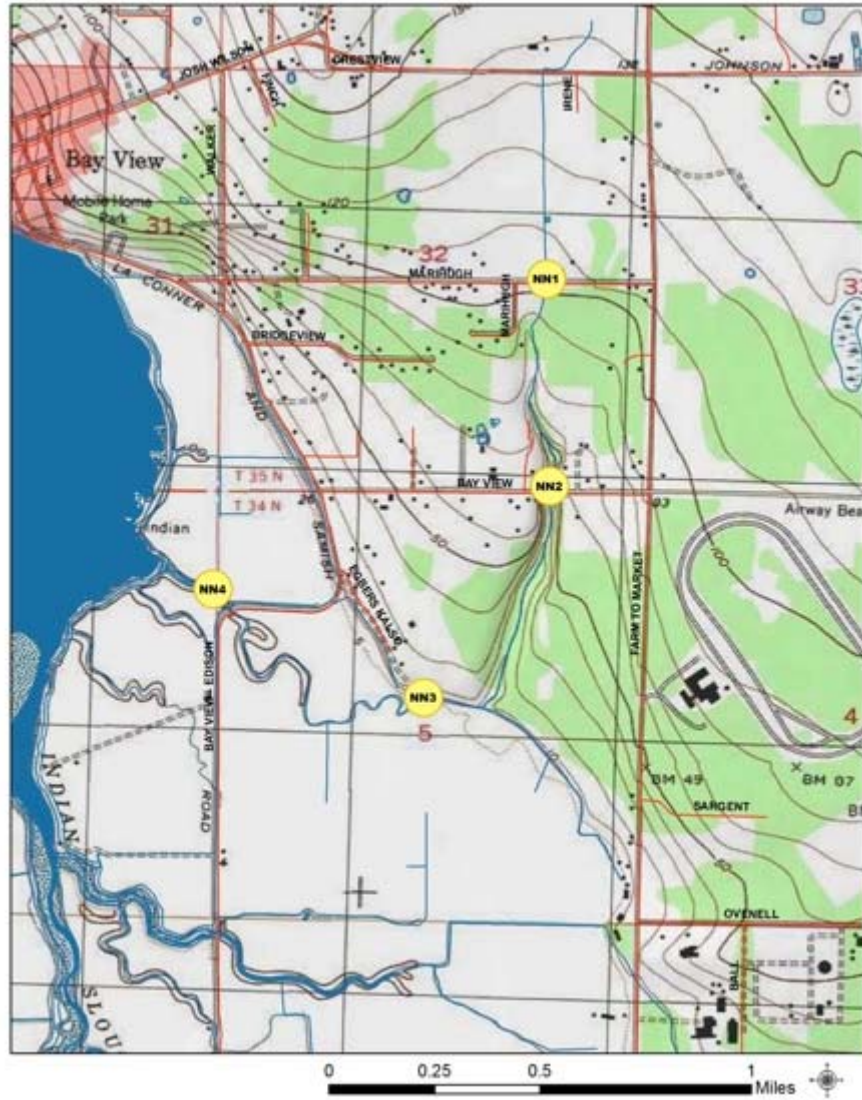
Figure 3. Map of No Name Slough Sites

NN1	Marihugh Road Culvert	N48°17'53. W122°17'31
NN2	Bay View Road Ravine	N48°18'121 W122°17'41
NN3	Egber's Field Bridge	N48°18'30. W122°17'53
NN4	Field Culvert, Bay View-Edison Road	N48°19'11 W122°19'47

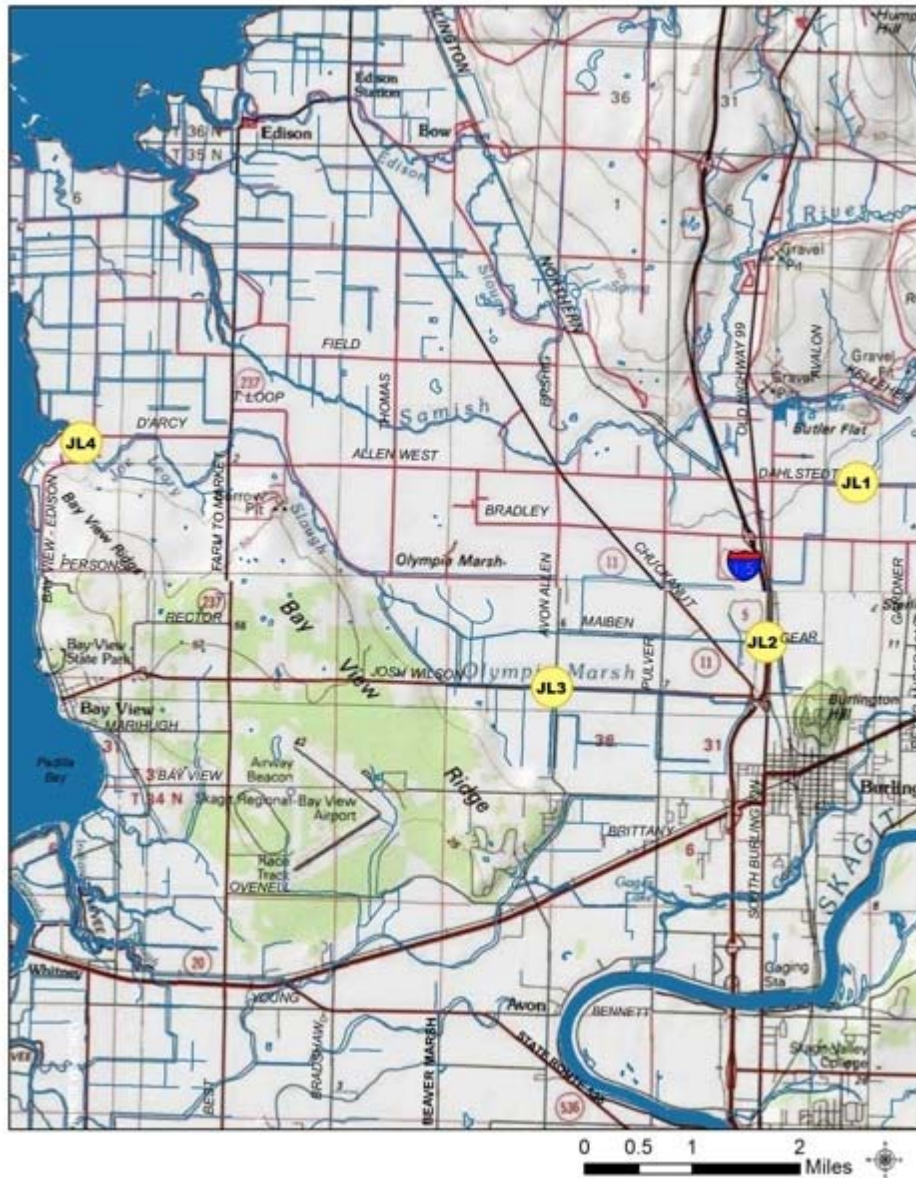
Figure 5. Map of Joe Leary Slough Sites

JL1	Dahlstedt Road	N48°30'53.35 W122°19'2.46
JL2	Hwy 99	N48°29'35.37 W122°20'6.61
JL3	Wilson Rd and Avon-Allen Rd.	N48°29'11.33 W122°22'41.96
JL4	Tide Gate	N48°31'4.90 W122°28'27.87

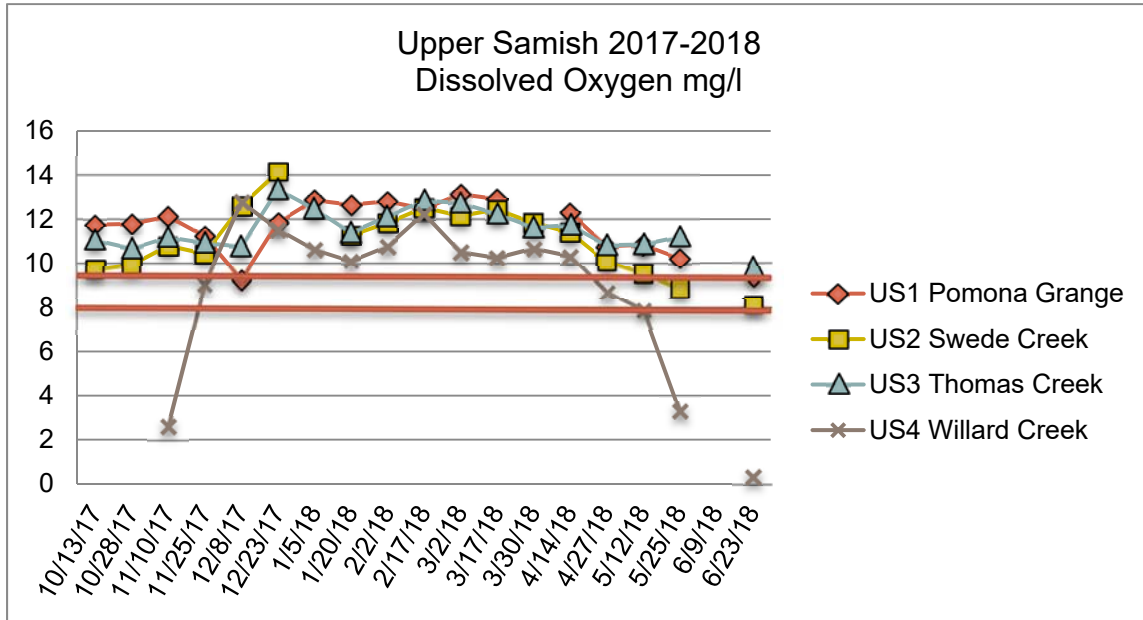
Figure 10. Upper Samish DO: 2017-2018

For dissolved oxygen, Sites 1 and 3 maintained levels above the state standard. As in past years, Site 4, the Willard Creek site had the lowest levels, with 4 occurrences below the state standard of 8.0 mg/l. Site 2, Swede Creek is considered core summer salmonid habitat, and should maintain DO levels above 9.5 mg/l. It dropped below 9.5mg/l twice in May and June.

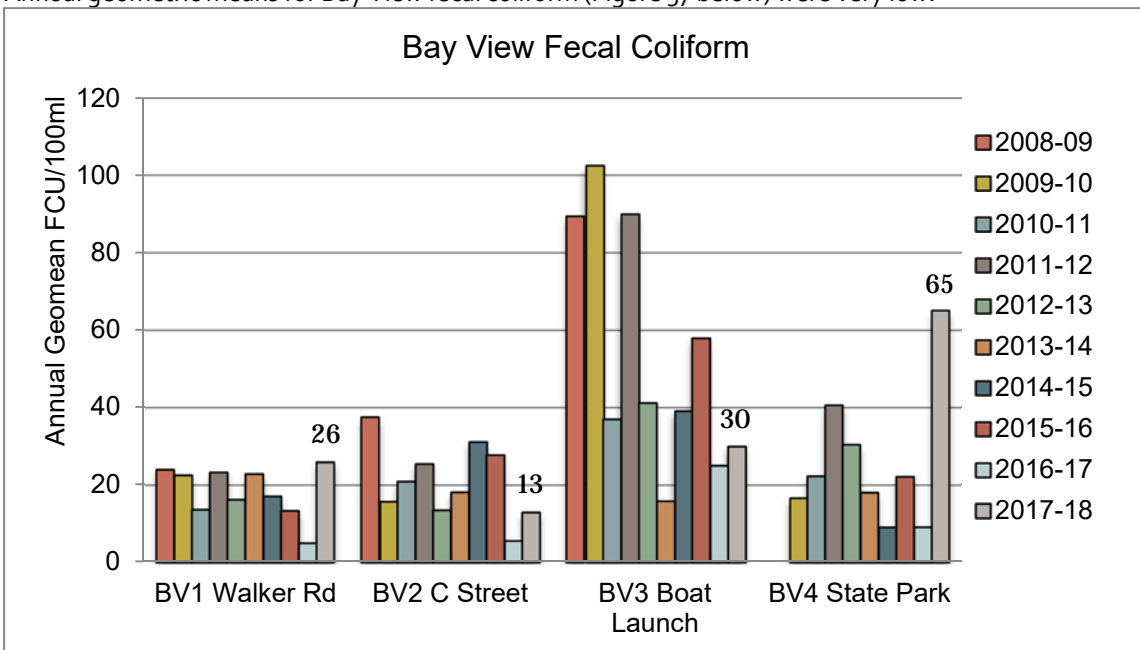
Figure 57. Bay View Drainage Fecal Coliform: Ten-year comparison

Annual geometric means for Bay View fecal coliform (Figure 57 below) were very low.
