# Skagit Stream Team Water Quality Report

*Citizen Monitoring Summary for Samish Bay, Padilla Bay,  
Ace of Hearts, Gages Slough, Trumpeter Basin,  
Kulshan Creek and Nookachamps Creek*

2018 - 2019 Annual Water Quality Report

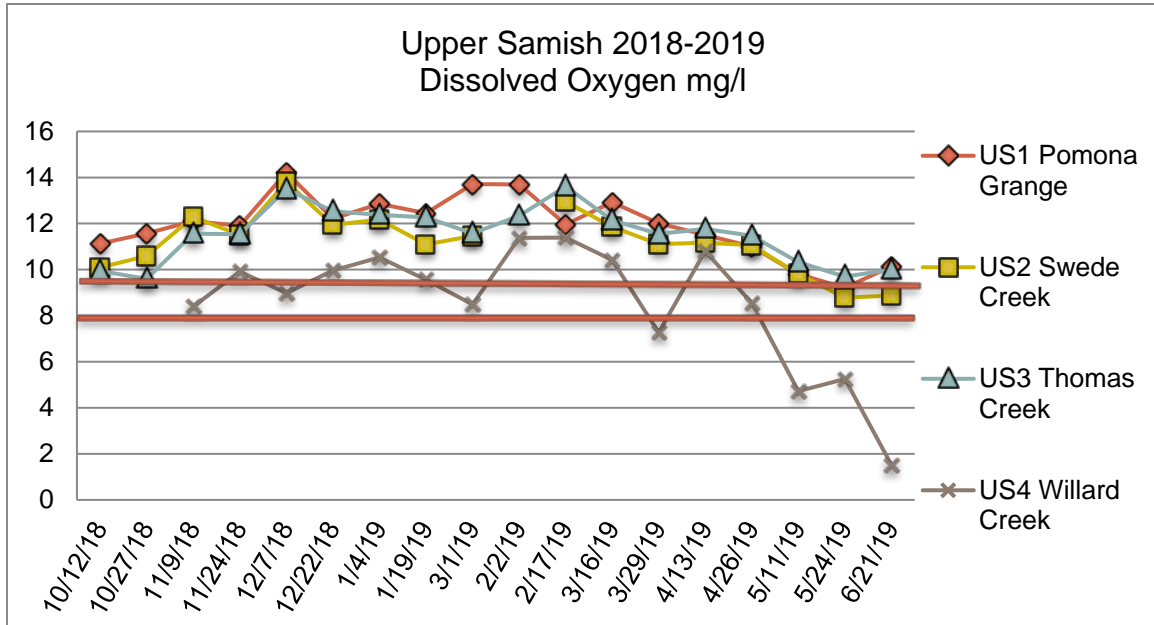
Figure 10. Upper Samish DO: 2018-2019

For dissolved oxygen, Sites 1 and 3 maintained levels above the state standard. As in past years, Site 4, the Willard Creek site had the lowest levels, with 4 occurrences below the state standard of 8.0 mg/l. Site 2, Swede Creek is considered core summer salmonid habitat, and should maintain DO levels above 9.5 mg/l. It dropped below 9.5mg/l twice in May and June.

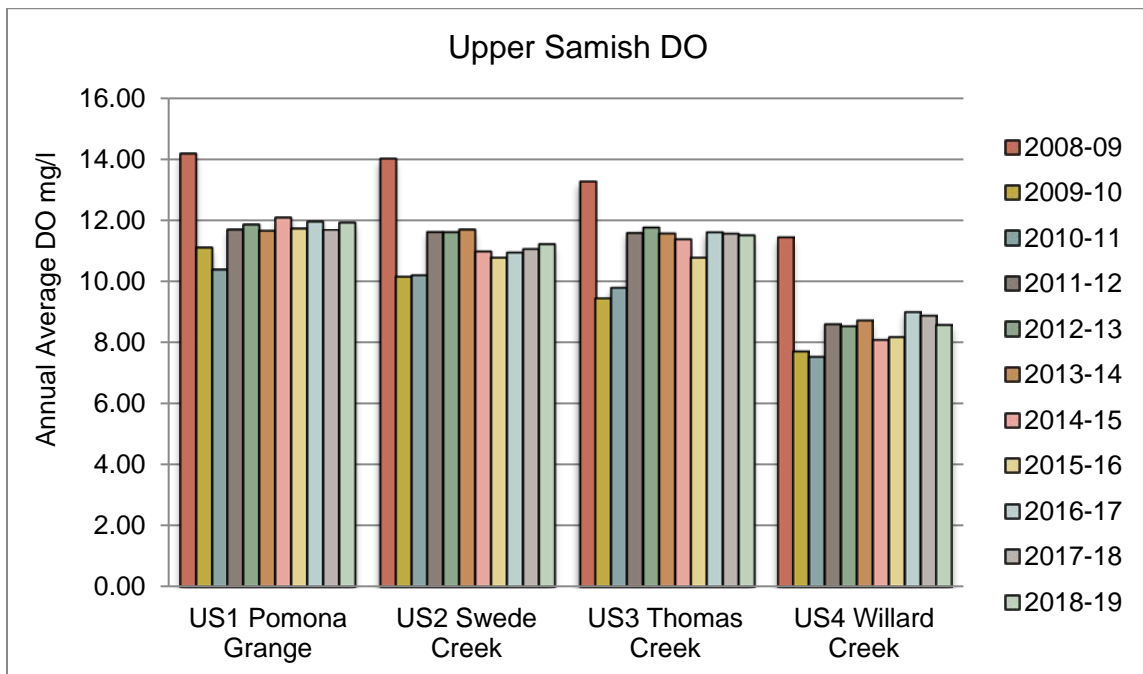
Figure 11. Upper Samish DO: Eleven-year comparison

Figure 11 below shows a comparison of Upper Samish sites over the past 9 years.

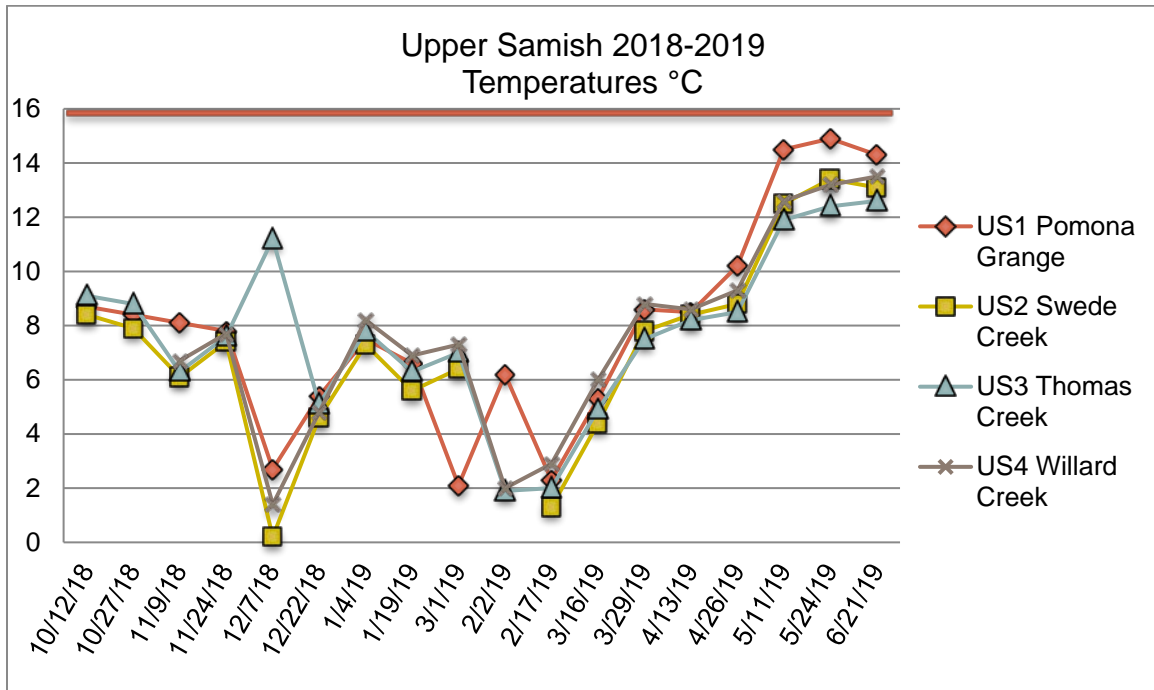
Figure 12. Upper Samish Temperature: 2018-2019

Though all temperature readings during the sampling season fell within state standard temperatures, sampling stopped before the warm season. Temperatures were similar for all Upper Samish sites. Average temperatures have steadily decreased from their 2014-2015 high.

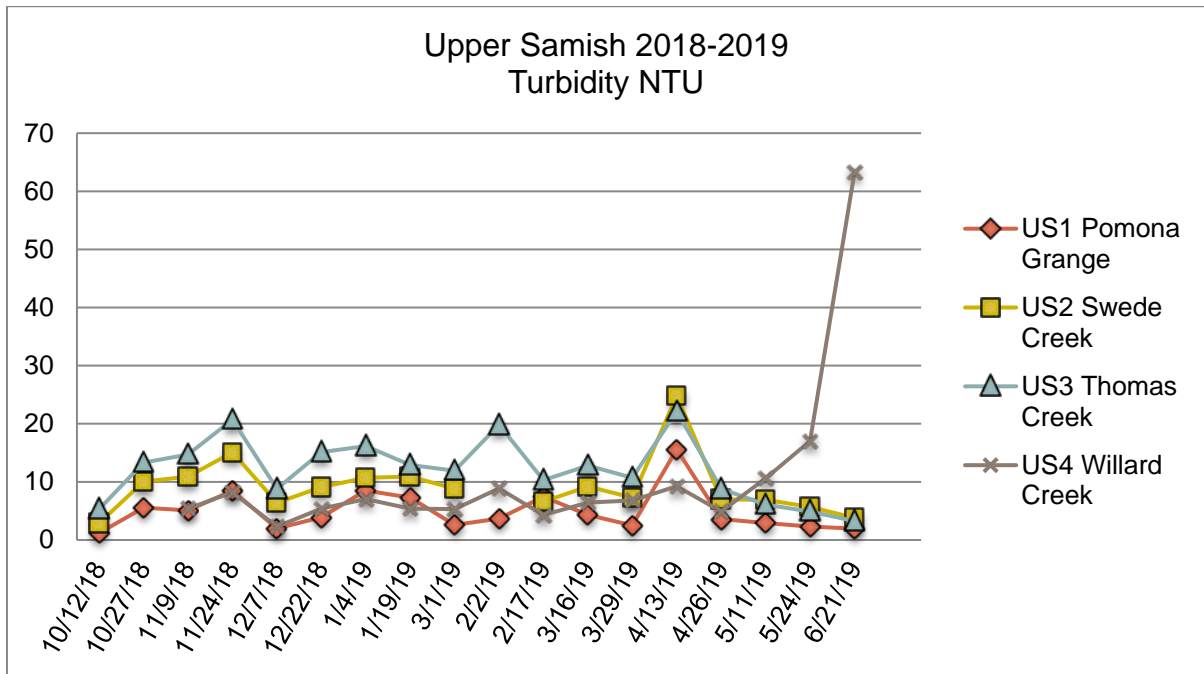
Figure 14. Upper Samish Turbidity: 2018-2019

Turbidity levels in the Upper Samish (Figure 15) were slightly higher at Site 3, Thomas Creek, and lowest at Site 1, Pomona Grange. The high turbidity levels on 6/21/2019 corresponded to a large rise in fecal coliform levels. (See figure 16.)

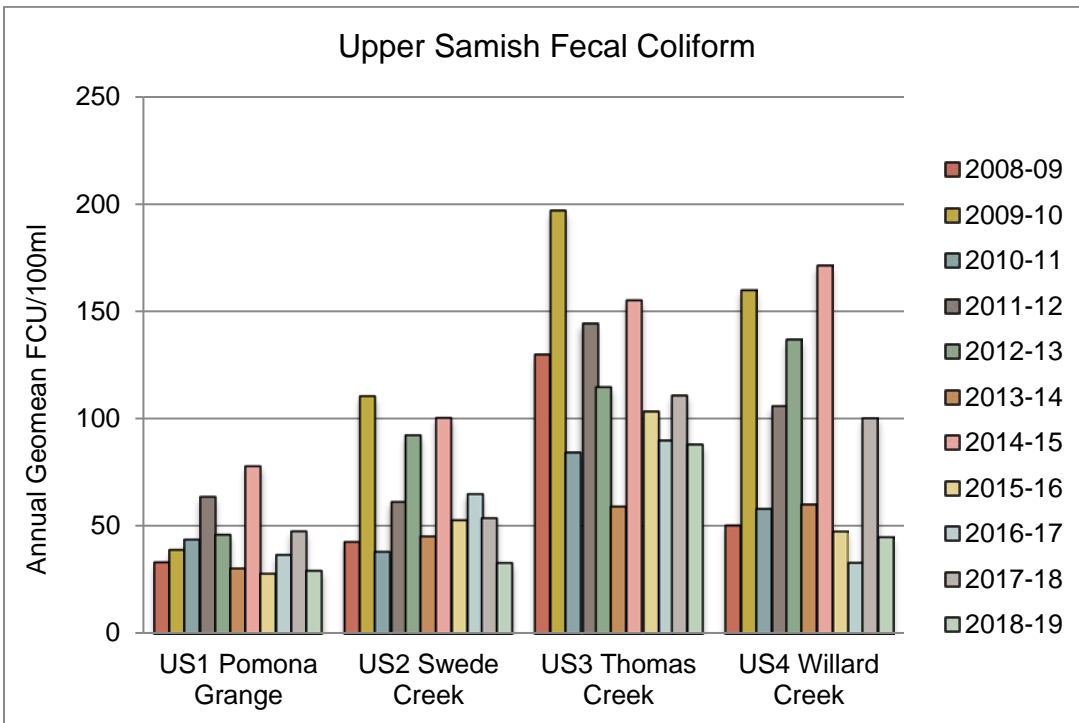
Figure 17. Upper Samish Fecal Coliform: Eleven-year comparison

Fecal coliform levels in the Upper Samish watershed were highest at Site 3. All sites met the state standard of 100CFU/100ml. Sites 1 and 2 had fewer than 10% of the samples over 200 CFU/100ml and therefore met both standards.

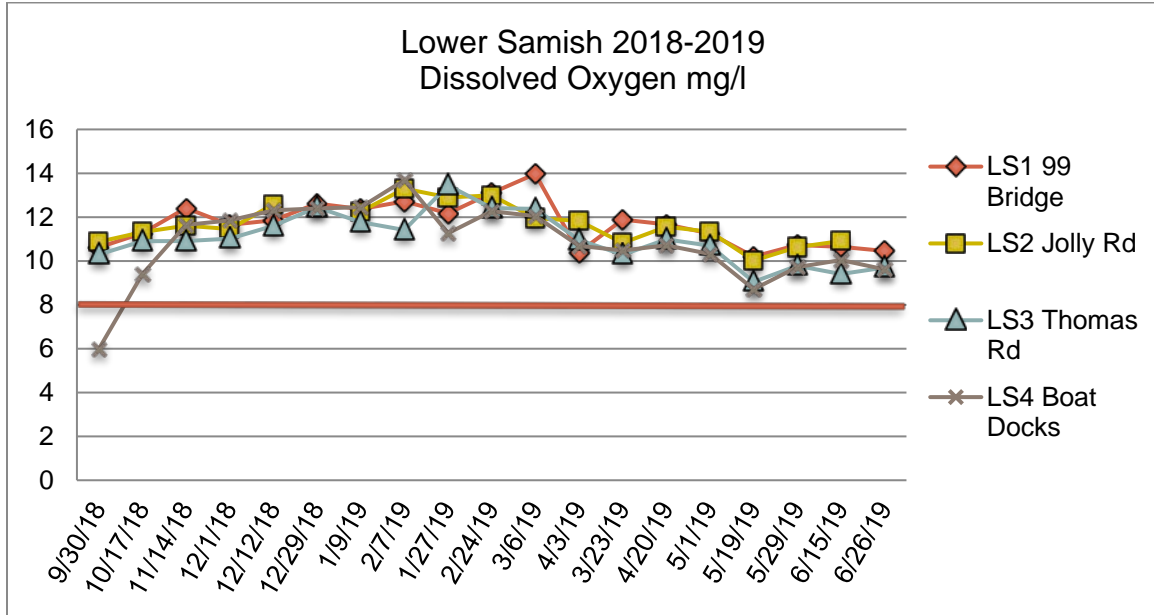
Figure 18. Lower Samish DO: 2018-2019

Dissolved oxygen levels were similar for all sites, staying above 8mg/l through the sampling season with one exception at Site 4. Sites were not sampled during the warmest summer months when dissolved oxygen is likely to be lowest.

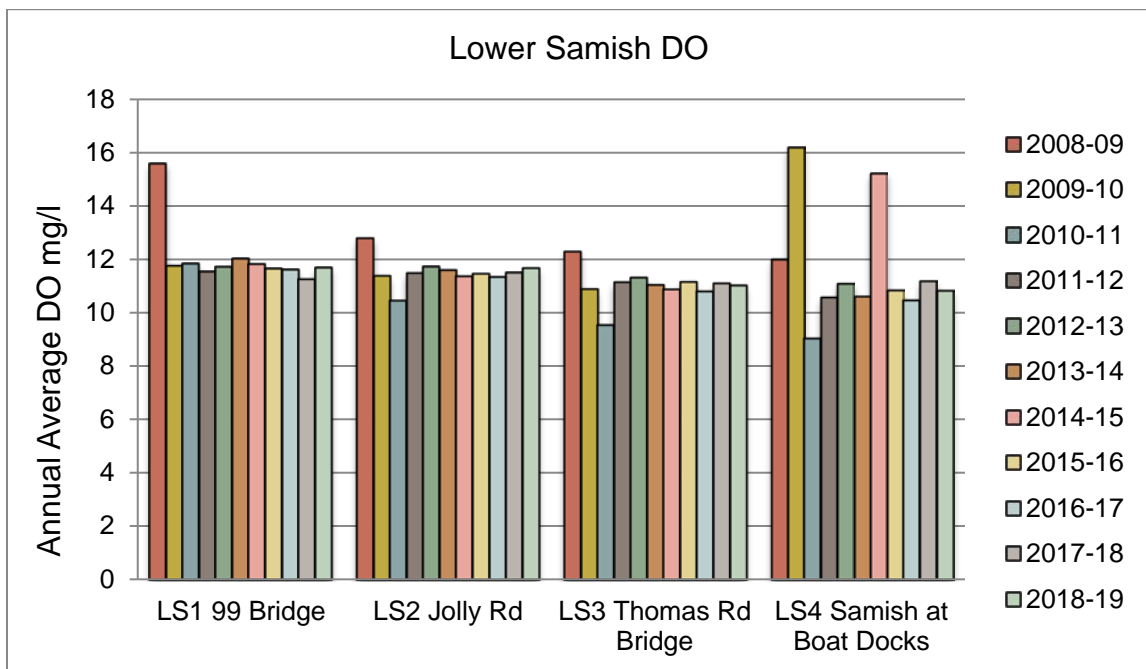
Figure 19. Lower Samish DO: Eleven-year comparison

Average dissolved oxygen levels (Figure 19) have been consistent over ten years at sites 1-3. The standard is based on the lowest single day, not on an annual average.

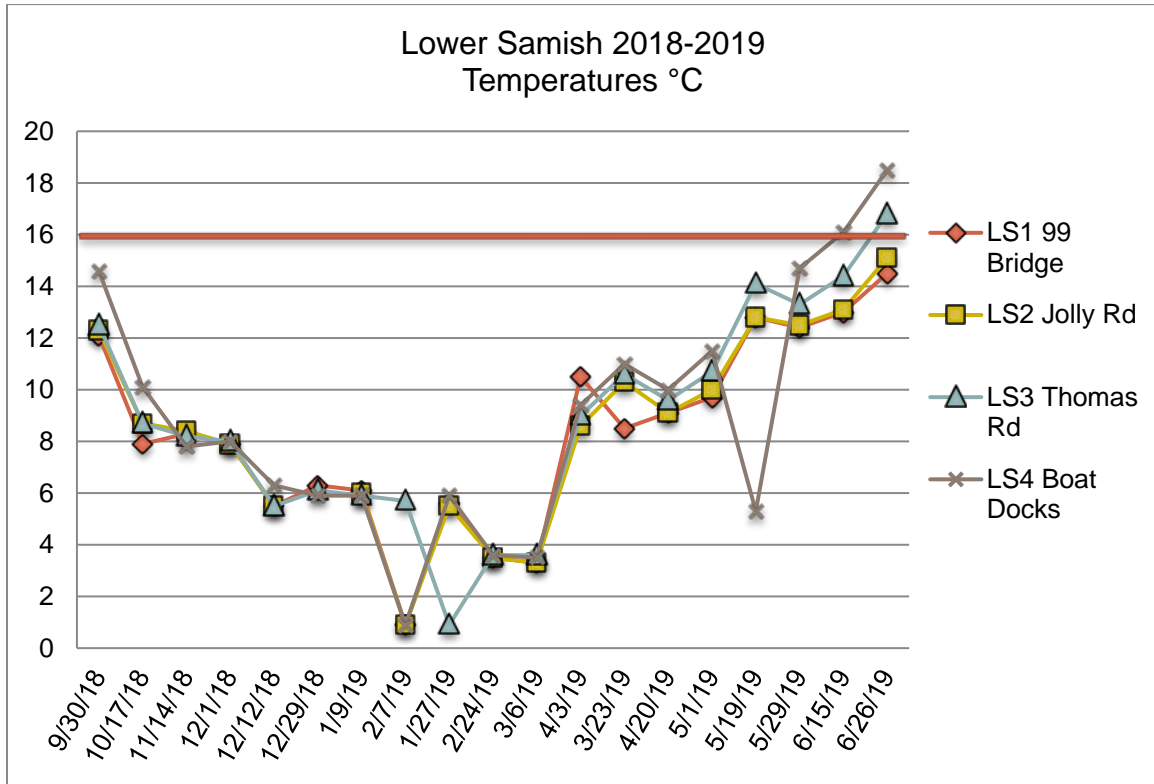
Figure 20. Lower Samish Temperature: 2018-2019

Temperatures went above 16 °C in June at sites 3 and 4. Sampling stopped before the warmest months.

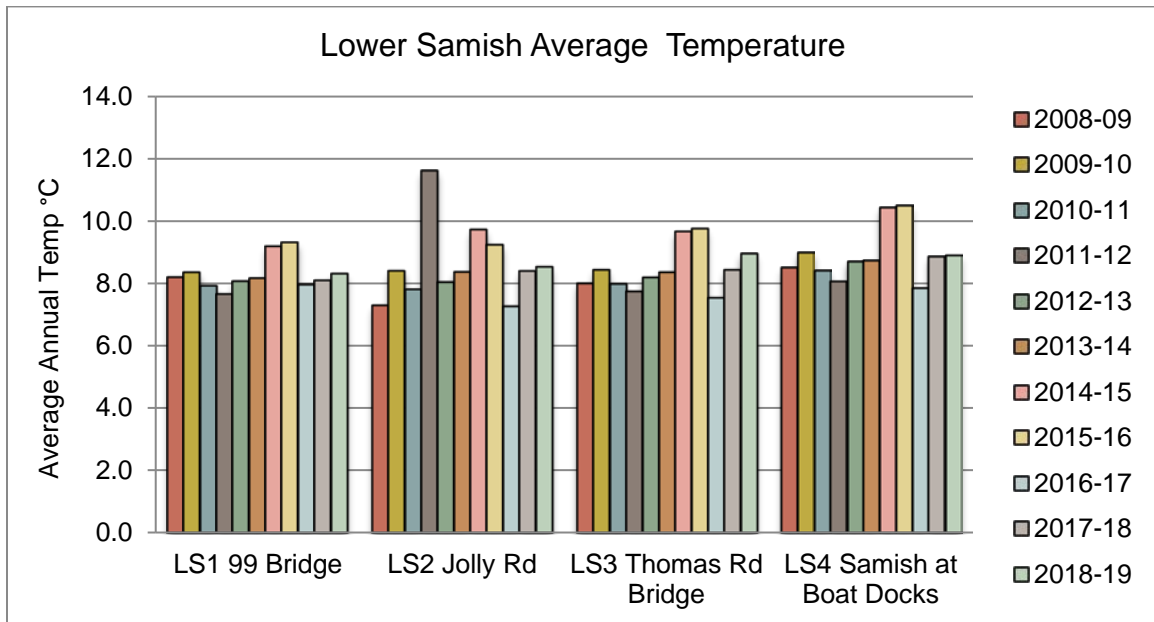
Figure 21. Lower Samish Temperature: Eleven-year comparison

Average temperatures stayed below the high temperatures of 2014-2016. Standards are not based on average temperatures.

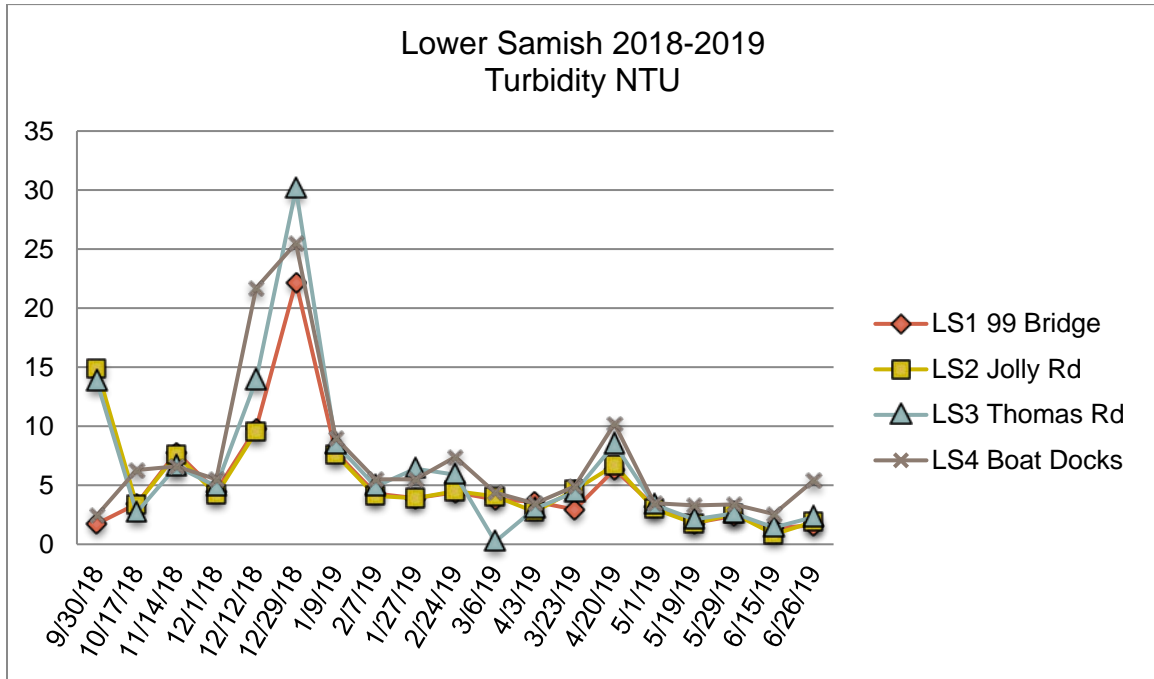
Figure 22. Lower Samish Turbidity: 2018-2019

The spike in turbidity 12/29/2018 corresponds to an inch of rainfall the previous 24 hours.

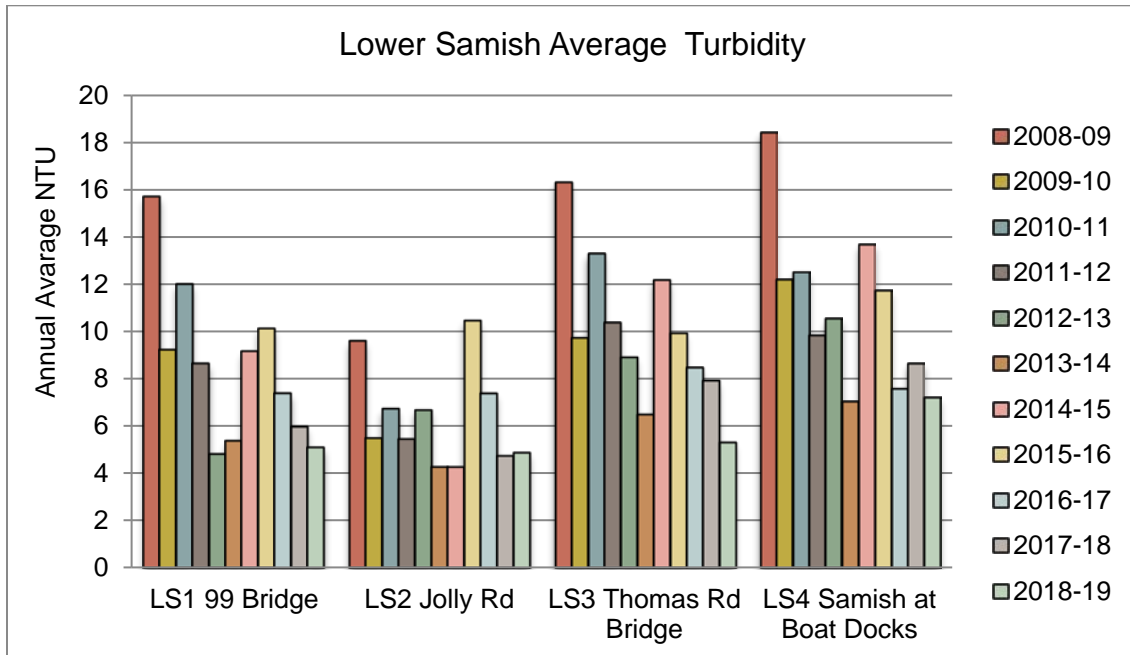
Figure 23. Lower Samish Turbidity: Eleven-year comparison

Turbidity levels have trended downward over the past ten years.

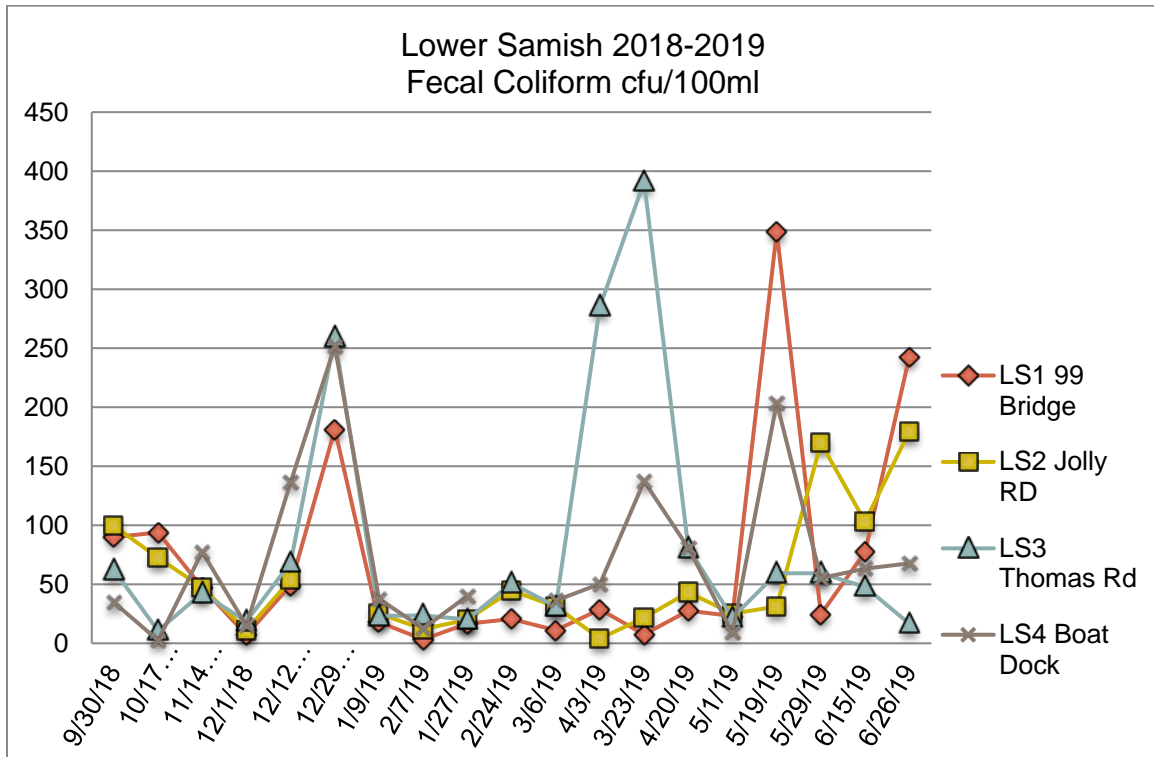
Figure 24. Lower Samish Fecal Coliform: 2018-2019

Fecal Coliform levels for the Lower Samish were higher than last year at sites 3-5, with multiple incidents of high counts throughout the spring.

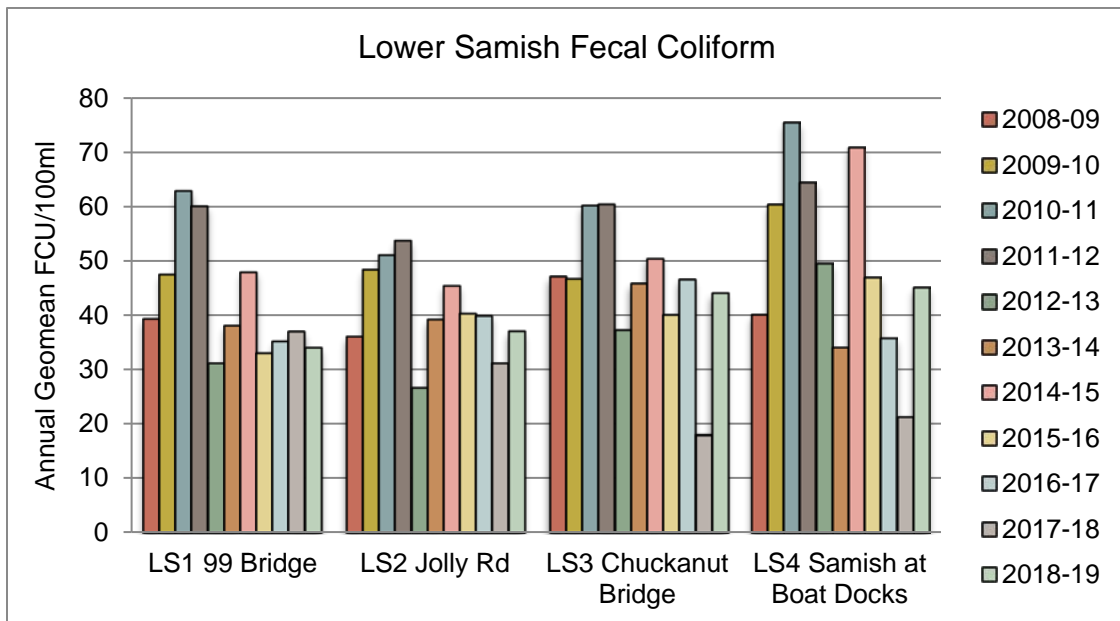
Figure 25. Lower Samish Fecal Coliform: Eleven-year comparison

Geometric mean averages for fecal coliform (Figure 26) for all four sites were well below 100 CFU/100 ml. Last year, all four sites had fewer than 10% of the samples over 200 CFU.100 ml. This year, only site 2 met that standard.

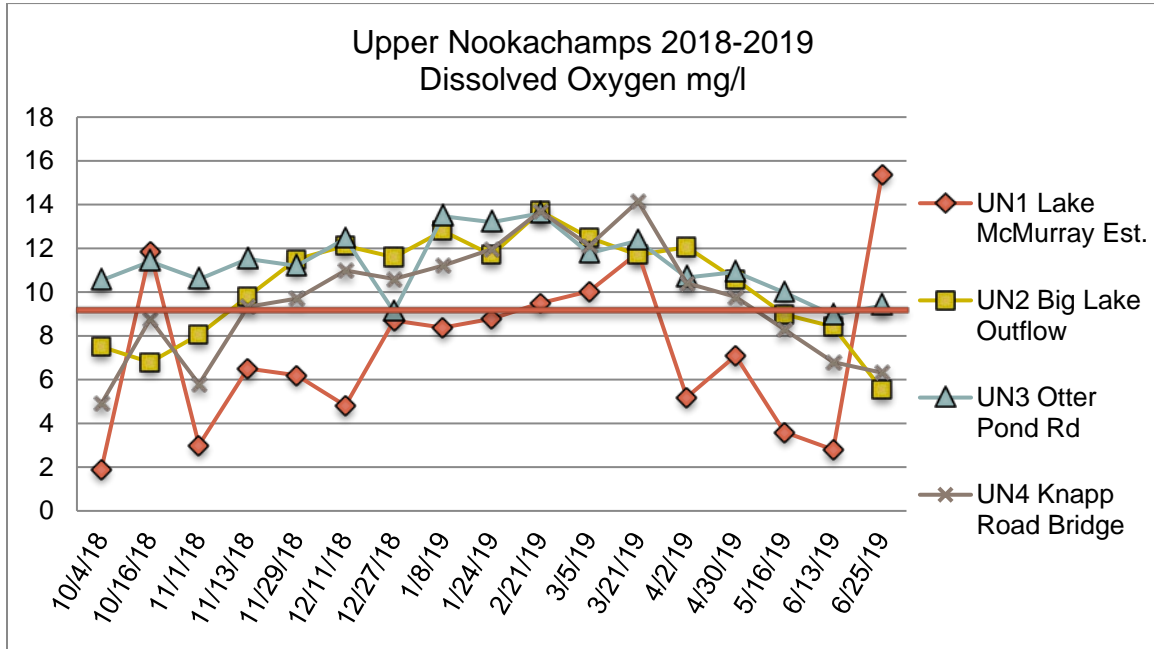
Figure 26. Upper Nookachamps DO: 2018-2019

All four sites had DO levels below 9.5 mg/l multiple times. Once again, Site 1 was below 9.5<sup>o</sup> much of the season, and was usually the lowest of the four sites.

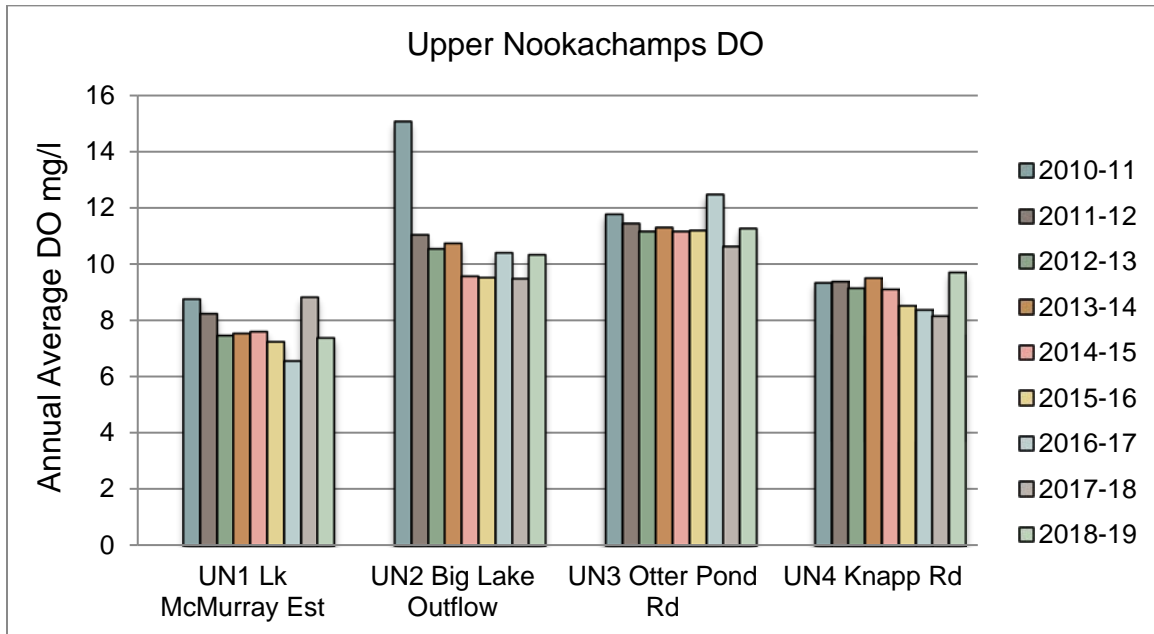
Figure 27. Upper Nookachamps DO: Nine-year comparison

Site 4 average DO was the highest in nine years. State standards are based on the single lowest measurement, not on annual averages, so to see averages below 9.5<sup>o</sup>C indicates a serious, long-term problem.

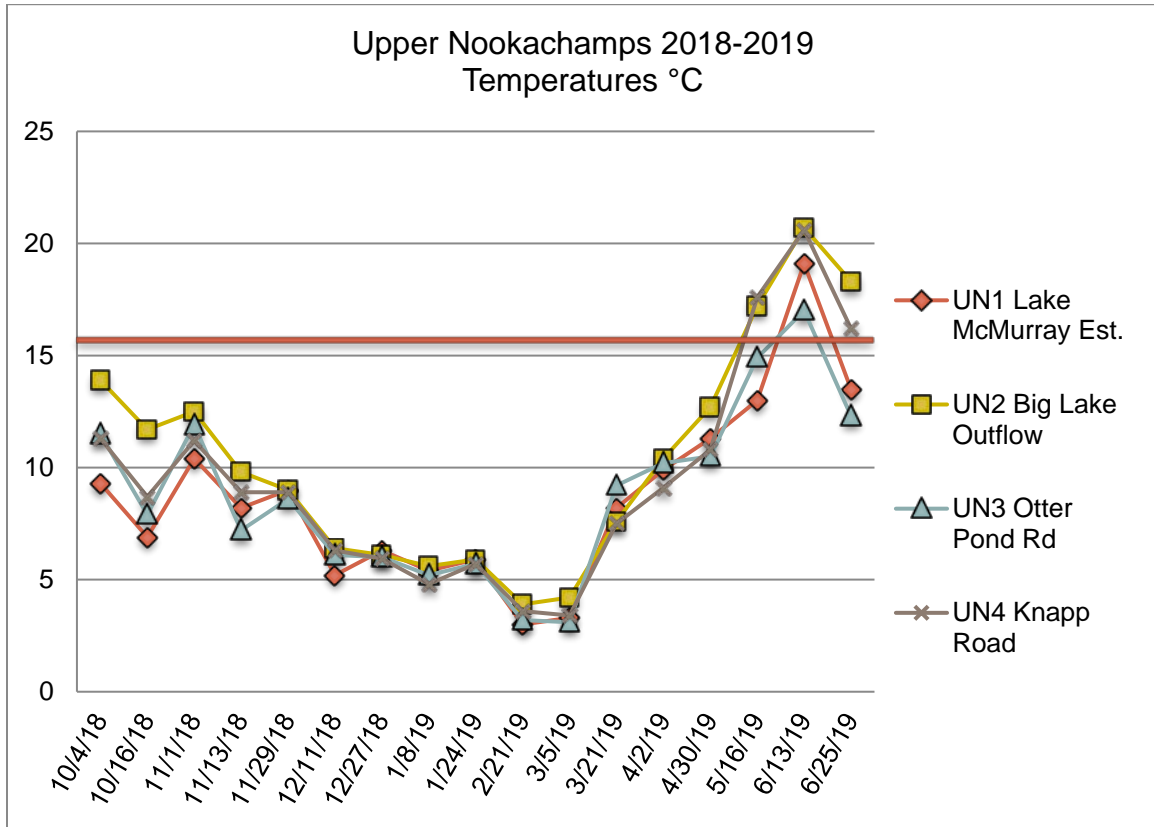
Figure 28. Upper Nookachamps Temperature: 2018-2019

Temperatures for Upper Nookachamps sites went above the standard of 16° in June.

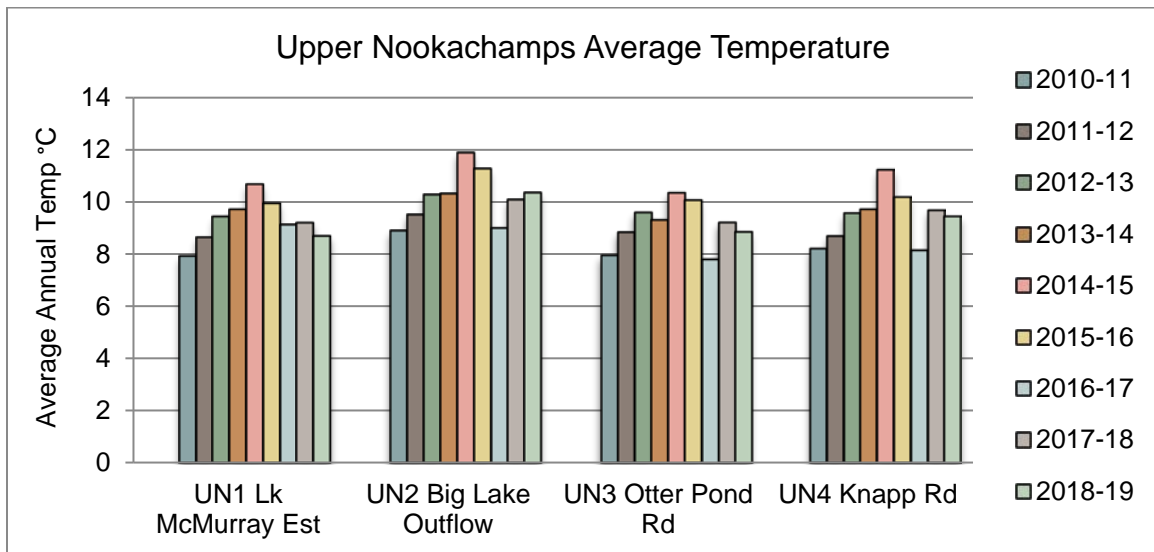
Figure 29. Upper Nookachamps Temperature: Nine-year comparison

Average temperatures for all Upper Nookachamps sites were comparable to the previous year, and lower than the highest temperatures in 2014-15. State standards are not based on average annual temperature.

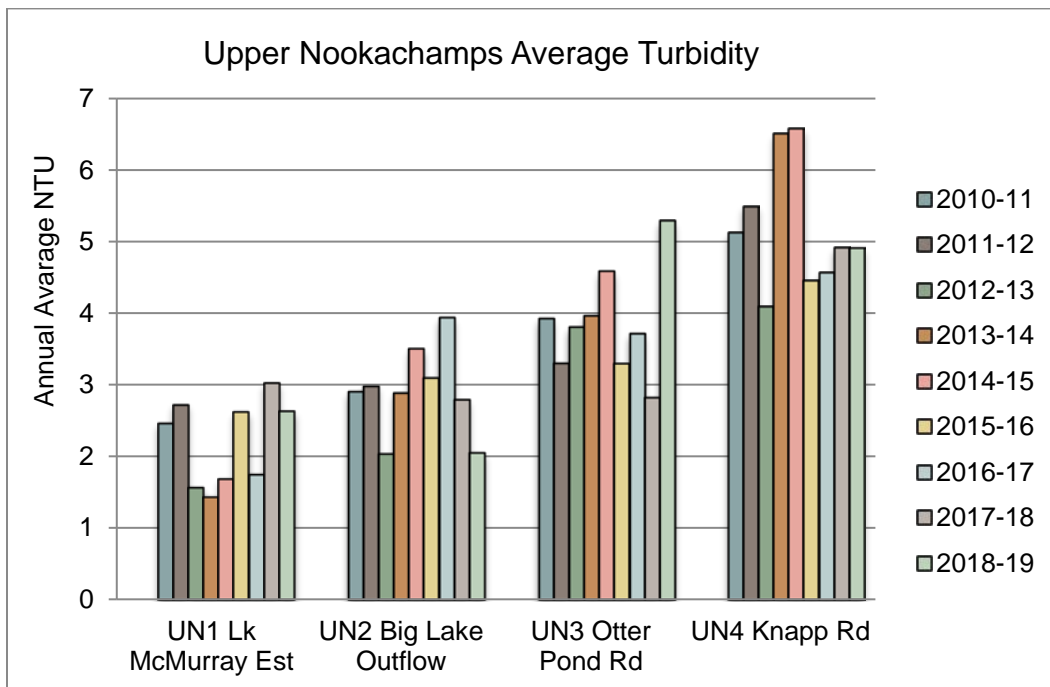
Figure 31. Upper Nookachamps Turbidity: Nine-year comparison

Site 3 had higher average turbidity levels than site 4, due to an abnormally high event on November 1.

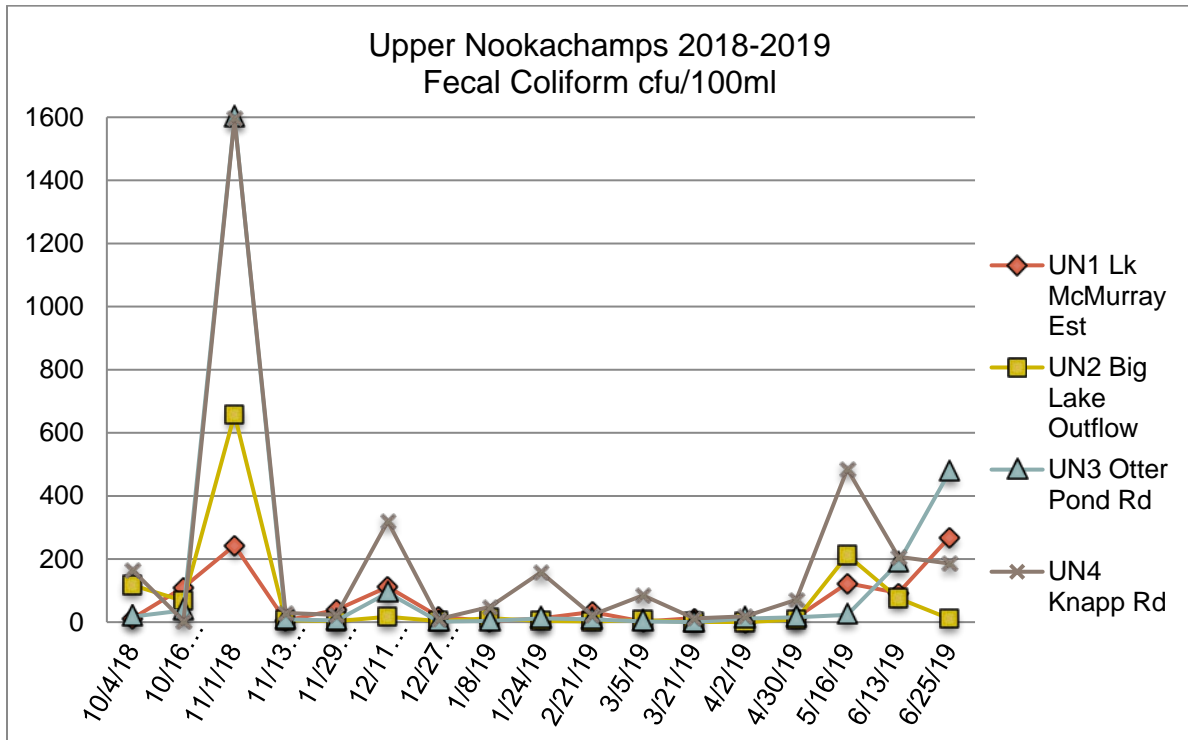
Figure 32. Upper Nookachamps Fecal Coliform: 2018-2019

Fecal coliform levels (Figure 32 below) stayed relatively low through the season for Sites 1-3. Site 4 was more variable, with several very high counts.

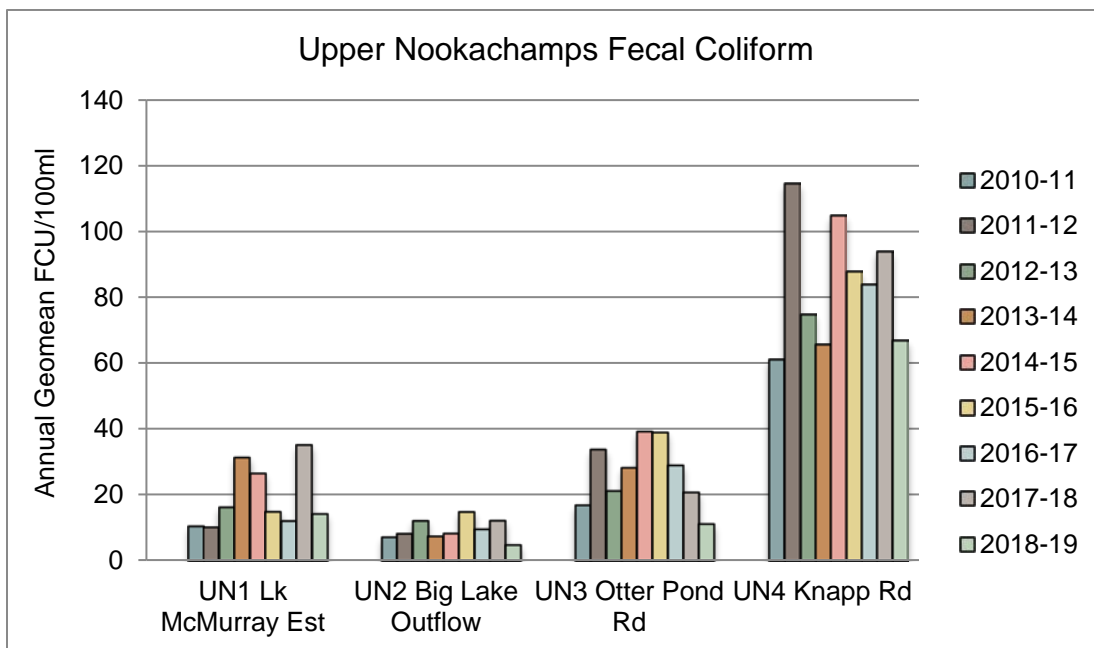
Figure 33. Upper Nookachamps Fecal Coliform: Nine-year comparison

Annual geometric means for fecal coliform for all Sites (Figure 33 below) met part 1 of the state standard (100 CFU/100ml). None of the sites met part 2 with <10% of samples below 200 CFU/100ml, though site 2 came very close with 2 out of 20 samples above 200CFU/100ml.

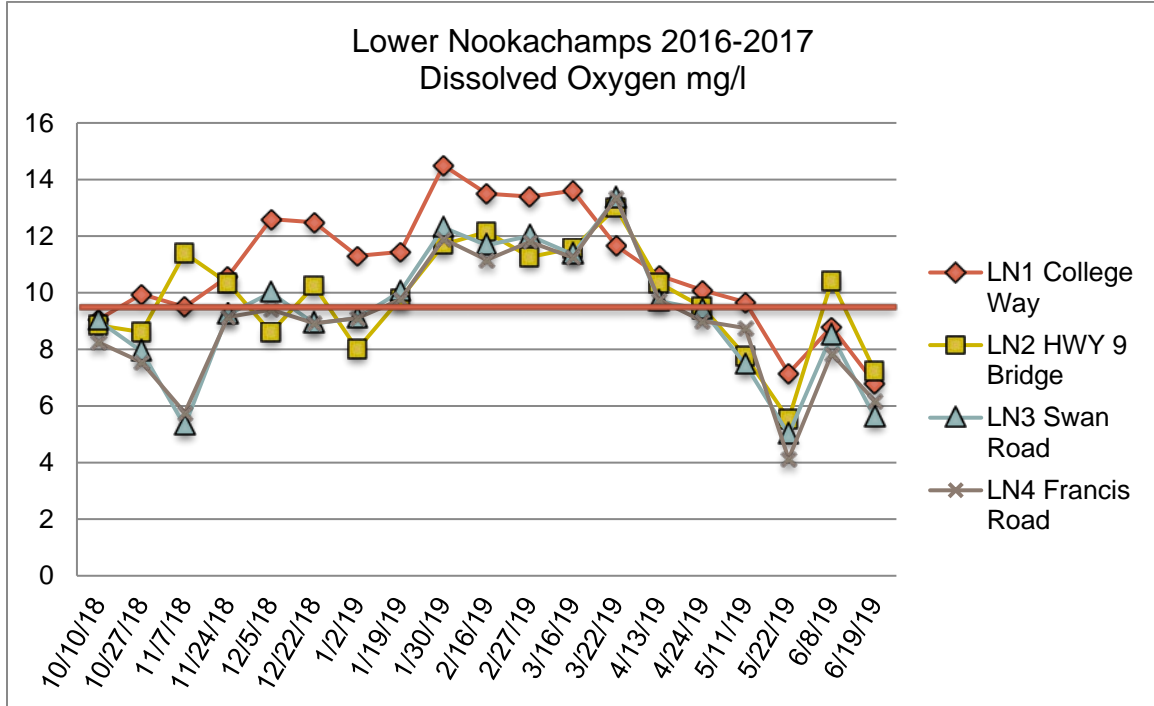
Figure 34. Lower Nookachamps DO: 2018-2019

All Lower Nookachamps sites had similar dissolved oxygen levels. All sites dropped below the state standard of 9.5°C during the year.

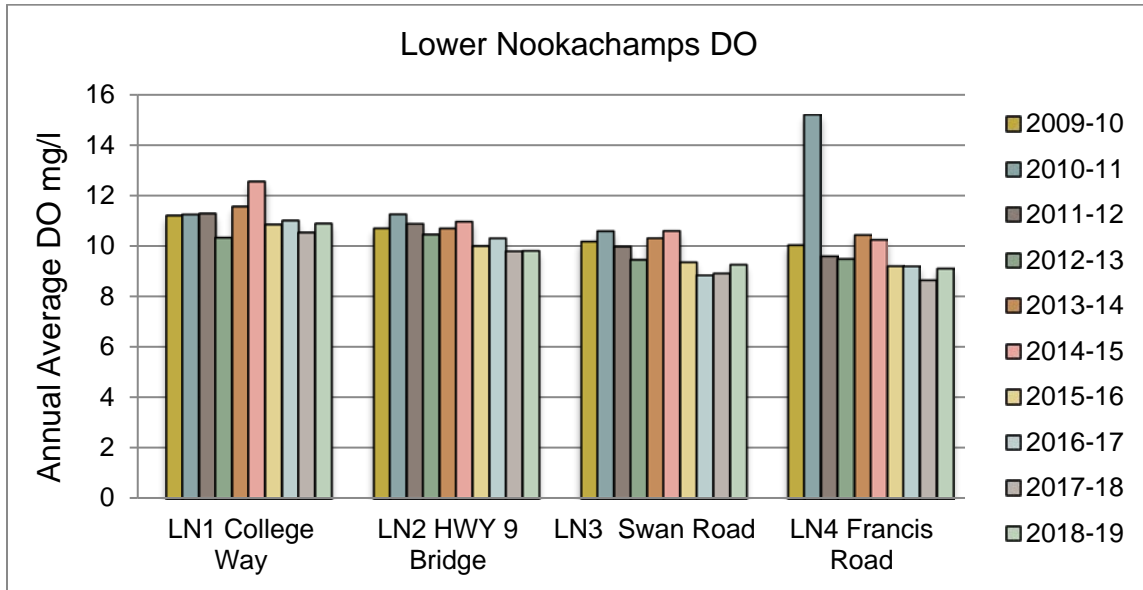
Figure 35. Lower Nookachamps DO: Eleven-year comparison

Average dissolved oxygen levels were low relative to the standard of 9.5°C at all sites. Averages are shown below for comparing sites and years, and are not relevant to state standards.

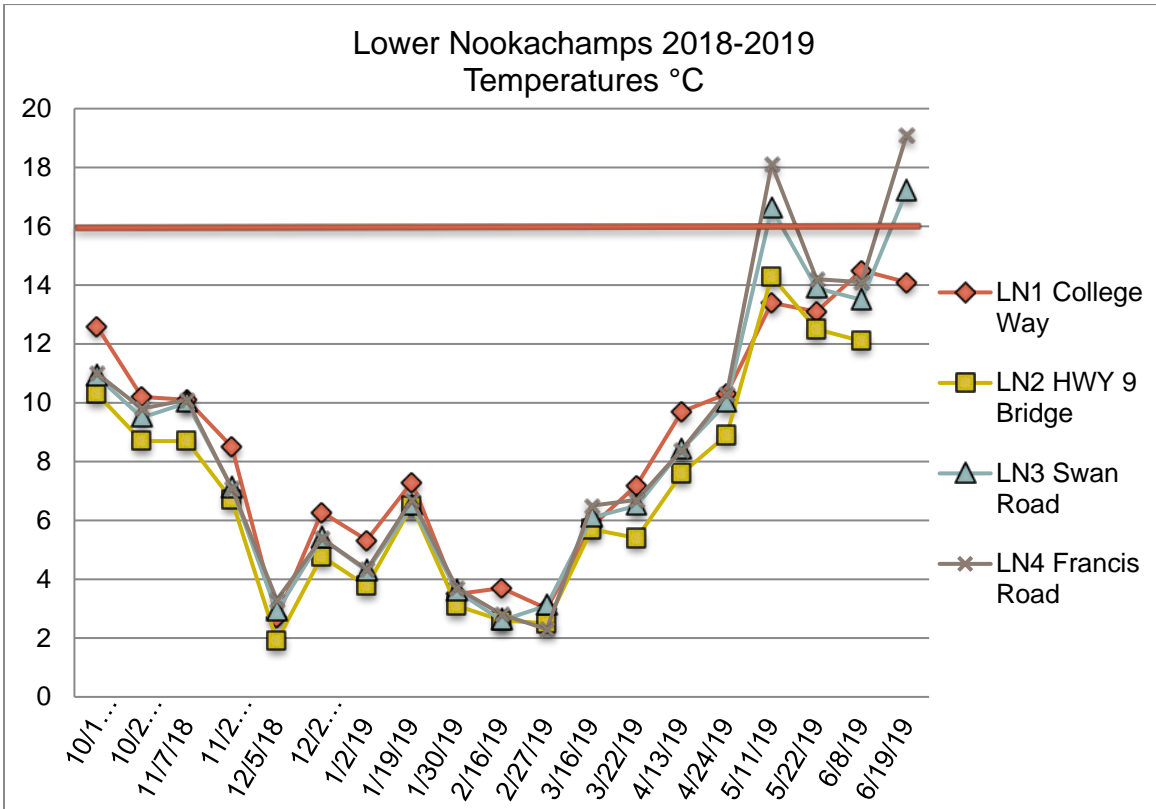
Figure 36. Lower Nookachamps Temperature: 2018-2019

Temperatures for sites 3 and 4 went above the state standard of 16°C in May and June. No samples were taken during the warmest summer months.

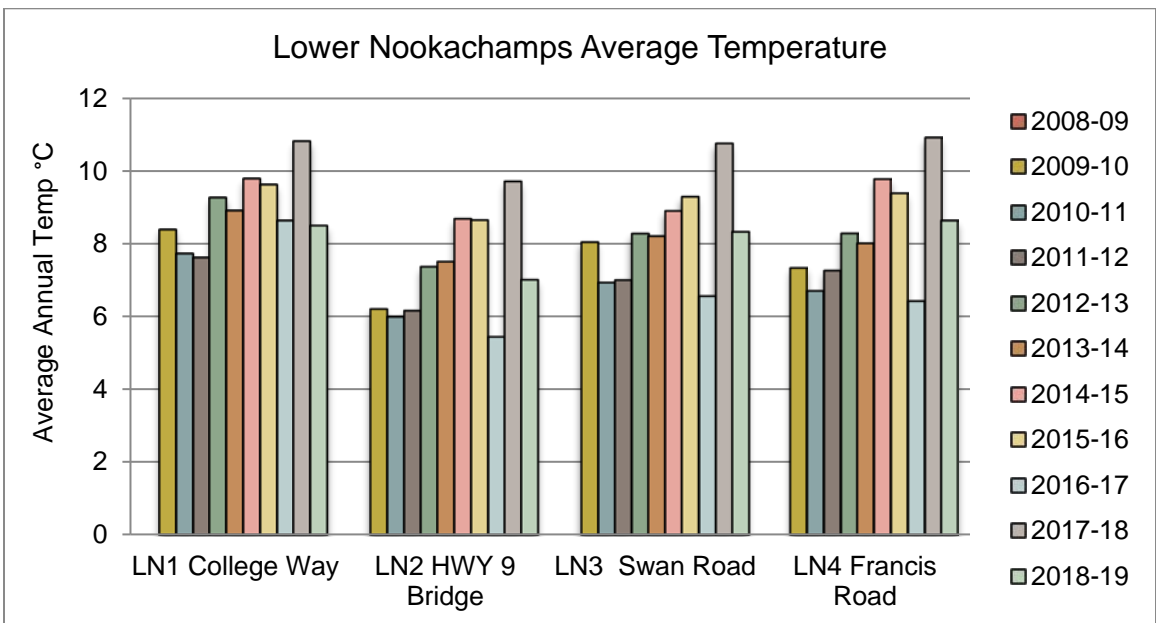
Figure 37. Lower Nookachamps Temperature: Eleven-year comparison

Annual average temperatures for all Lower Nookachamps Sites (Figure 37 below) improved from last year's high. State standards are not based on the annual average

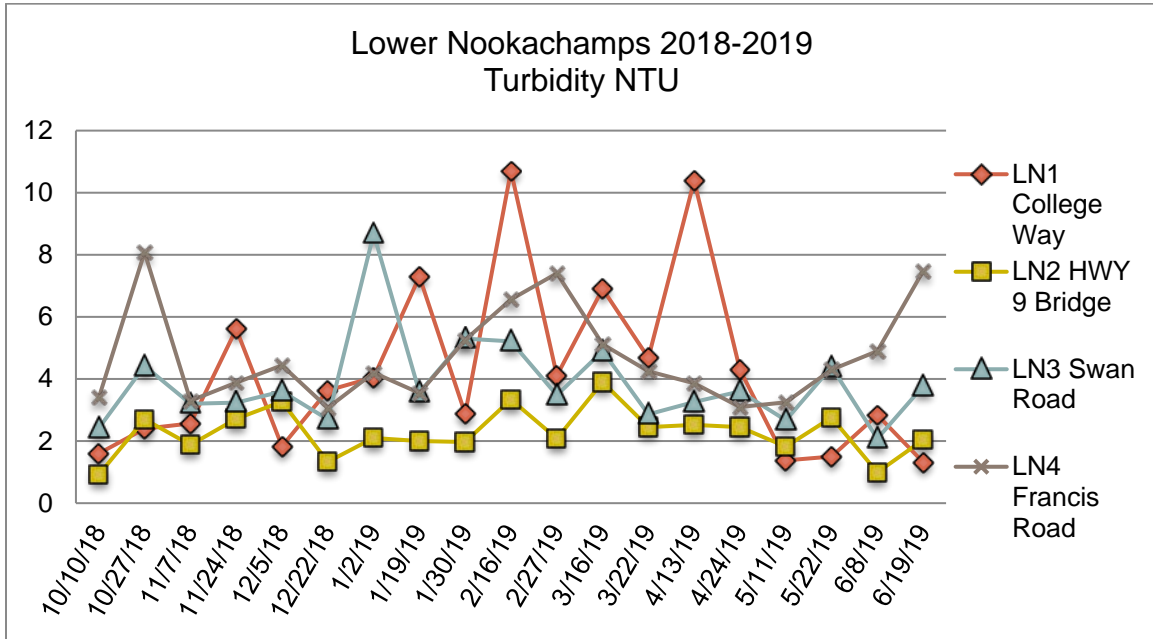
Figure 38. Lower Nookachamps Turbidity: 2018-2019

Turbidity levels were the lowest since sampling began in 2009.

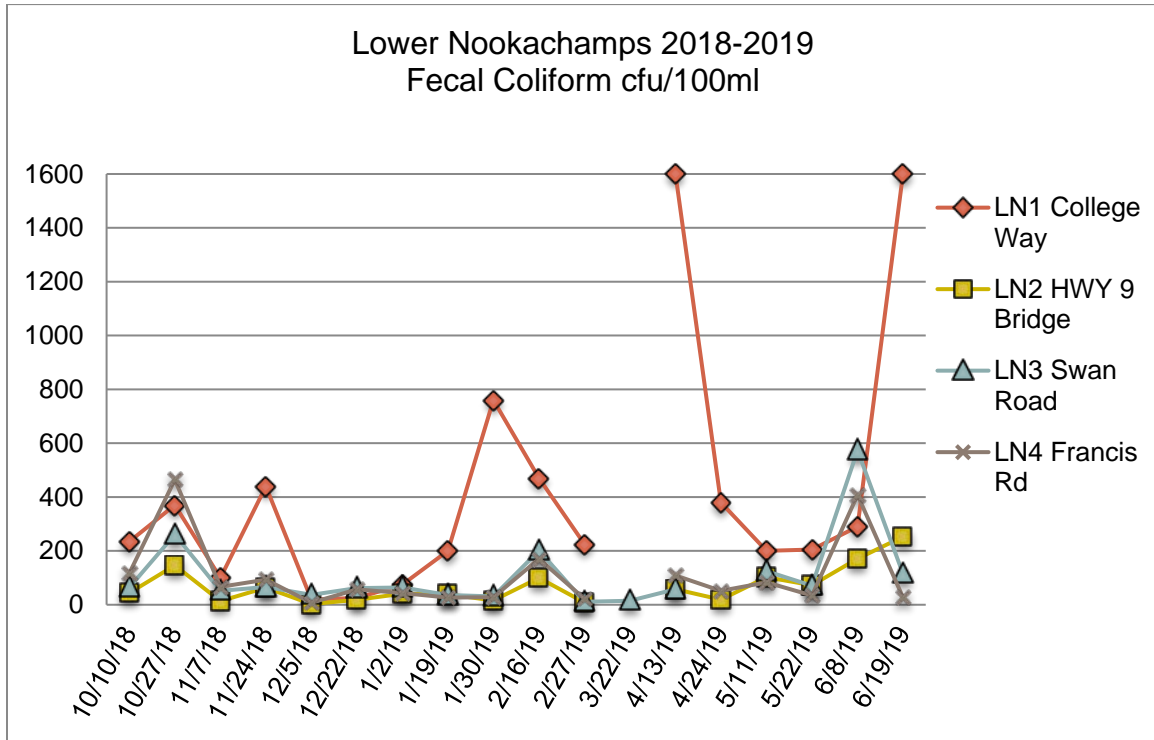
Figure 40. Lower Nookachamps Fecal Coliform: 2018-2019

Site 1, College Way again saw periodic high fecal coliform levels while other sites were relatively low.

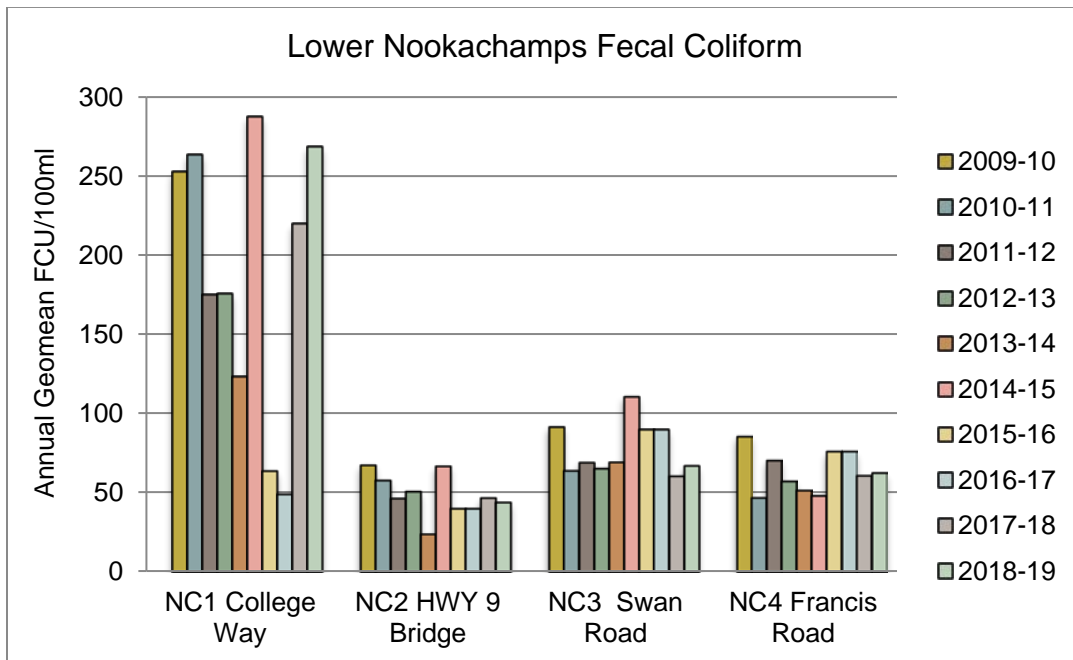
Figure 41. Lower Nookachamps Fecal Coliform: Eleven-year comparison

Site 1 fecal coliform has been highly variable over the past 10 years, and was very high again this year. Sites 2-4 met the first part of the standard (<100 CFU/100ml). None of the sites also met the <10% over 200 CFU/100ml standard.
