# Skagit Stream Team Water Quality Report

*Citizen Monitoring Summary for Samish Bay, Padilla Bay,  
Ace of Hearts, Gages Slough, Trumpeter Basin,  
Kulshan Creek and Nookachamps Creek*

2018 - 2019 Annual Water Quality Report

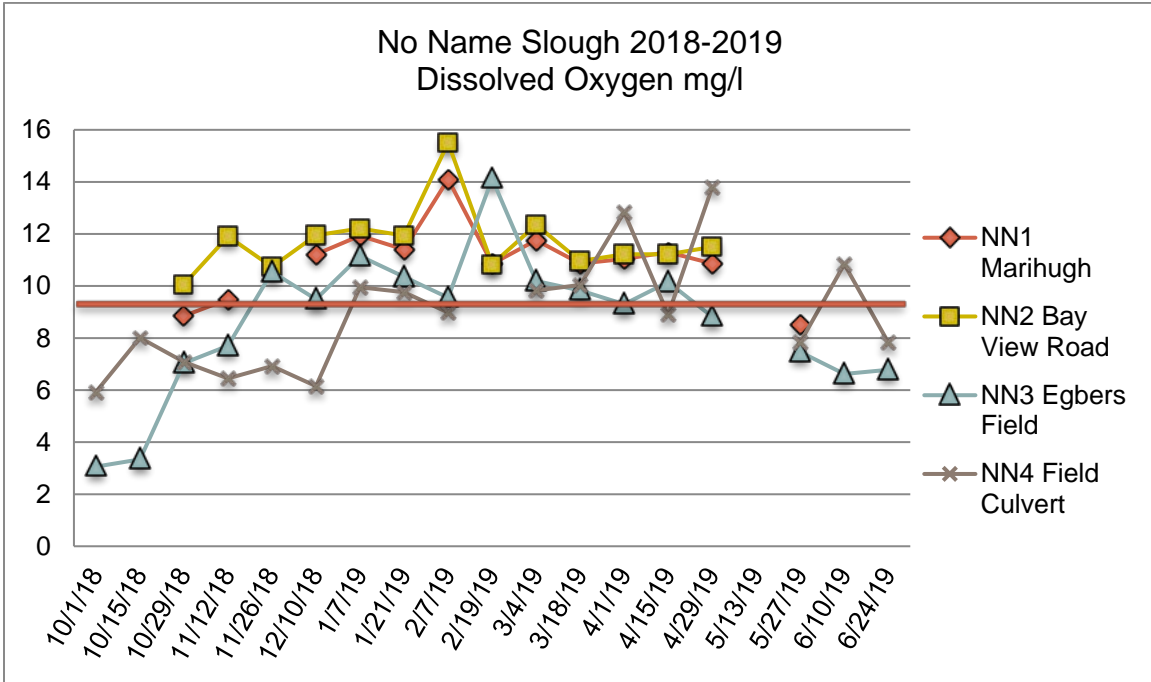
Figure 42. No Name Slough DO: 2018-2019

Dissolved oxygen levels fell below the state standard of 8mg/l at sites 1, 3, and 4 during the sampling season. The upper stream dries up in early summer.

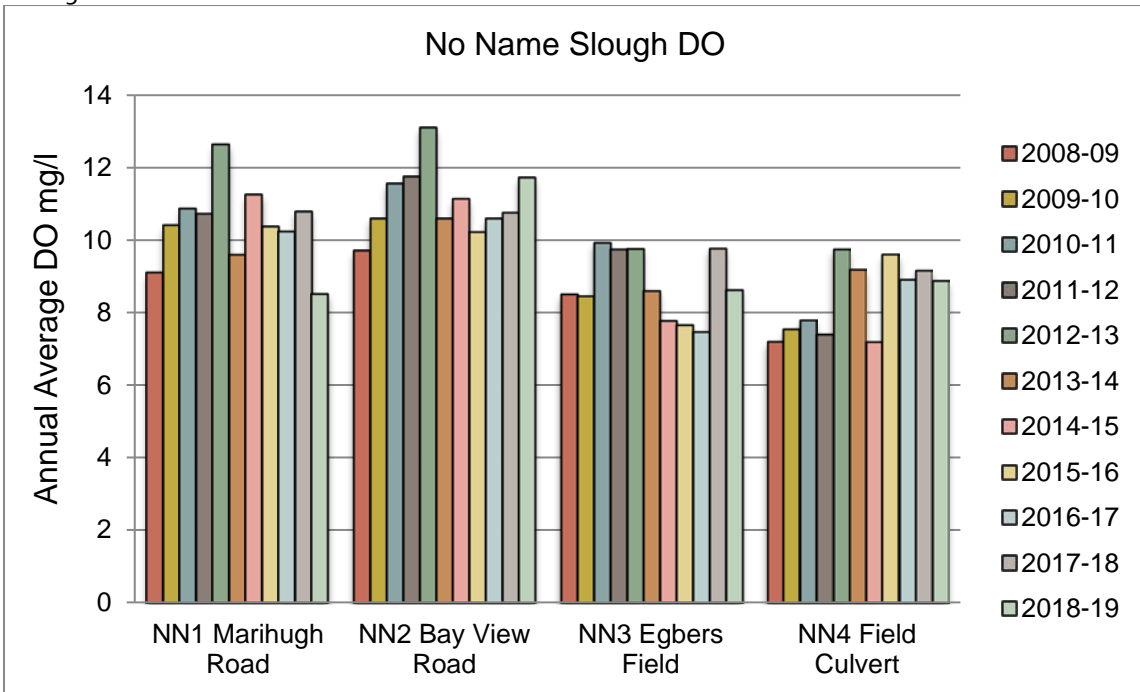
Figure 43. No Name Slough DO: Eleven-year comparison

Average DO were lowest at site 1 since sampling began. State standards are not based on the annual average.

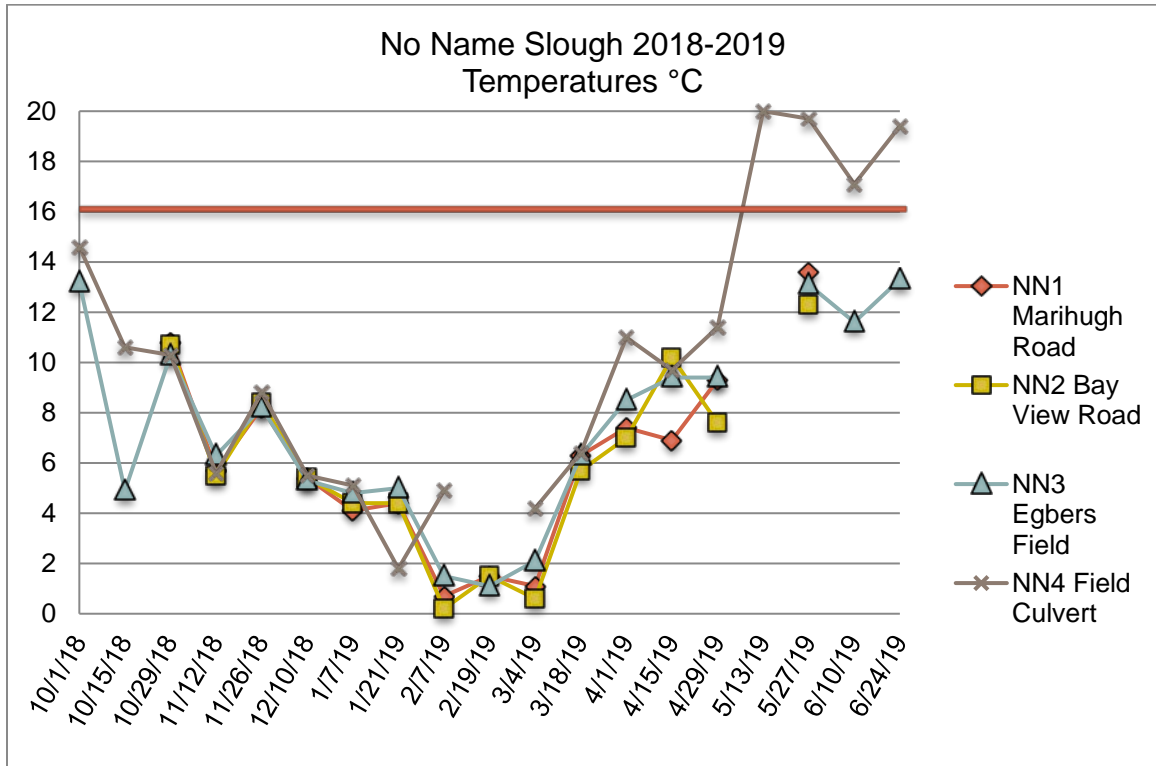
Figure 44 No Name Slough Temperature: 2018-2019

Temperatures at No Name Sites 1-3 were within the optimum range of  $<17.5^{\circ}\text{C}$  throughout the sampling period. Site 4 was above this temperature in May and June. No samples were taken during the warmest summer season when temperatures were most likely to be warmer than the state standard.

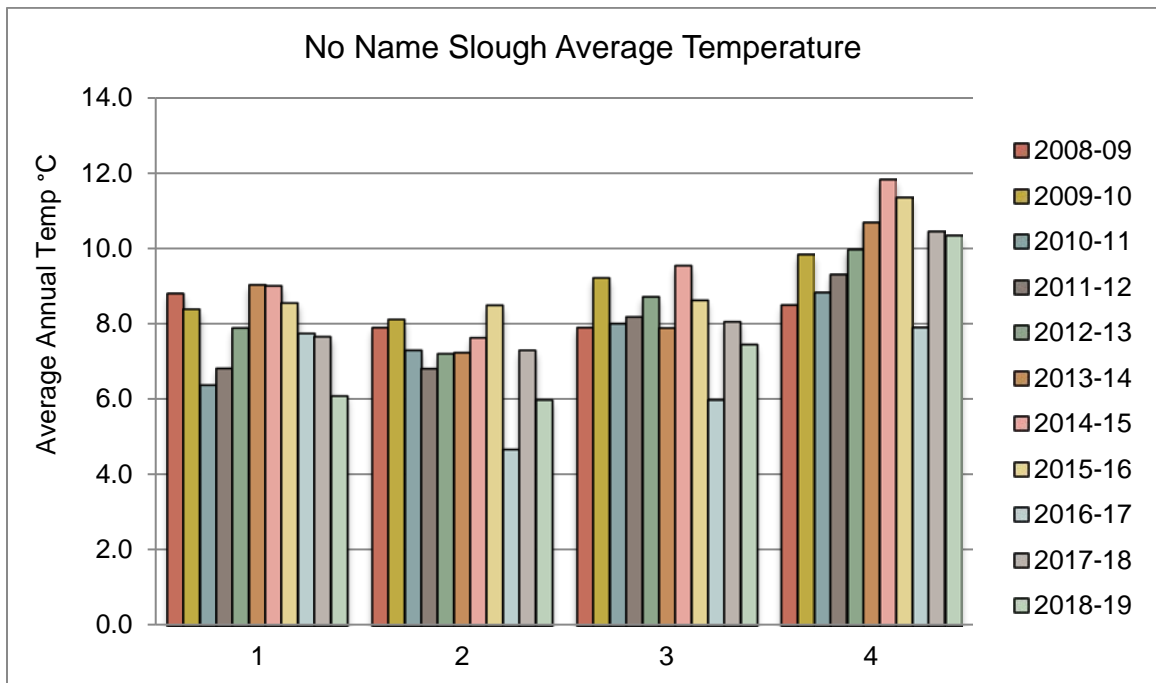
Figure 45. No Name Slough Temperature: Eleven-year comparison

Average temperatures are shown for comparison. State standards are not based on the annual average.

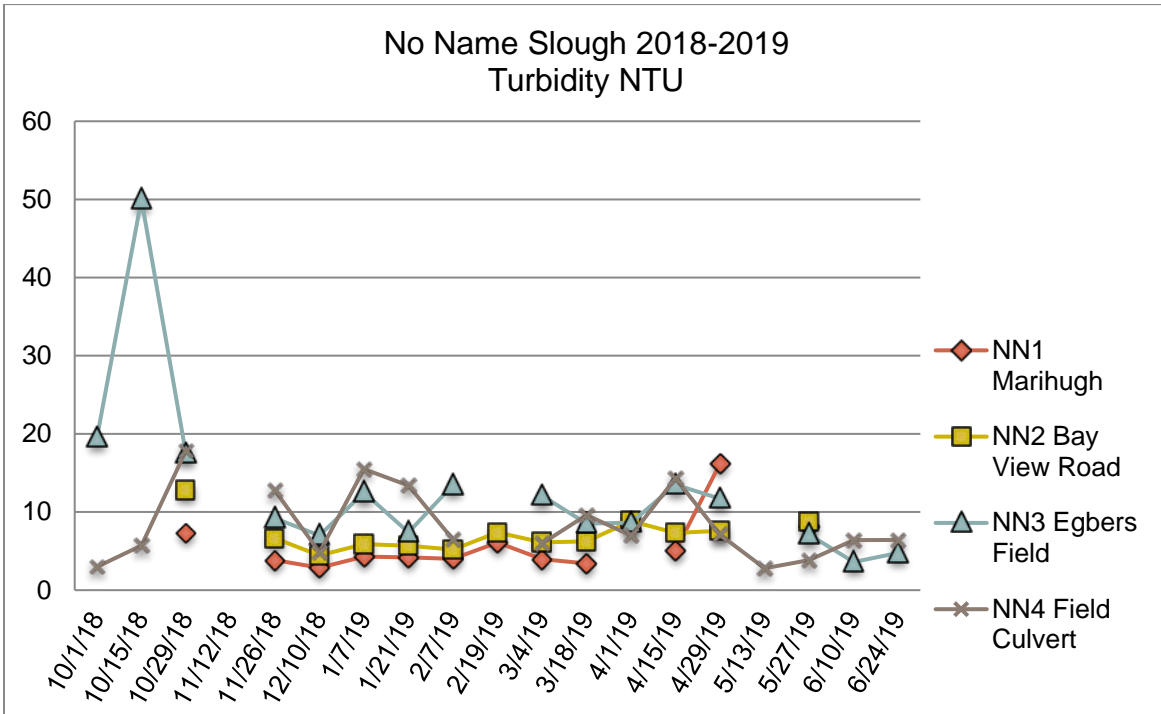
Figure 46. No Name Slough Turbidity: 2018-2019

Turbidity levels were generally low during 2018-2019 .

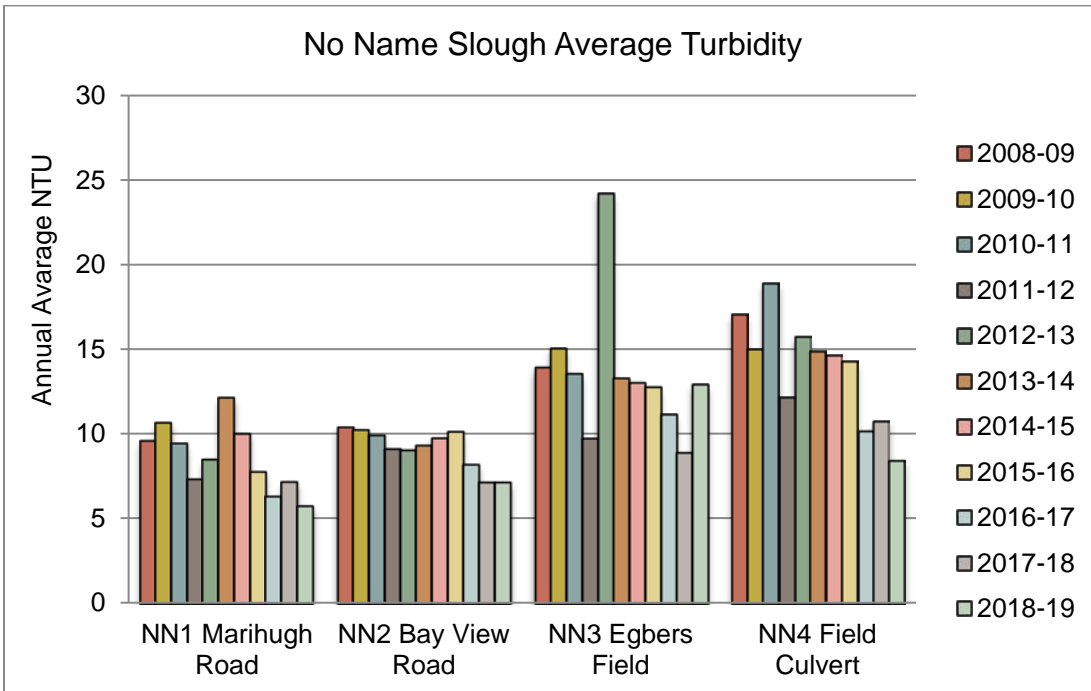
Figure 47. No Name Slough Turbidity: Eleven-year comparison

Figure 47 below shows average turbidity levels that are comparatively low. Sites 3 and 4 have benefitted from extensive plantings along the slough.

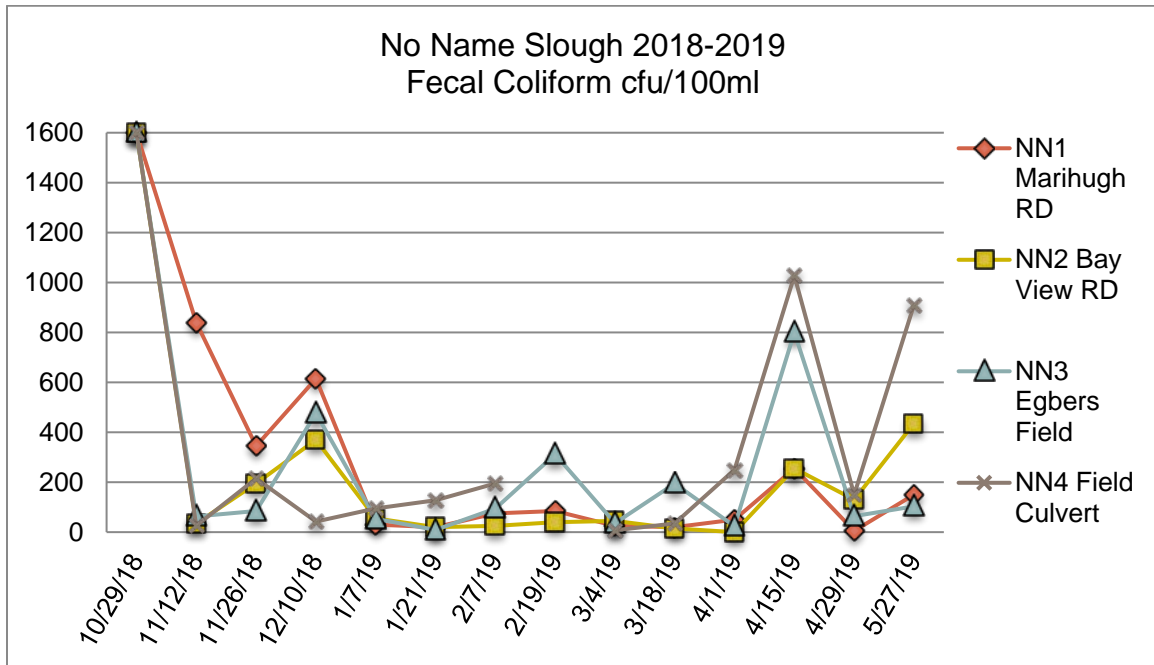
Figure 48. No Name Slough Fecal Coliform: 2018-2019

All No Name Slough sites had instances of very high fecal coliform levels in 2018-2019, with lowest numbers at site 2. None of the sites met the <10% over 200 CFU/100ml standard.

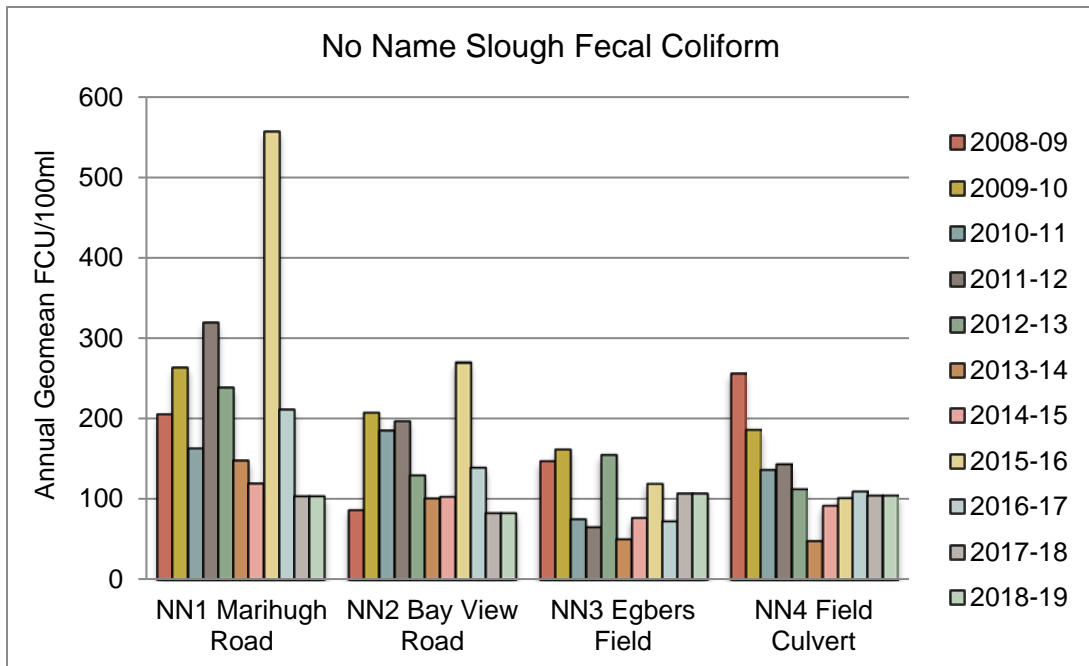
Figure 49. No Name Slough Fecal Coliform: Eleven-year comparison

Sites 1 and 2 met the standard of <100CFU/100ml.

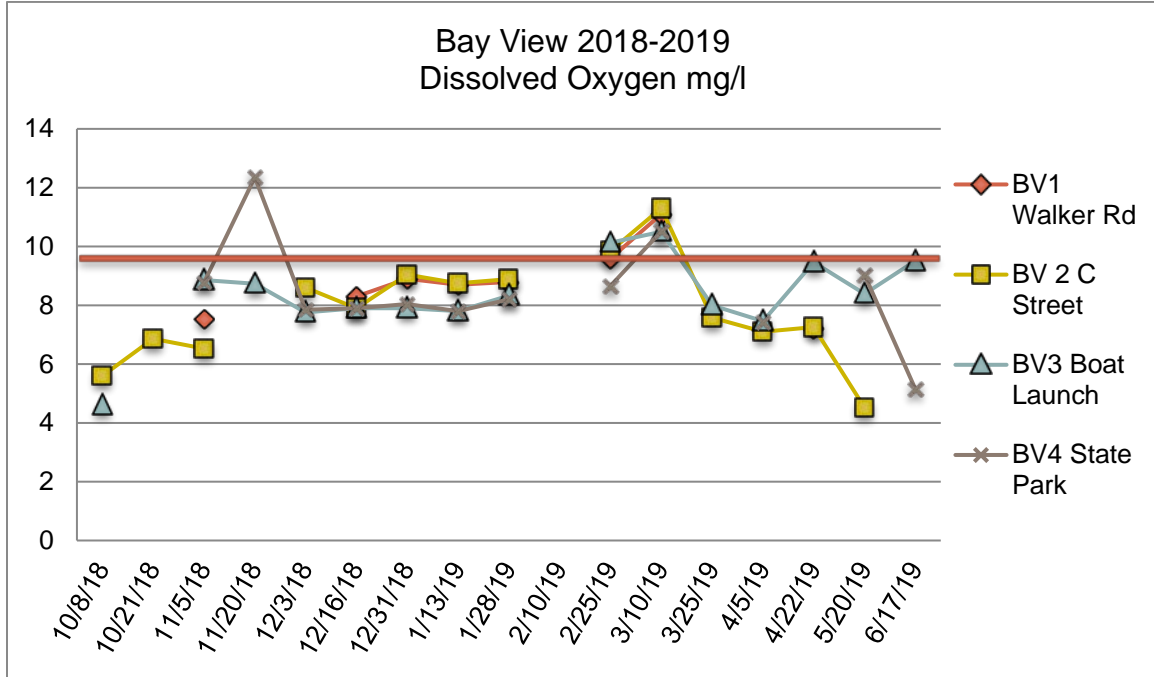
Figure 50. Bay View Drainage DO: 2018-2019

Dissolved oxygen measurements are limited for Bay View.

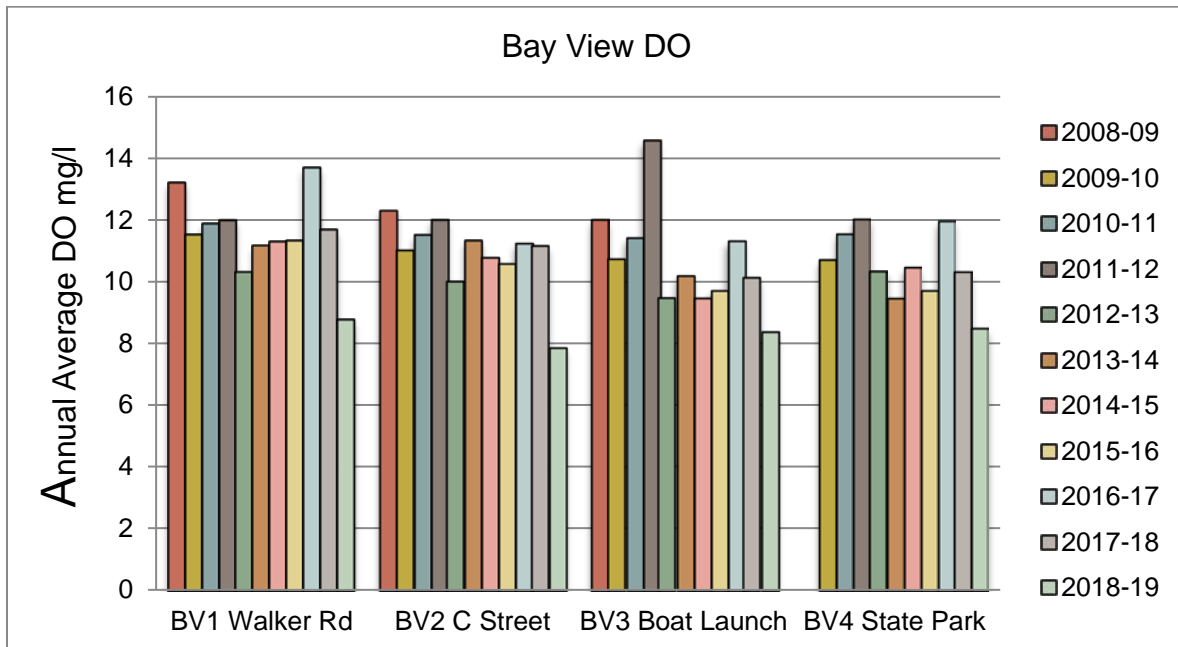
Figure 51. Bay View Drainage DO: Eleven-year comparison

Average dissolved oxygen levels were notably lower at all sites. State standards are not based on averages.

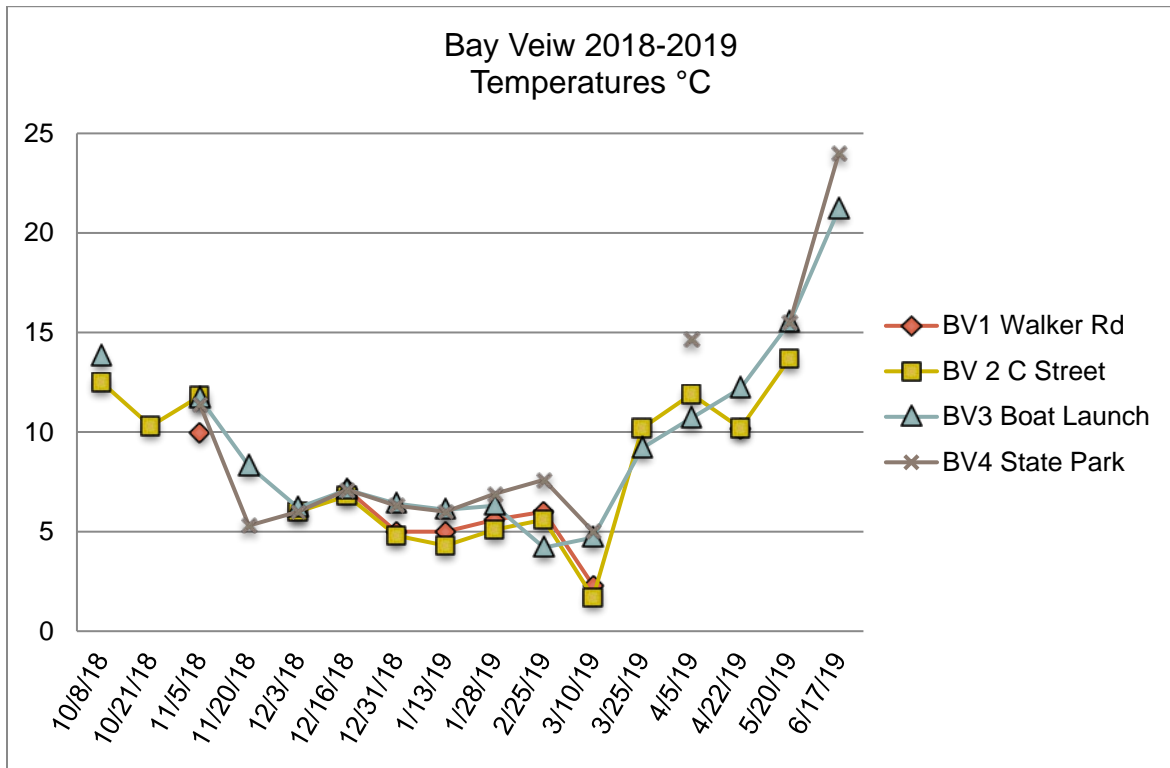
Figure 52. Bay View Drainage Temperature: 2018-2019

Temperatures in 2018-2019 went above the maximum of 17.5°C at sites 3 and 4. Sites dry up during the dry season.

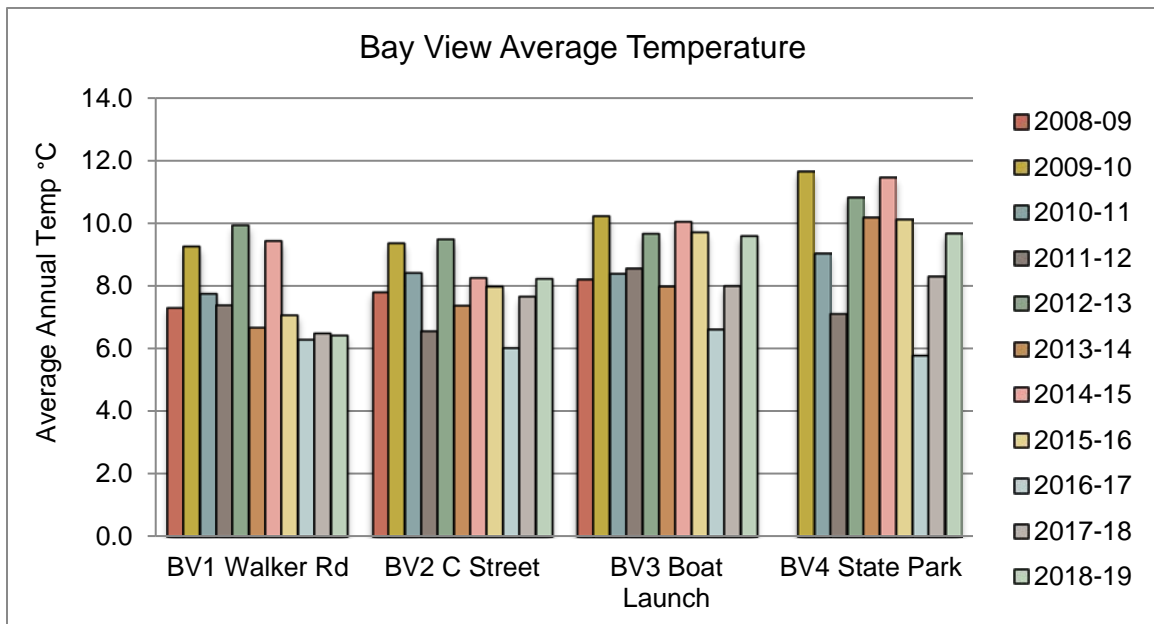
Figure 53. Bay View Drainage Temperature: Eleven-year comparison

Average annual temperatures are shown for comparison.

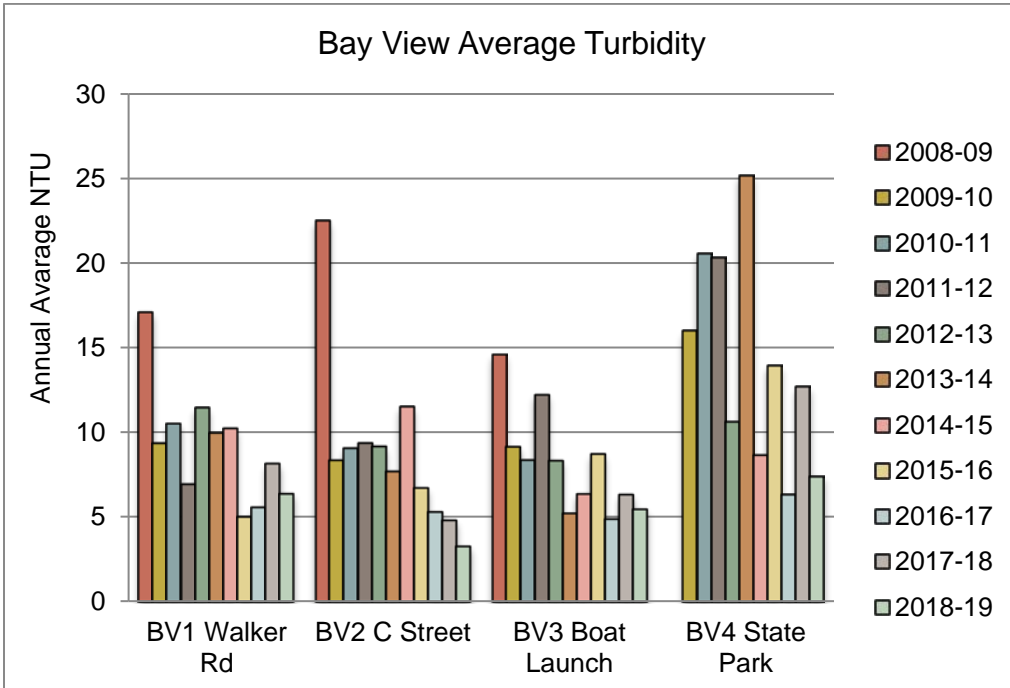
Figure 55. Bay View Drainage Turbidity: Eleven-year comparison

Average turbidity levels (Figure 55 below) were low at all sites, and at site 2 were the lowest in eleven years.

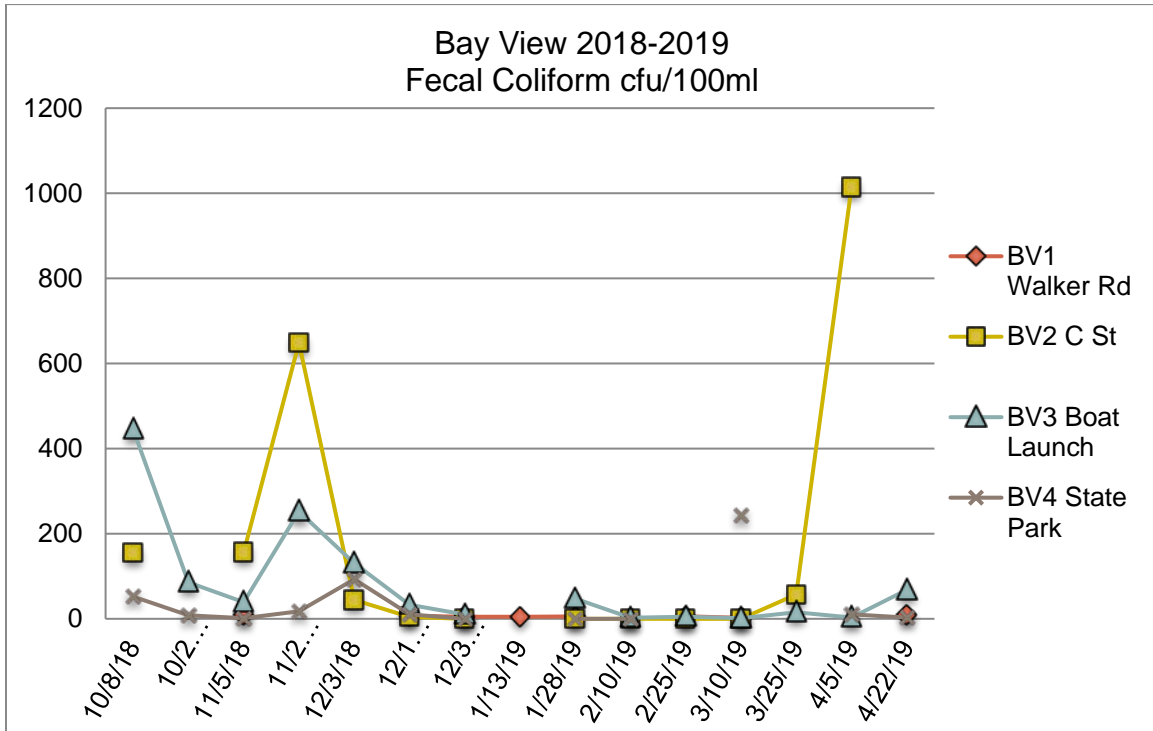
Figure 56. Bay View Drainage Fecal Coliform: 2018-2019

All Bay View sites met part 1 of the state standards for fecal coliform, and met part 2 at sites 1 and 4.

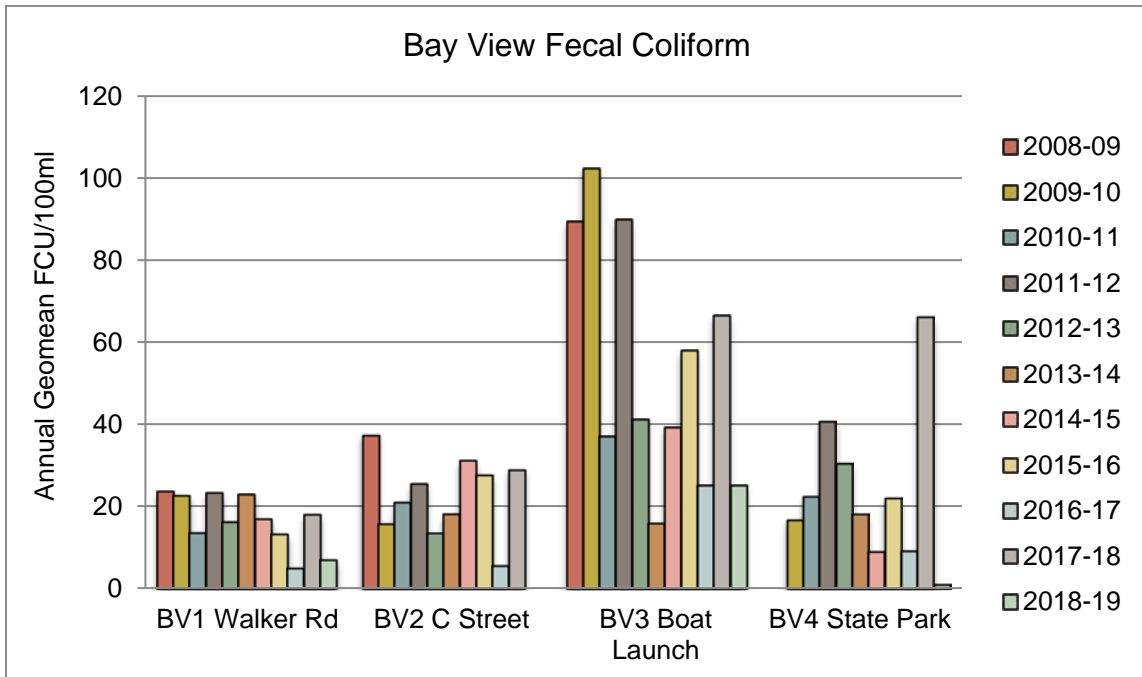
Figure 57. Bay View Drainage Fecal Coliform: Eleven-year comparison

Annual geometric means for Bay View fecal coliform (Figure 57 below) were very low in 2018-2019.

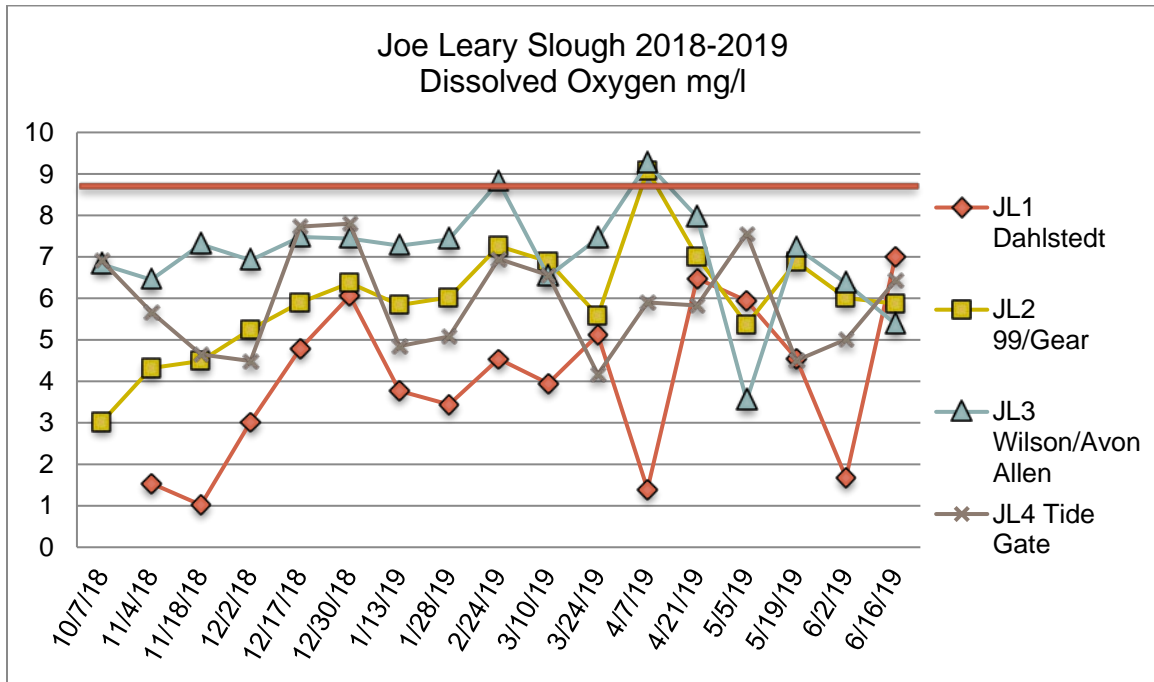
Figure 58. Joe Leary Slough DO: 2018-2019

Once again, dissolved oxygen levels were consistently below standards for all sites, even during the cold winter months.

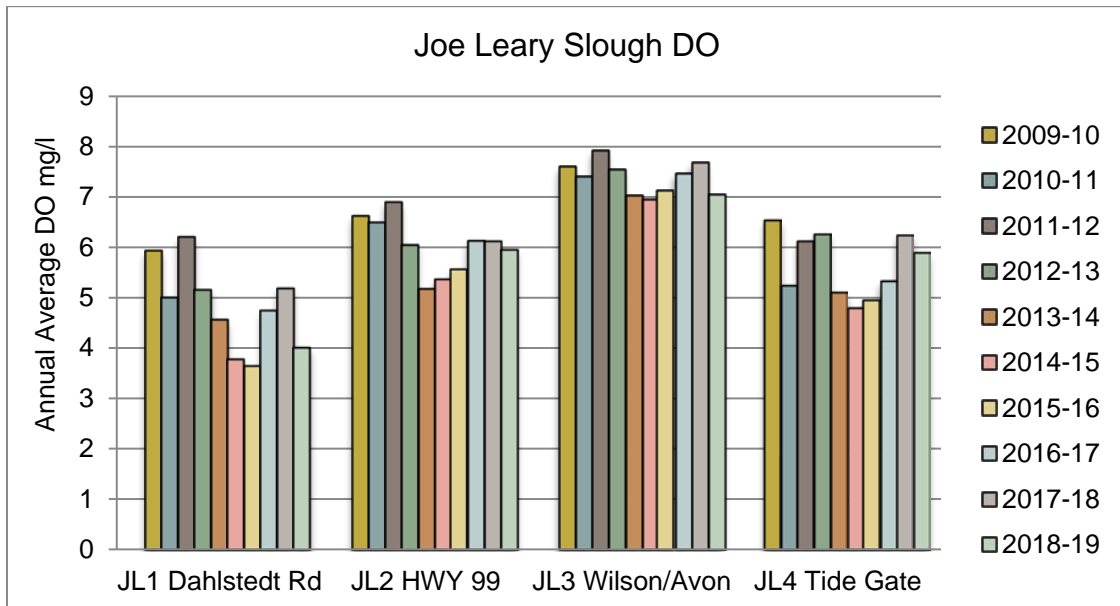
Figure 59. Joe Leary Slough DO: Eleven-year comparison

Dissolved oxygen levels for all sites over the past ten years have been very low, with averages below the state standard of 8mg/l. Standards are not based on average levels.

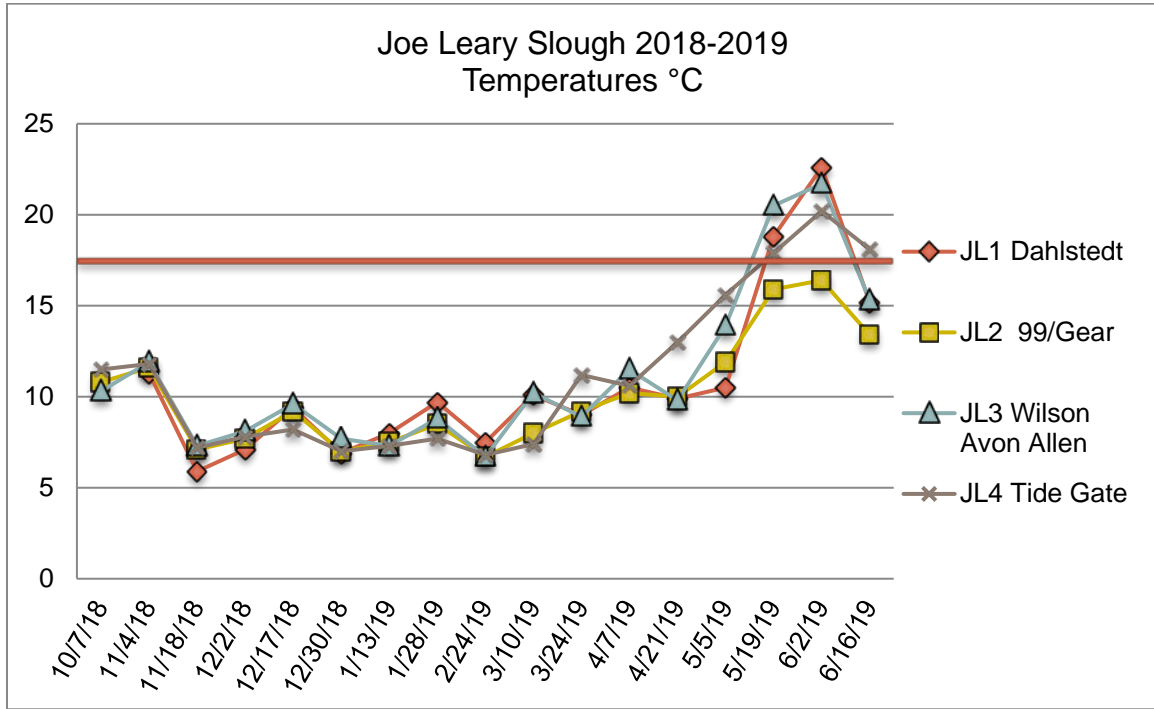
Figure 60. Joe Leary Slough Temperature: 2018-2019

Sites 1, 3 and 4 temperatures were above 17.5 °C in June. No samples were taken during the warmest summer season when temperatures may have risen above the standard.

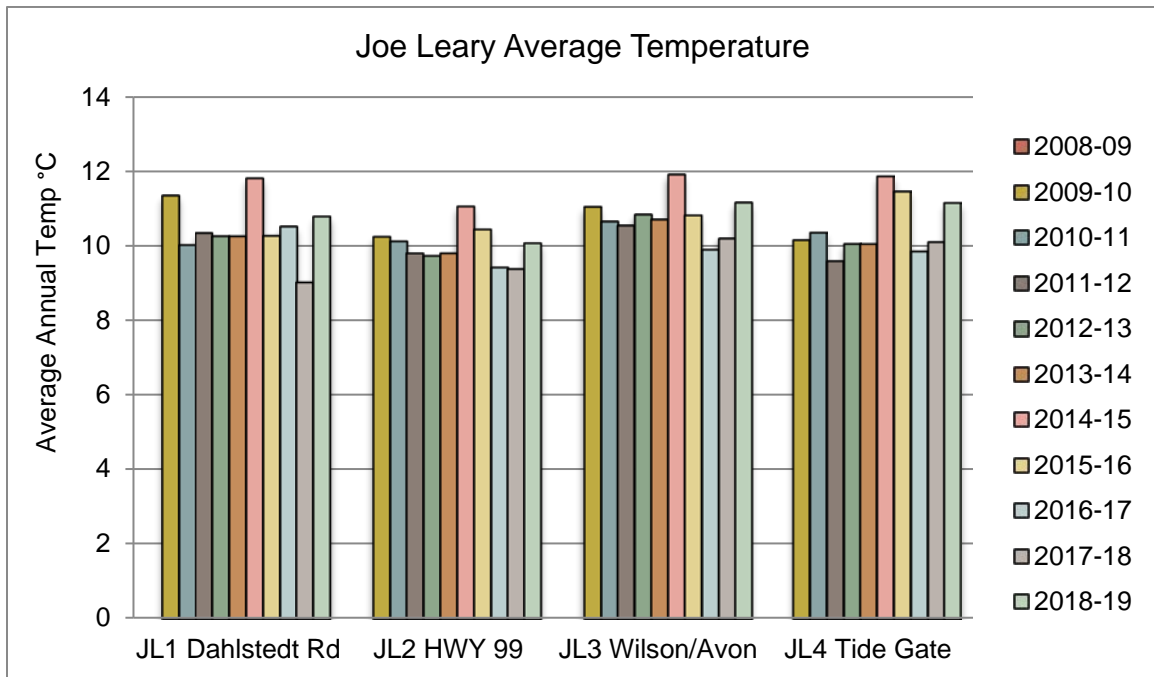
Figure 61. Joe Leary Slough Temperature: Eleven-year comparison

Average annual temperatures (Figure 61 below) for all sites were similar to past years. Standards are not based on average temperature.

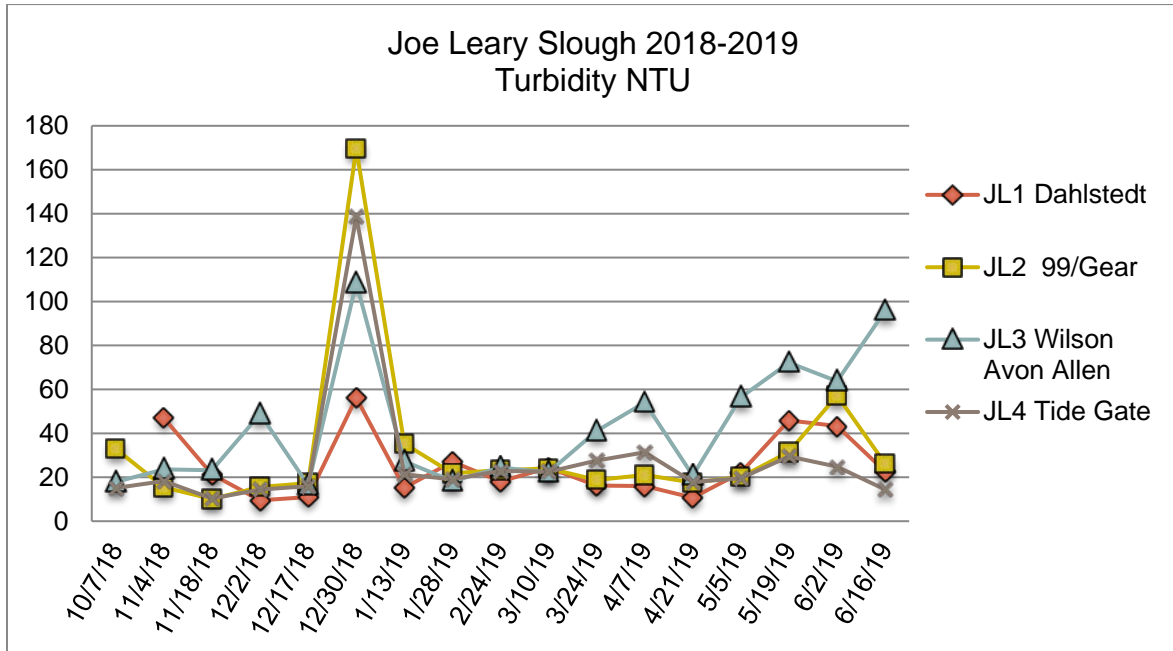
Figure 62. Joe Leary Slough Turbidity: 2018-2019

Joe Leary Slough maintains its distinction of having the highest turbidity of all the stream team sites.

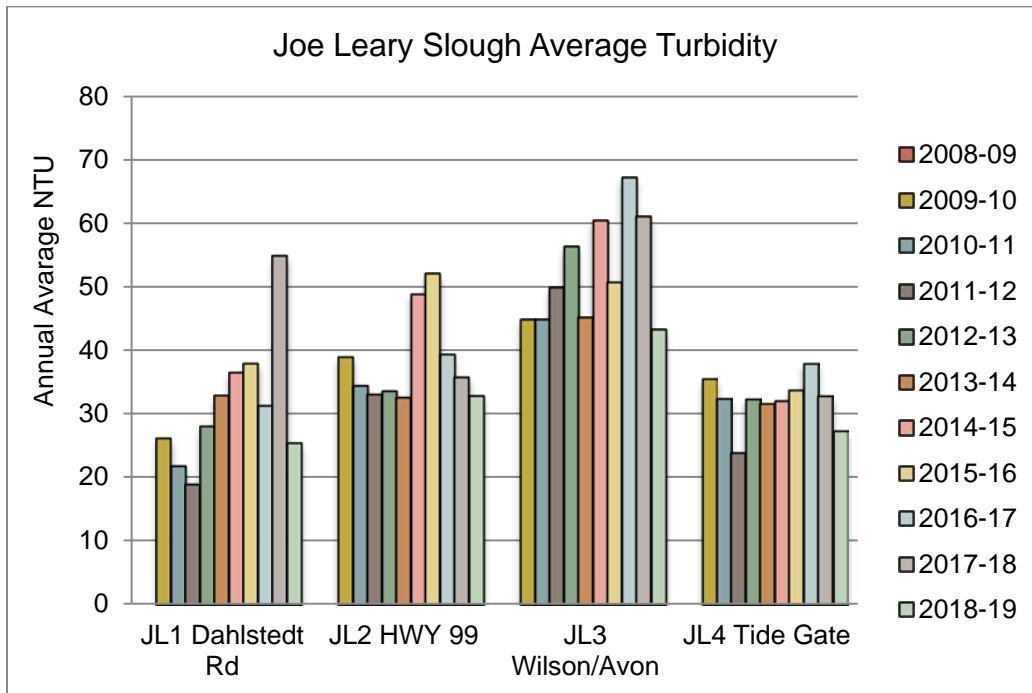
Figure 63. Joe Leary Slough Turbidity: Eleven-year comparison

Average turbidity in Joe Leary Slough was lower than past years, but still very high relative to other streams.

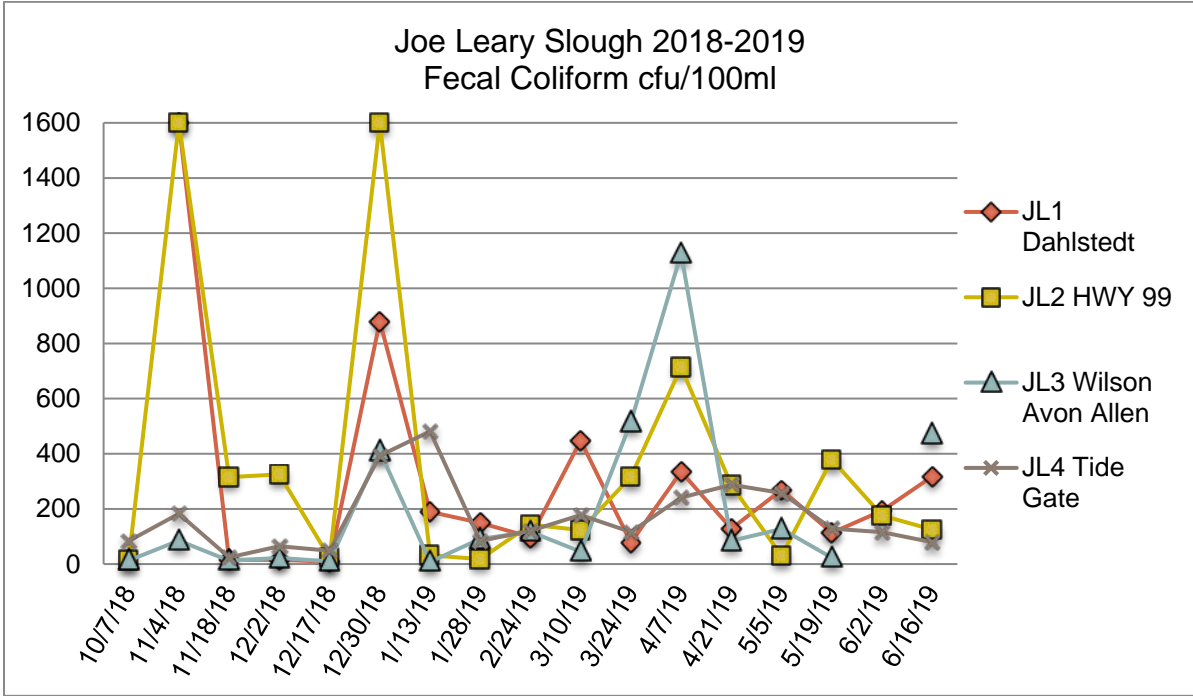
Figure 64. Joe Leary Slough Fecal Coliform: 2018-2019

In 2018-2019, as in the previous year, none of the Joe Leary Slough sites met Part II of the state standard for fecal coliform: more than 10% of the samples were higher than 200CFU/100ml. At Site 3, over half of the samples were higher than 200CFU/100ml.

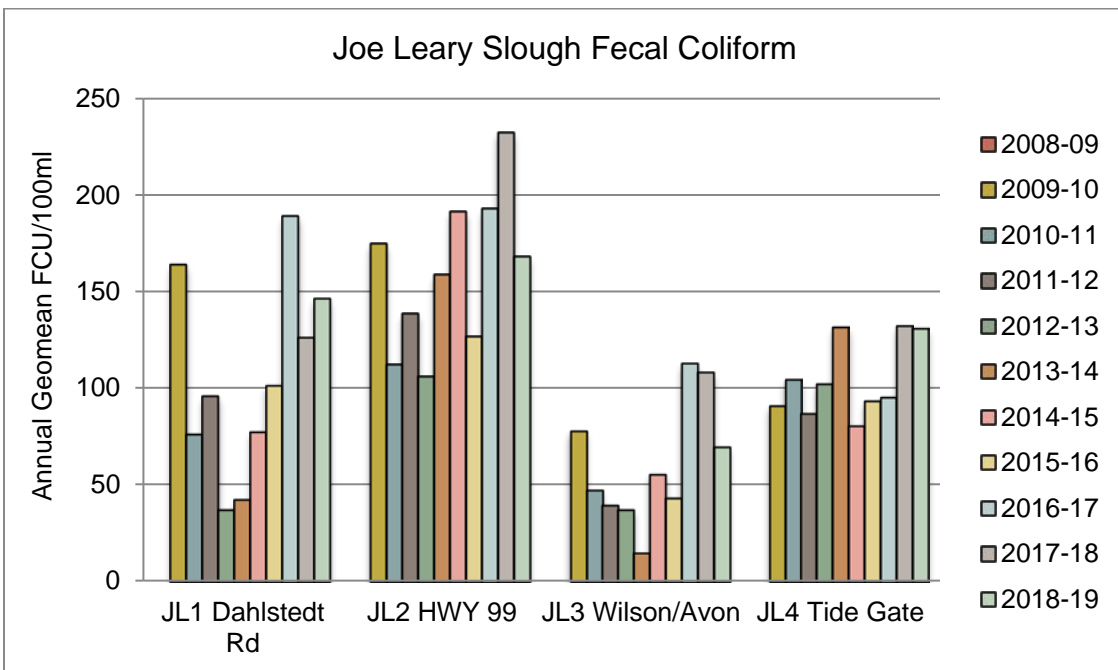
Figure 65. Joe Leary Slough Fecal Coliform: Eleven-year comparison

Site 3 had an annual geomean of 70, and was the only site to meet this part of the standard.

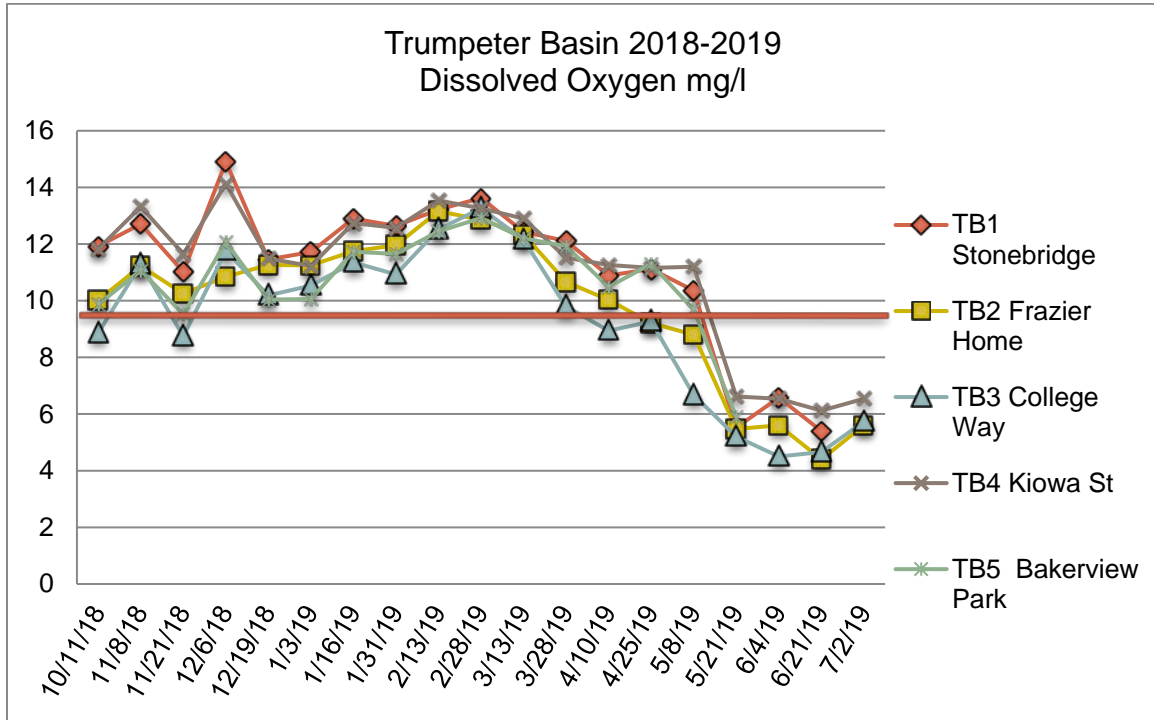
Figure 66. Trumpeter Basin DO: 2018-2019

Dissolved oxygen levels dropped below the standard of 9.5mg/l at all sites.

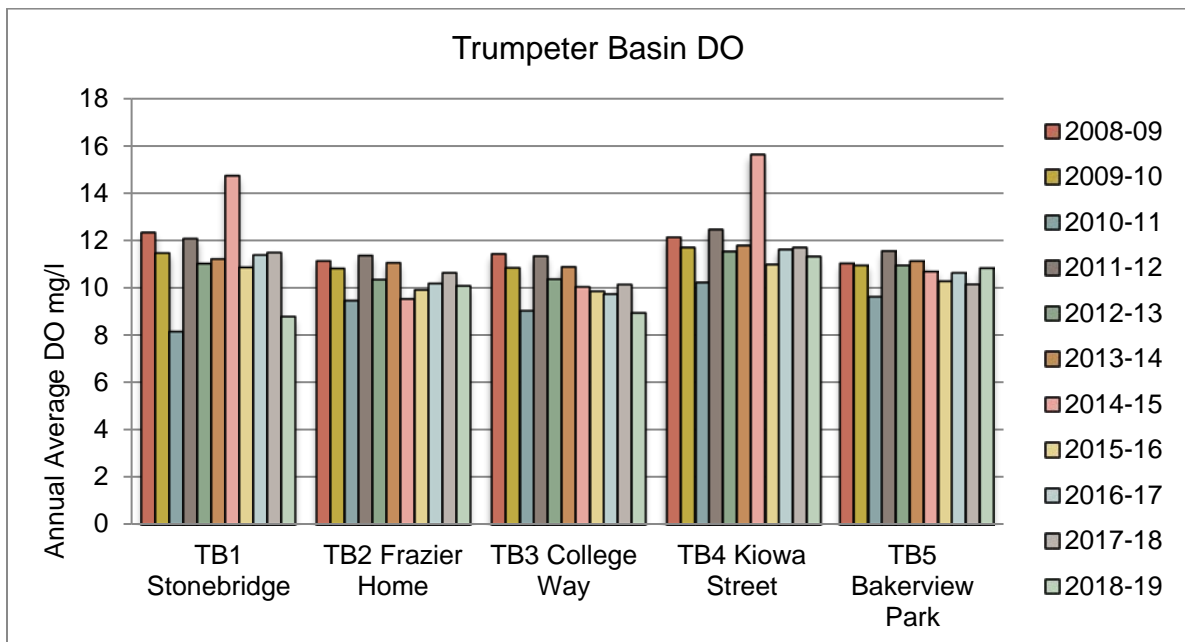
Figure 67. Trumpeter Basin DO: Eleven-year comparison

Average annual dissolved oxygen levels (Figure 67 below) were similar lower at sites 1 and 3 than past years. State standards are not based on annual averages.

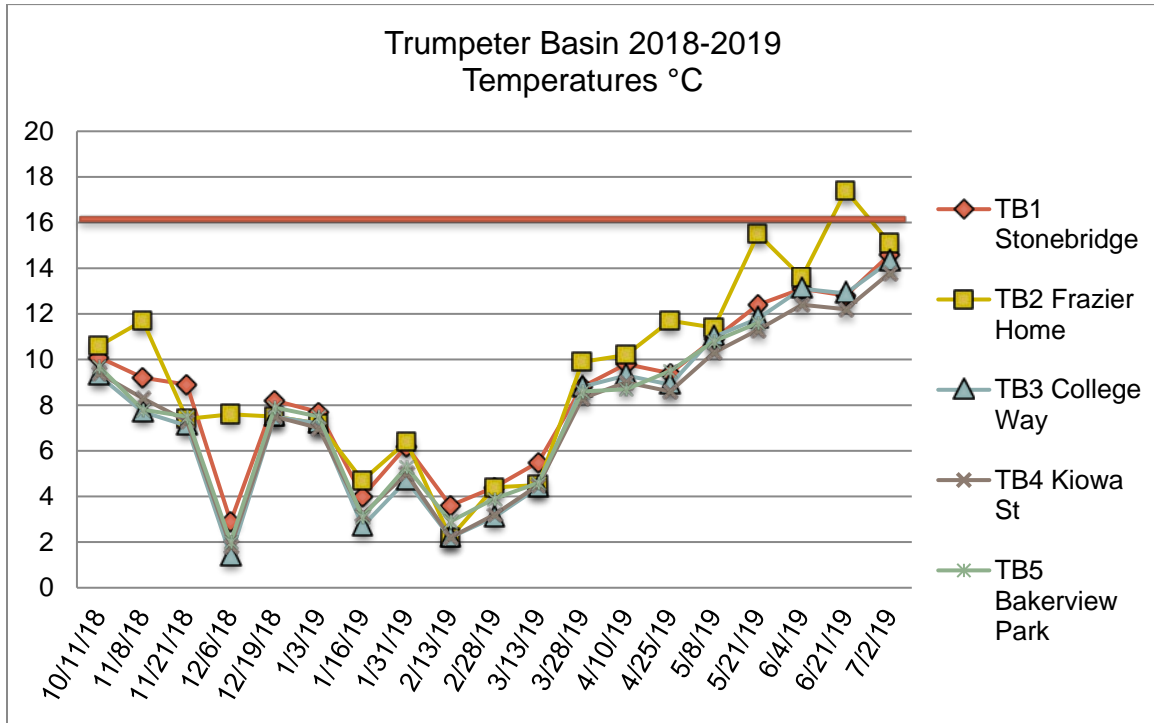
Figure 68. Trumpeter Basin Temperature: 2018-2019

Temperature at Sites 2 went above the standard of 16°C at site 2 in June.

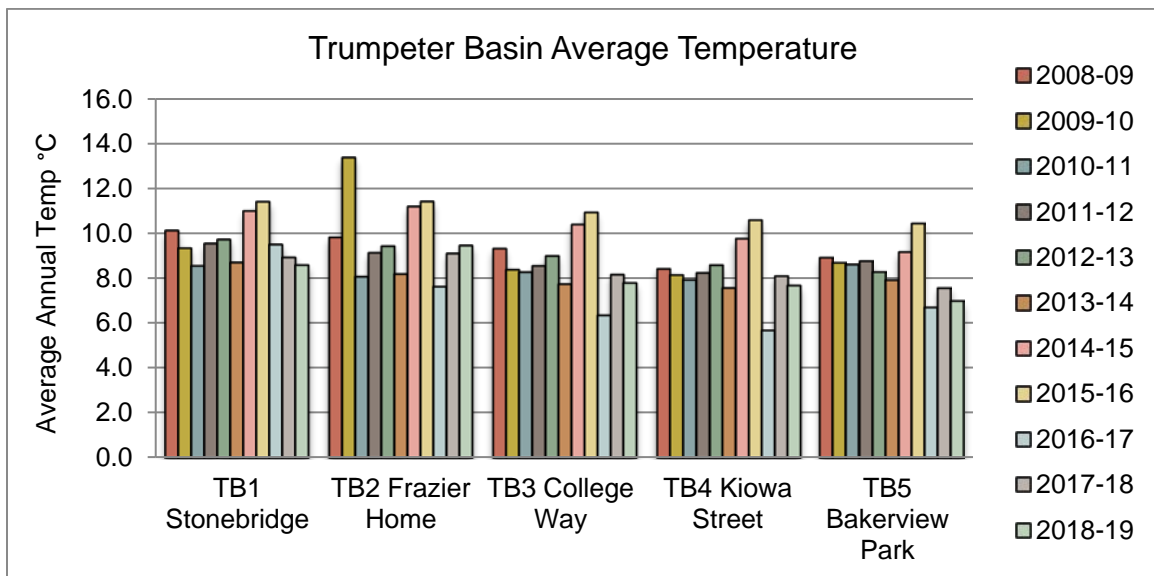
Figure 69. Trumpeter Basin Temperature: Eleven-year comparison

Average temperatures were nearly the same as last year. State standards are not based on the annual averages.

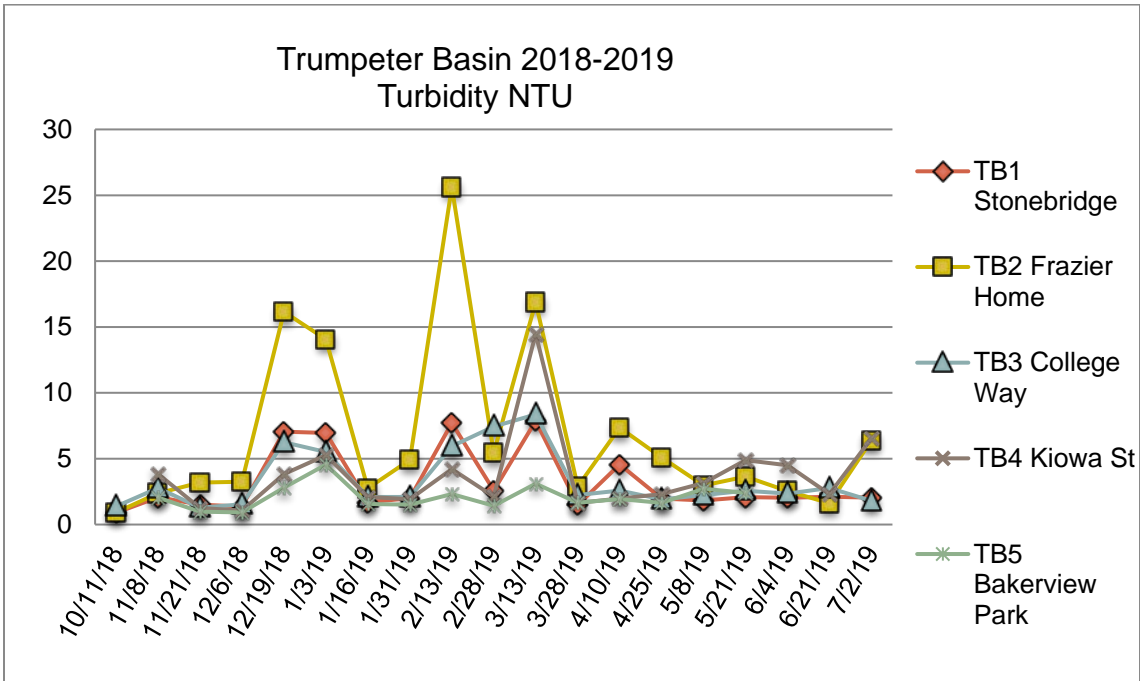
Figure 70. Trumpeter Basin Turbidity: 2018-2019

Turbidity levels for Trumpeter Basin were again highest at site 2.
