# Skagit Stream Team Water Quality Report

*Citizen Monitoring Summary for Samish Bay, Padilla Bay,  
Ace of Hearts, Gages Slough, Trumpeter Basin,  
Kulshan Creek and Nookachamps Creek*

2018 - 2019 Annual Water Quality Report

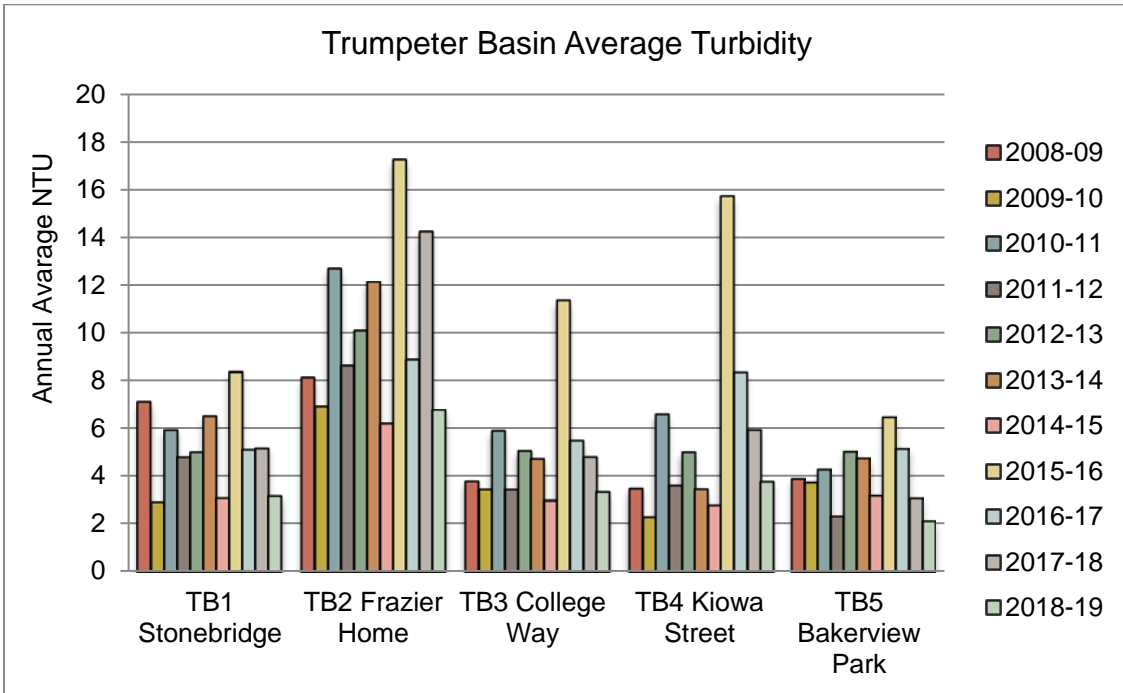
Figure 71. Trumpeter Basin Turbidity: Eleven-year comparison

Turbidity levels in Trumpeter Basin (Figure 71 below) continued to drop compared with past years.

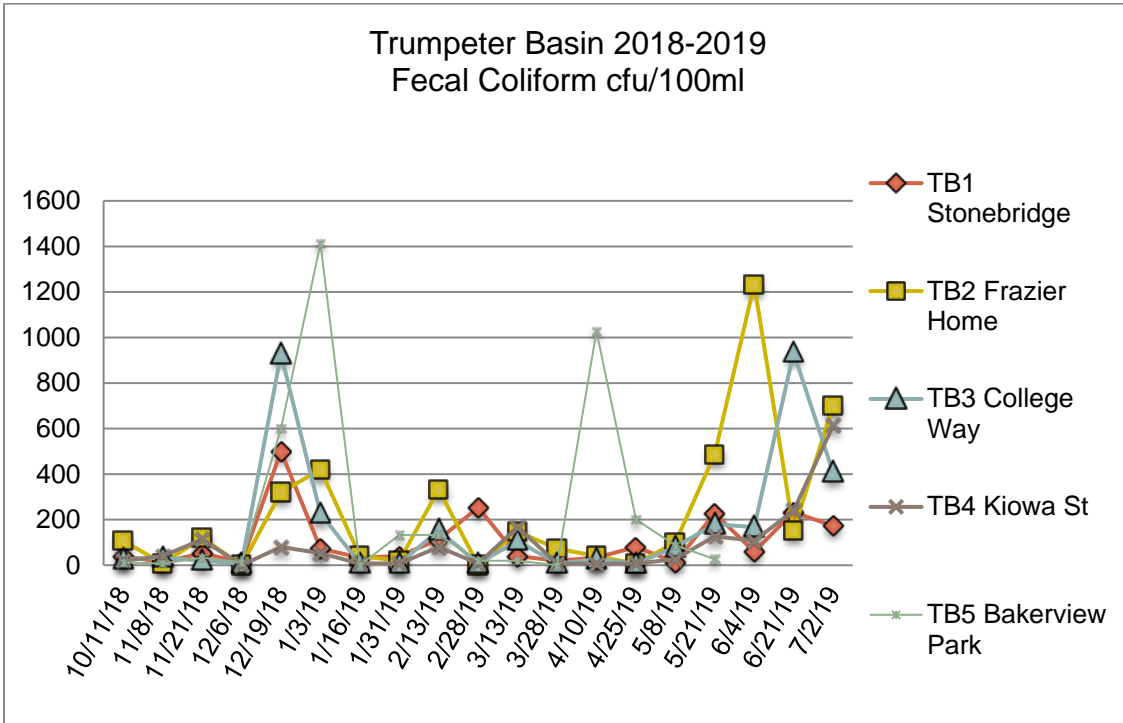
Figure 72. Trumpeter Basin Fecal Coliform: 2018-2019

While last year, all sites passed the standard of <10% of counts under 200 CFU/100ml, this year none of them passed.

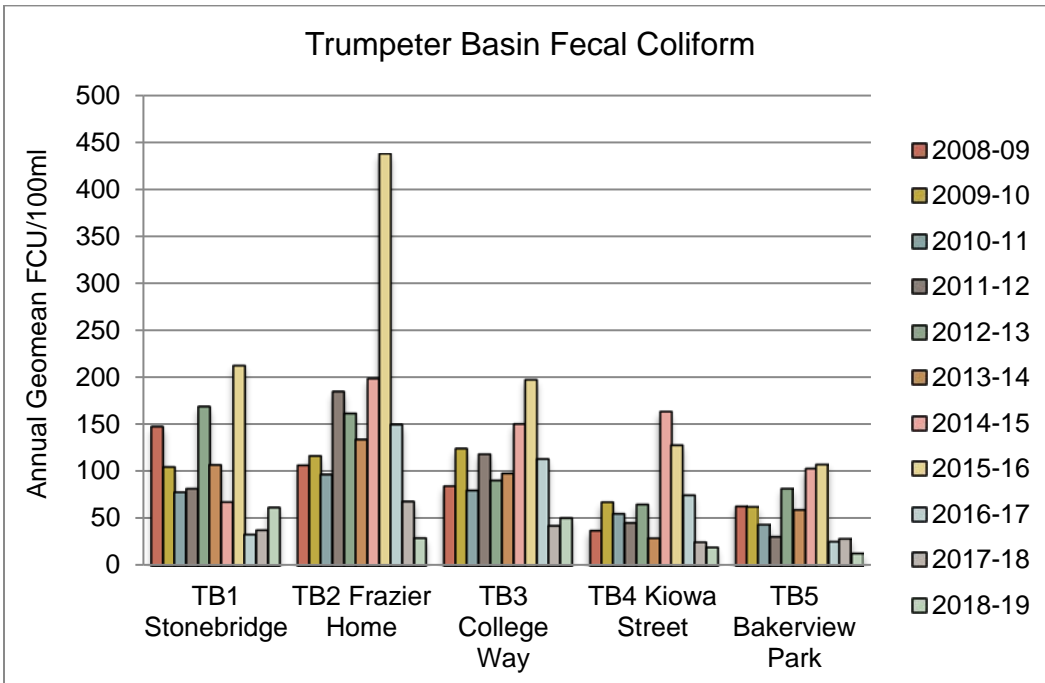
Figure 73. Trumpeter Basin Fecal Coliform: Eleven-year comparison

Fecal coliform geometric means for 2018-2019 were again lower than the high numbers in the past. (Figure 73 below) All Sites met Part I of the state standard: geometric mean <100CFU/100ml.

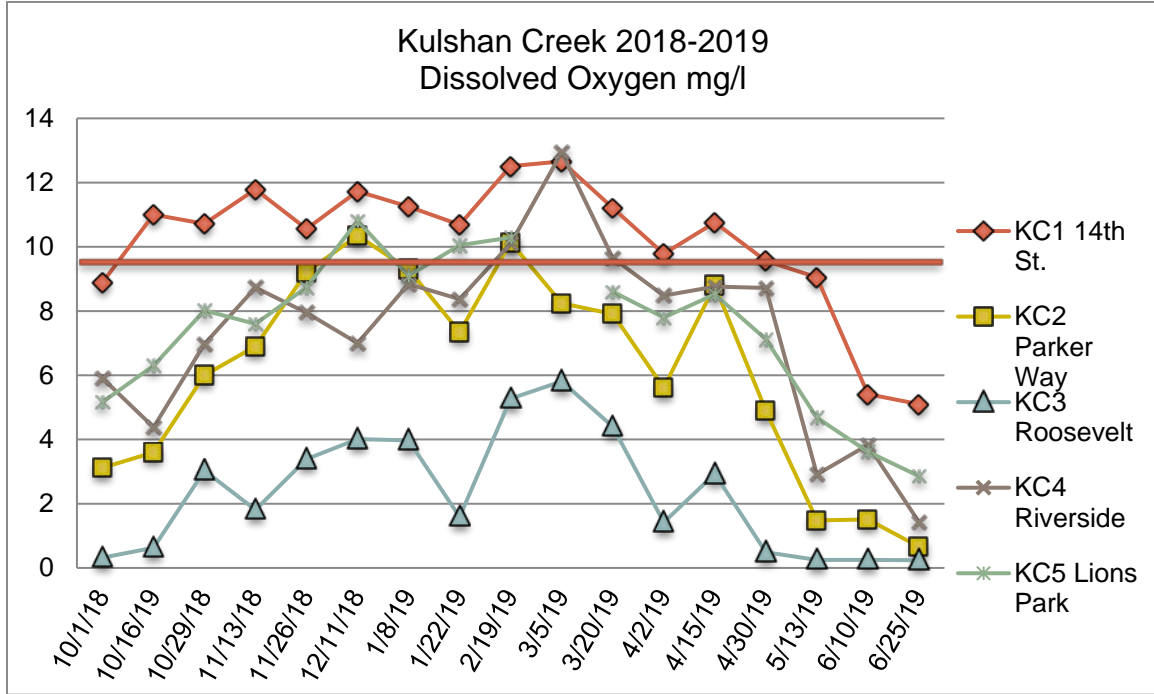
Figure 74. Kulshan Creek DO: 2018-2019

As in past years, dissolved oxygen in all Kulshan Creek sites went below the state standard of 9.5mg/l during this sampling season. Site 3 was never above the standard.

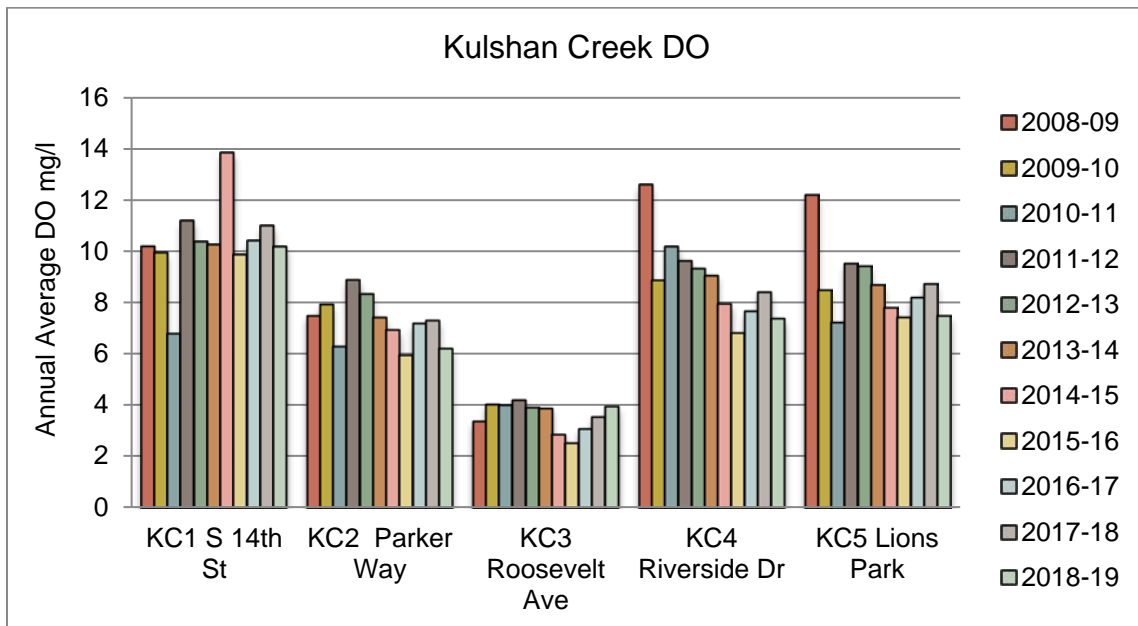
Figure 75. Kulshan Creek DO: Eleven-year comparison

Average dissolved oxygen levels show how big this problem is. Dissolved oxygen should not drop below 9.5 mg/l even once. Standards are not based on annual average measurements.

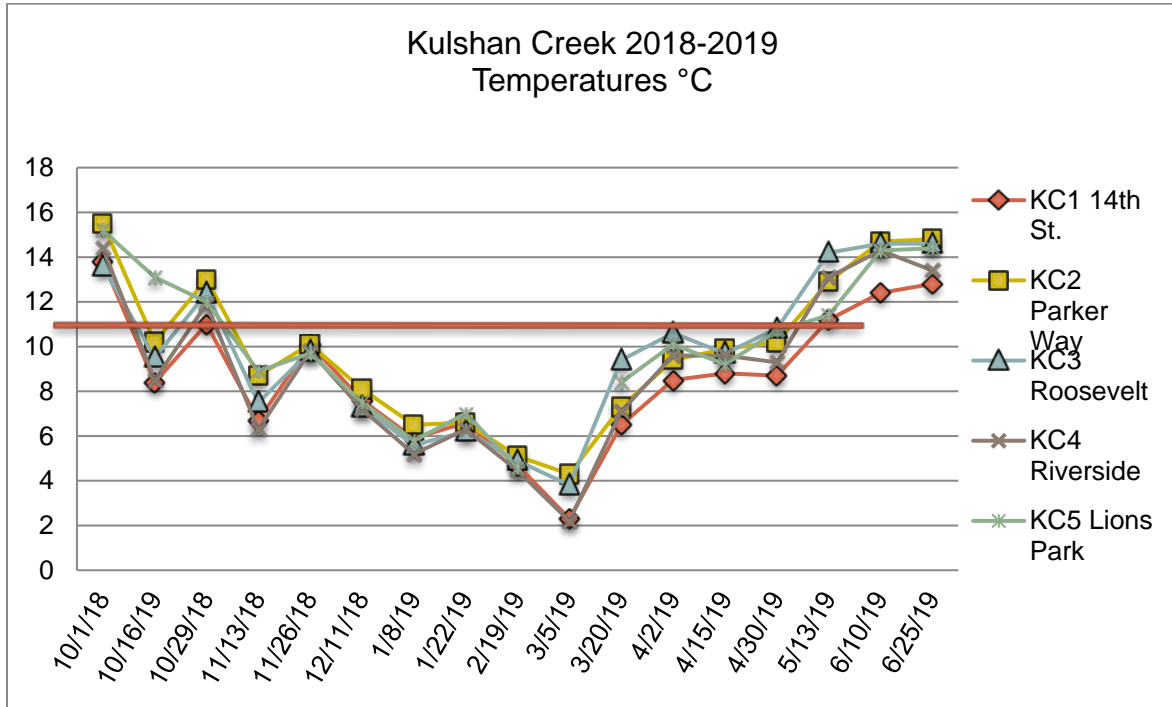
Figure 76. Kulshan Creek Temperature: 2018-2019

All sites started the year above 16°C and rose again in May. Kulshan Creek was not monitored after July 10 when temperatures may have been even warmer.

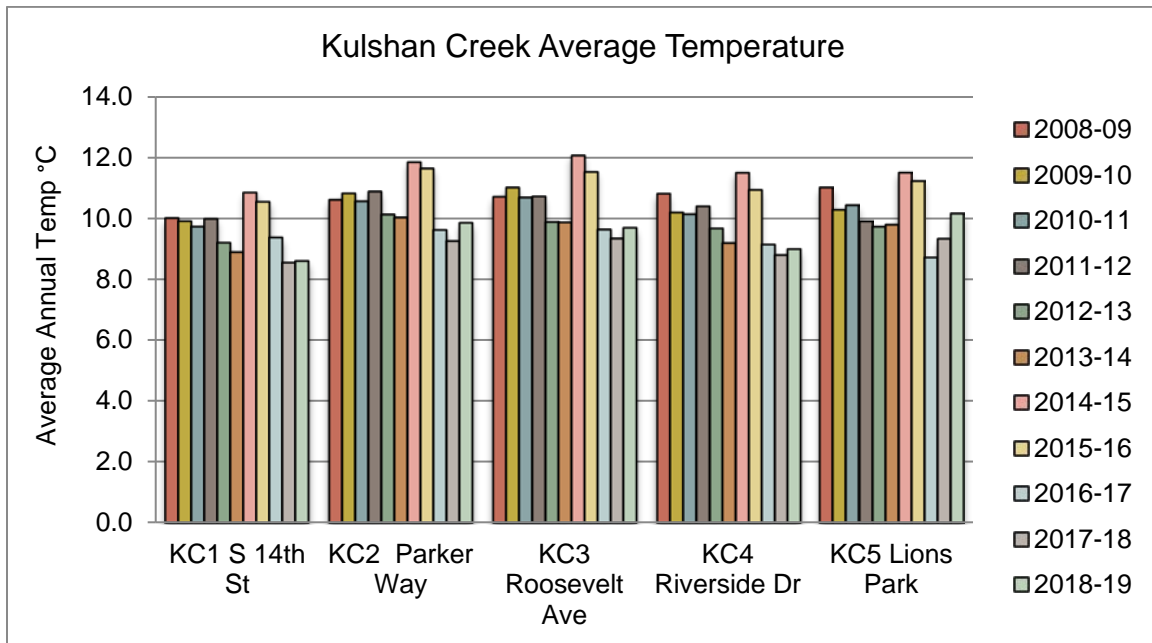
Figure 77. Kulshan Creek Temperature: Eleven-year comparison

Average temperatures are shown for comparison.

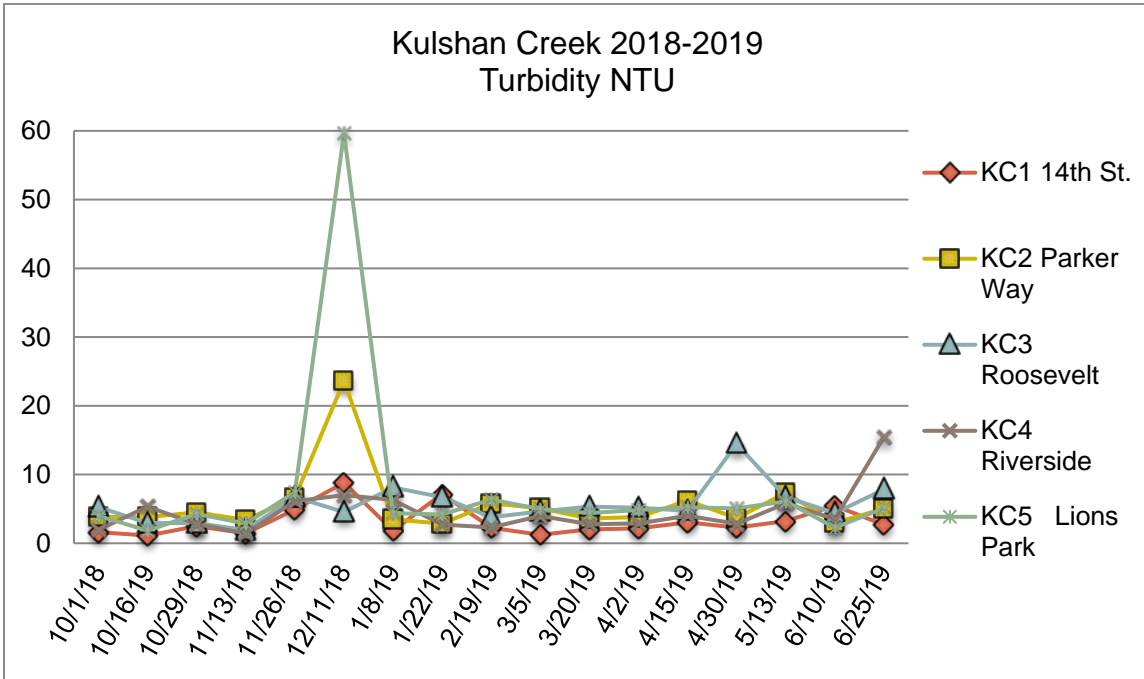
Figure 78. Kulshan Creek Turbidity: 2018-2019

Turbidity for Kulshan Creek was generally lower than most streams, with just one December spike.

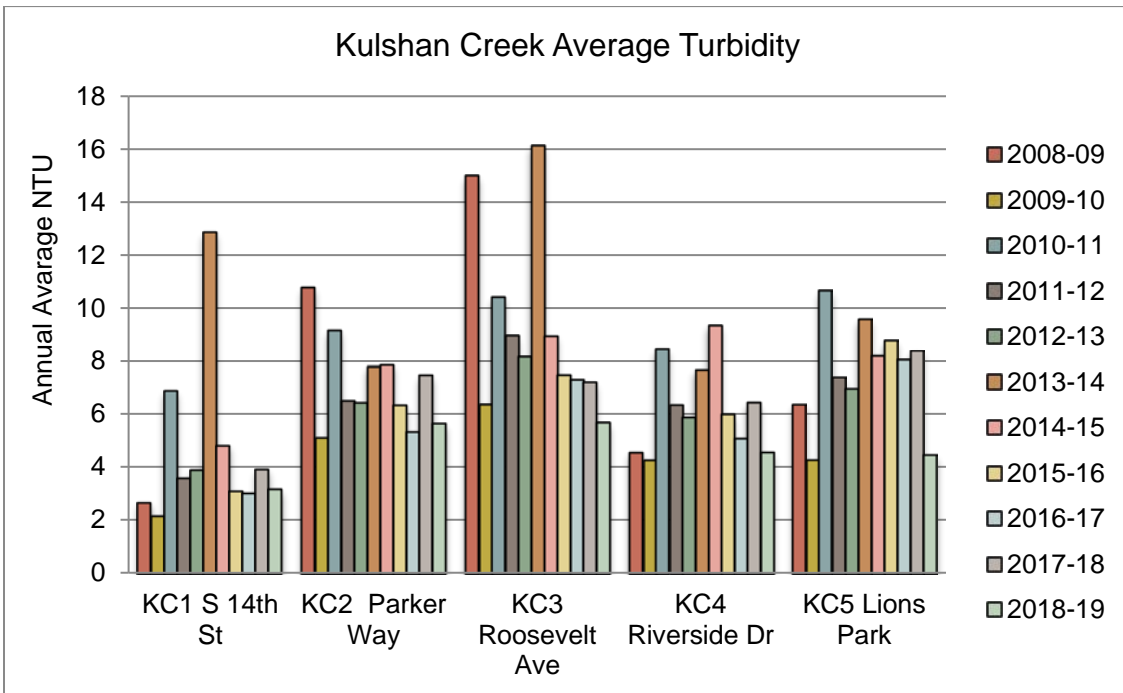
Figure 79. Kulshan Creek Turbidity: Eleven-year comparison

Average turbidity in Kulshan Creek (Figure 79 below) was very low.

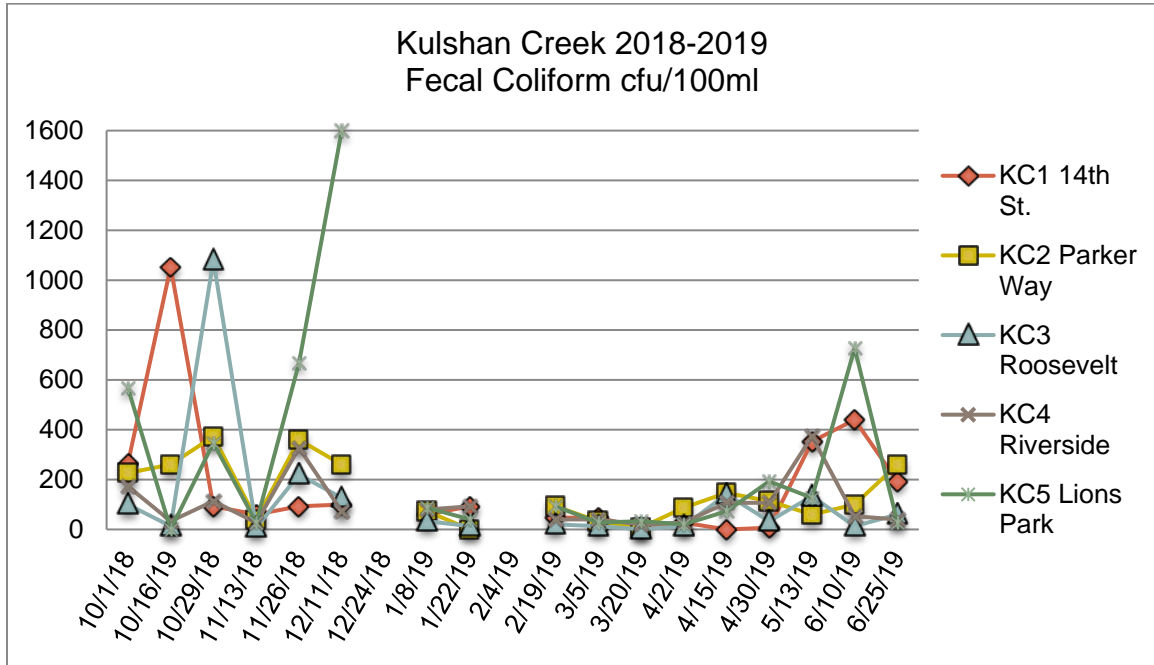
Figure 80. Kulshan Creek Fecal Coliform: 2018-2019

As in previous years, fecal coliform counts in Kulshan Creek were highly variable throughout the year. Site 4 had no samples over 200 CFU/100ml.

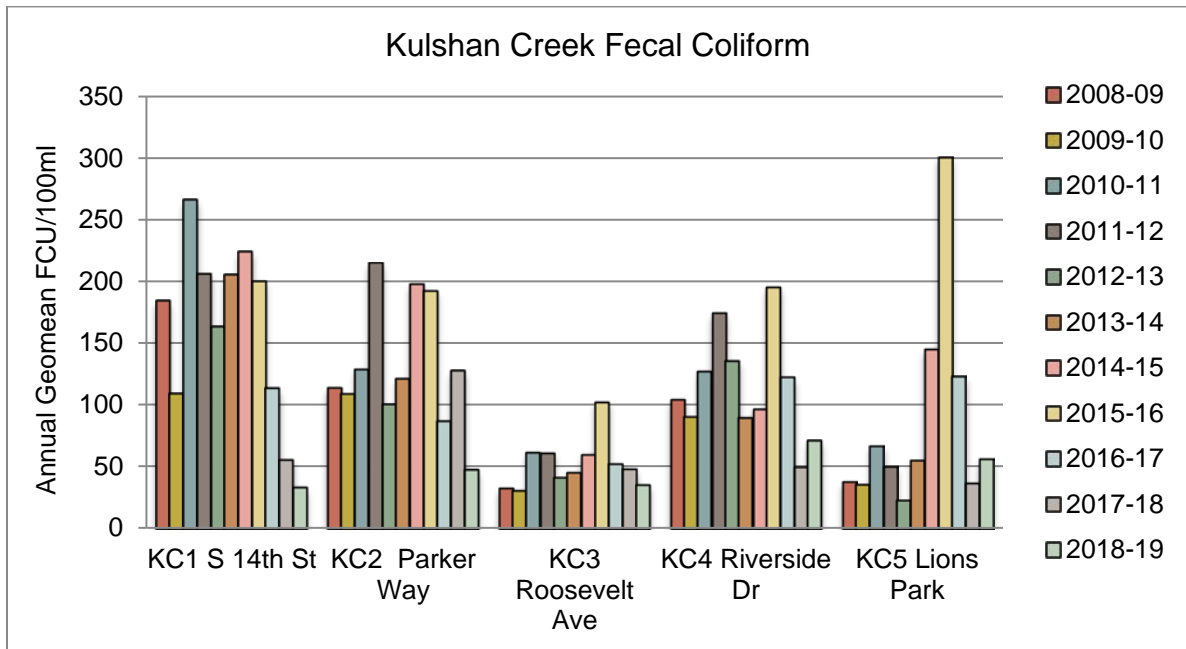
Figure 81. Kulshan Creek Fecal Coliform: Eleven-year comparison

All sites met the standard of <100 CFU/100ml.

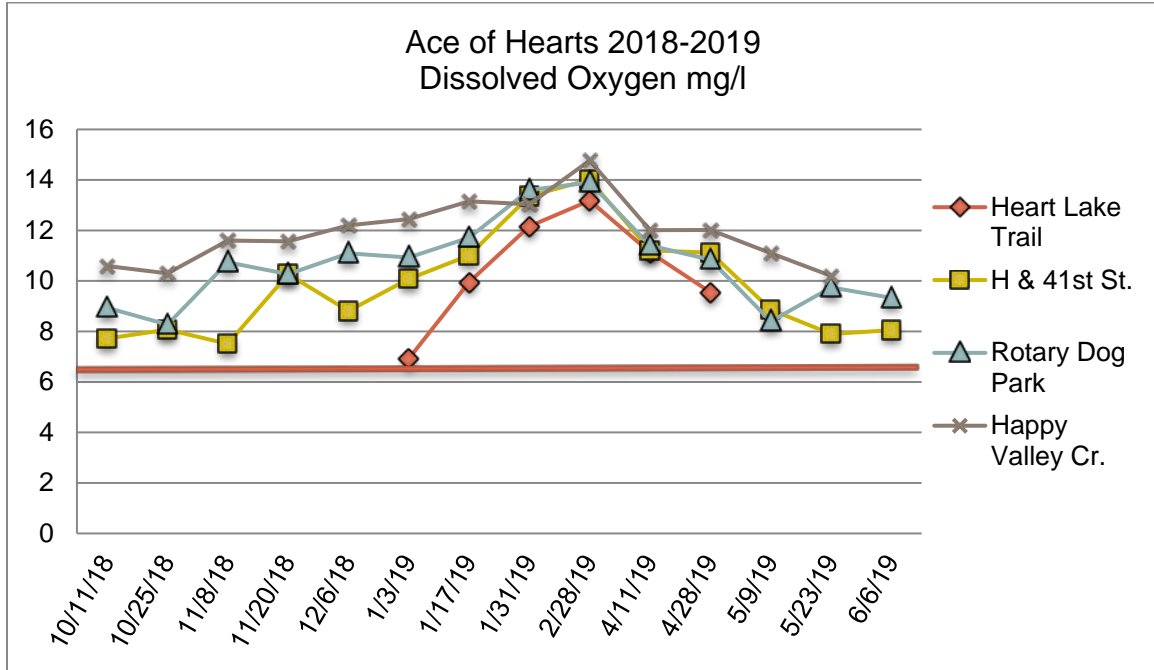
Figure 82. Ace of Hearts DO: 2018-2019

Dissolved oxygen for all sites was above the standard throughout the sampling season, but it was not monitored during the warmest months.

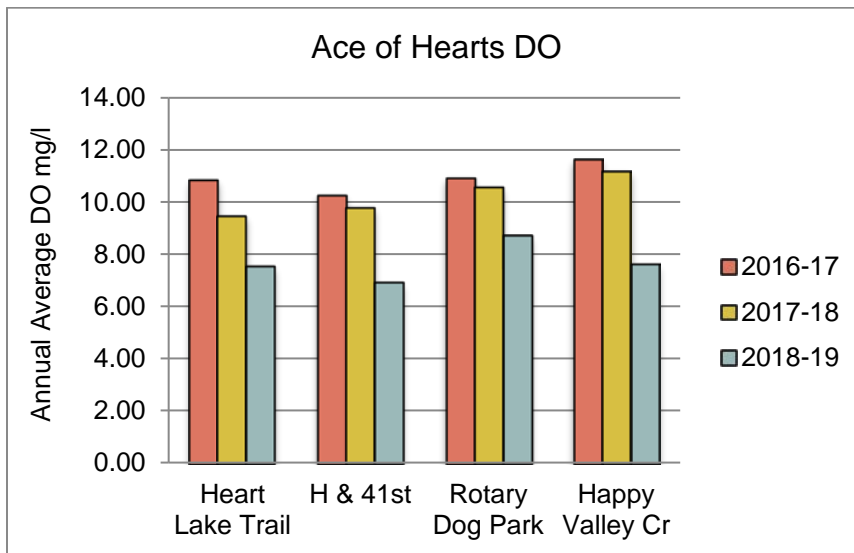
Figure 83. Ace of Hearts Average DO

Average dissolved oxygen levels were lower than the past 2 years.

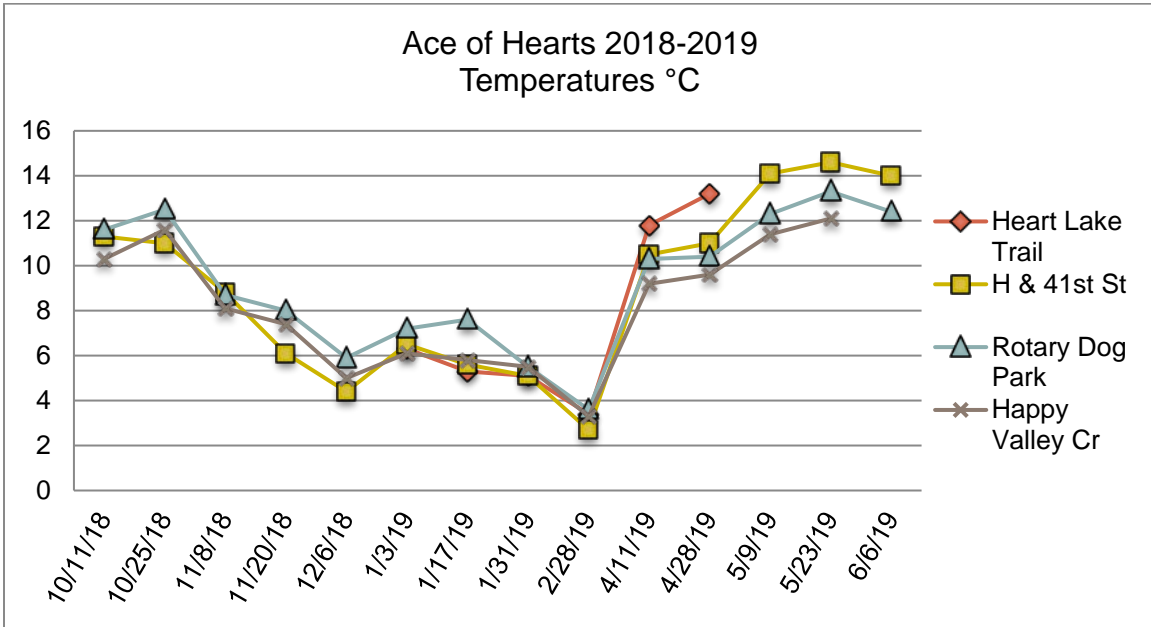
Figure 84. Ace of Hearts Temperature: 2018-2019

Temperatures at all sites stayed below 17.5 °. Ace of Hearts sites were not sampled in summer months because water dries up completely.

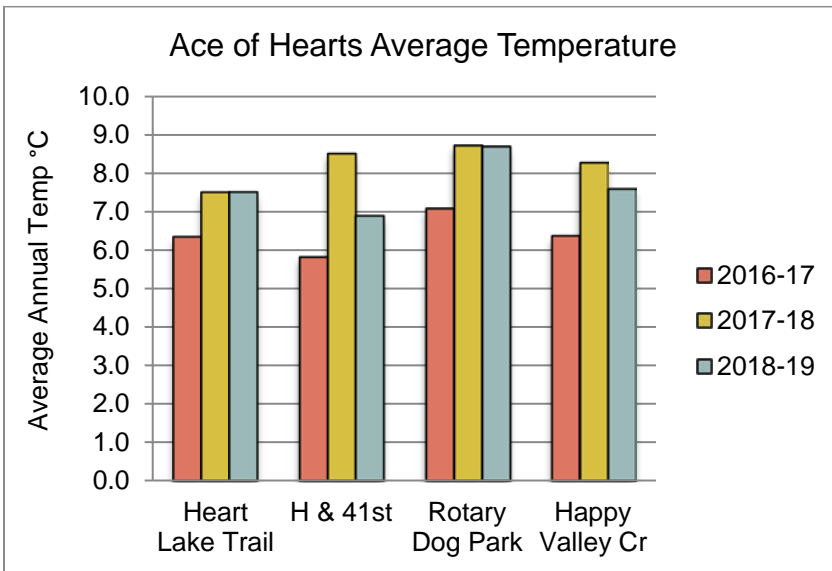
Figure 85. Ace of Hearts Average Temperature

Average annual temperatures (Figure 85 below) are shown for comparison, and are not related to state standards.

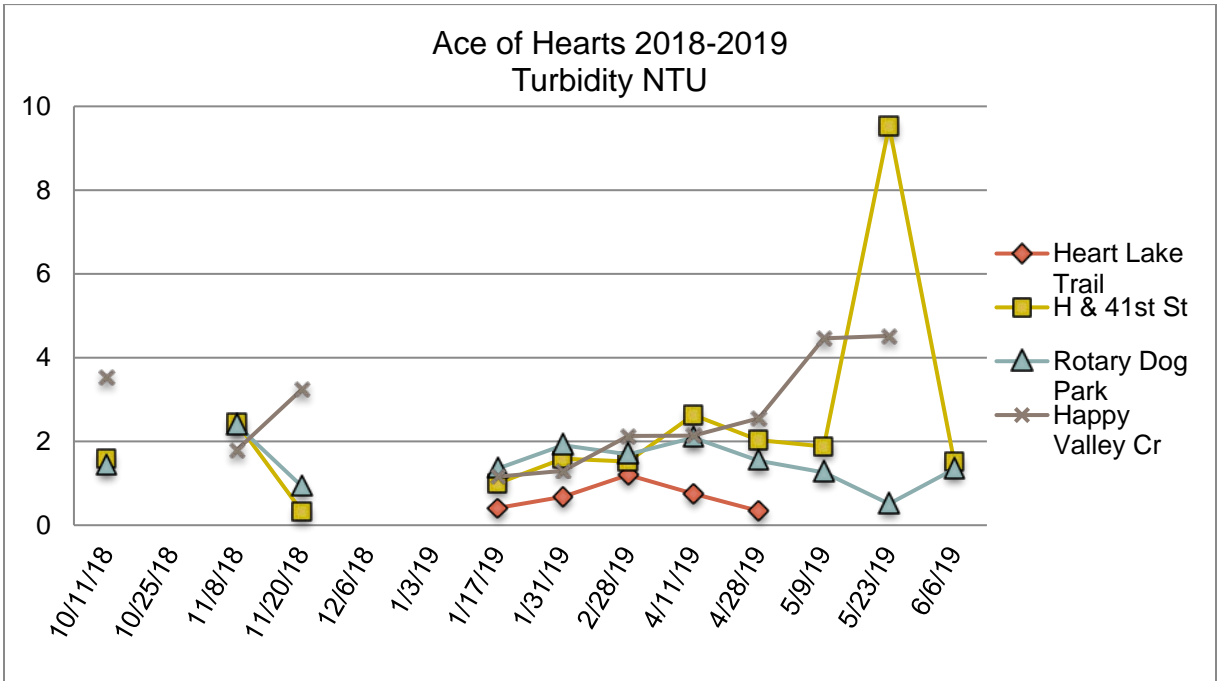
Figure 86. Ace of Hearts Turbidity: 2018-2019

Turbidity levels for Ace of Heart and Happy Valley Creeks were relatively low at all sites.

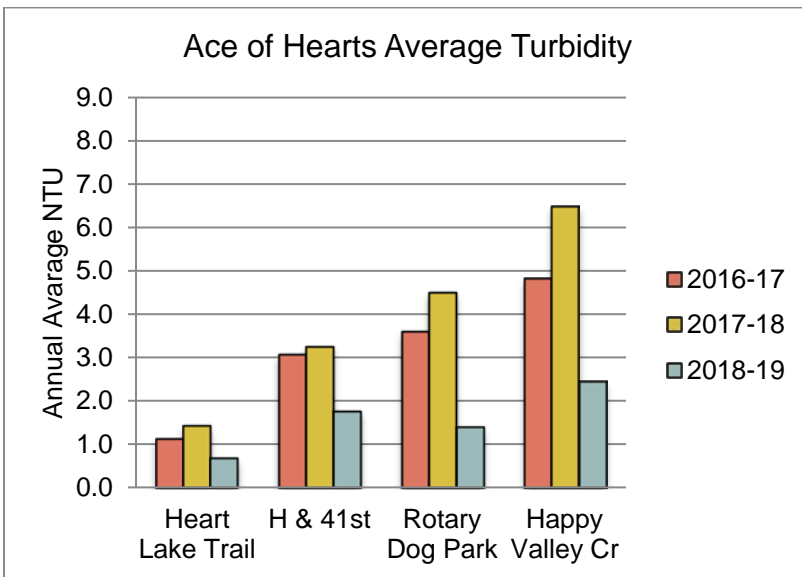
Figure 87. Ace of Hearts Average Turbidity

Average turbidity levels were the lowest in three years.(Figure 87 below)

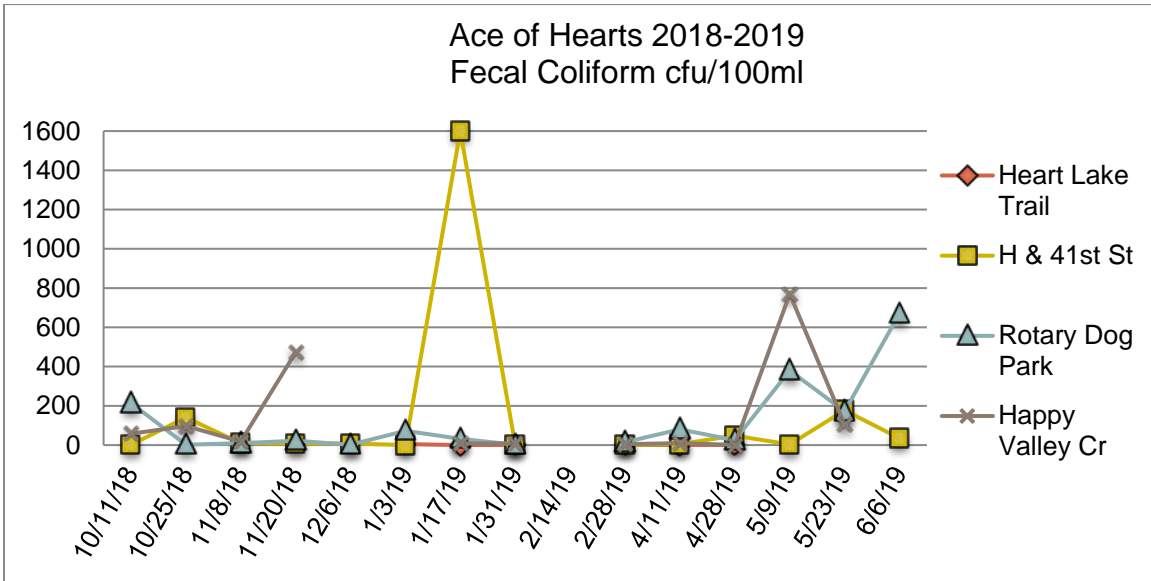
Figure 88. Ace of Hearts Fecal Coliform: 2018-2019

Sites 1 and 2 met Part II of the standard, with fewer than 10% of the counts higher than 200CFU/100ml.

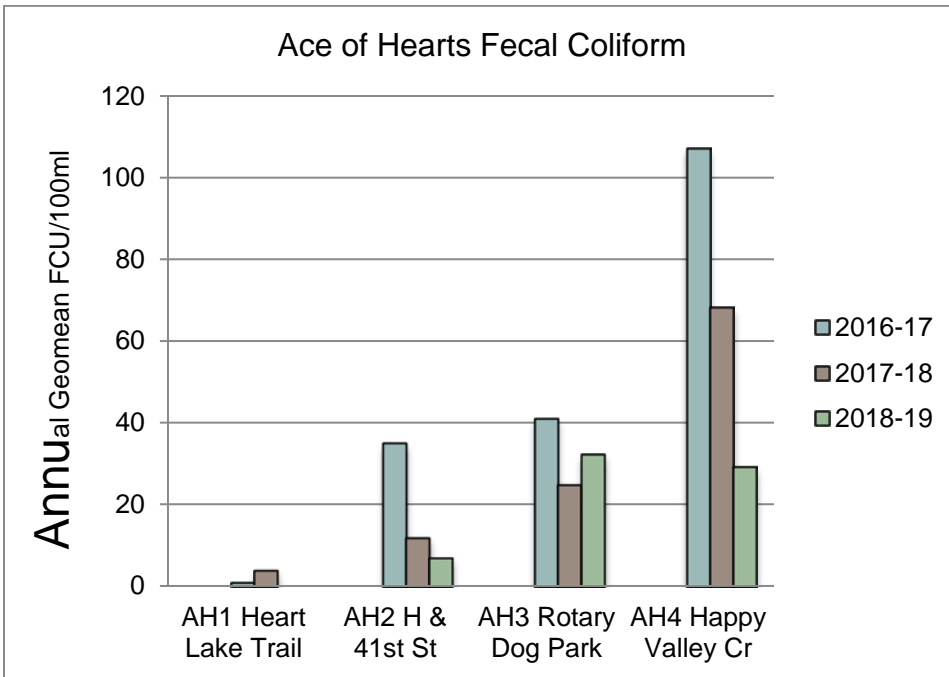
Figure 89. Ace of Hearts Fecal Coliform: Annual Geomean

Geometric means (Figure 89 below) for all Ace of Hearts sites were lower than the 100 CFU/100ml standard.

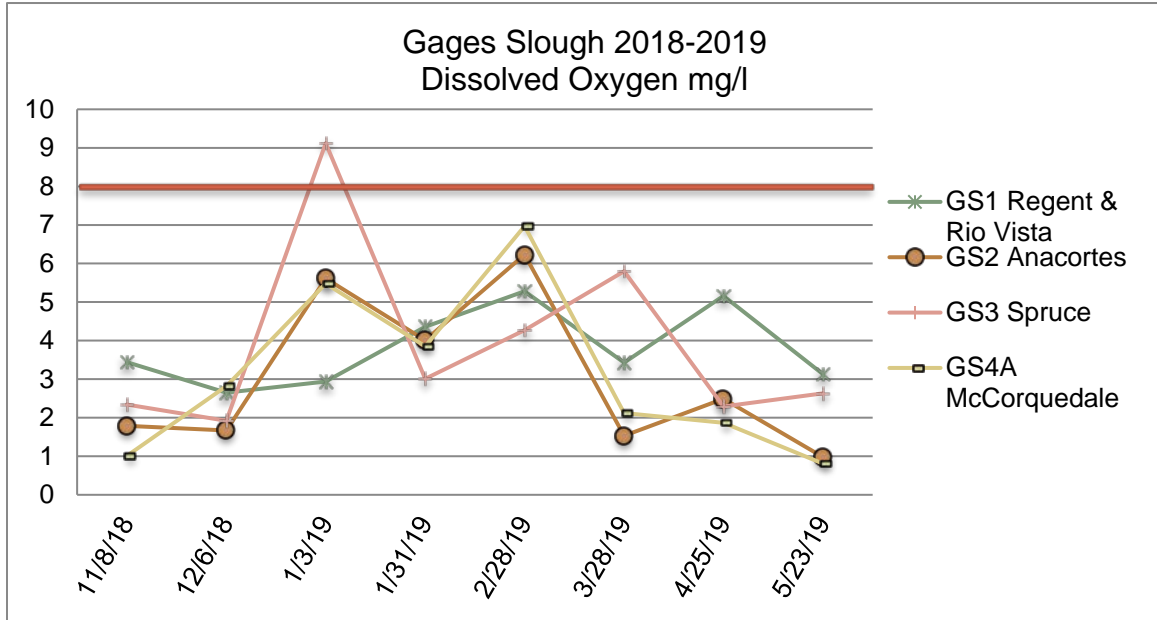
Figure 90. Gages Slough DO: 2018-2019

Dissolved oxygen at all Gages Slough sites was below the standard throughout the year, including December and January when cold water temperatures usually increase DO.

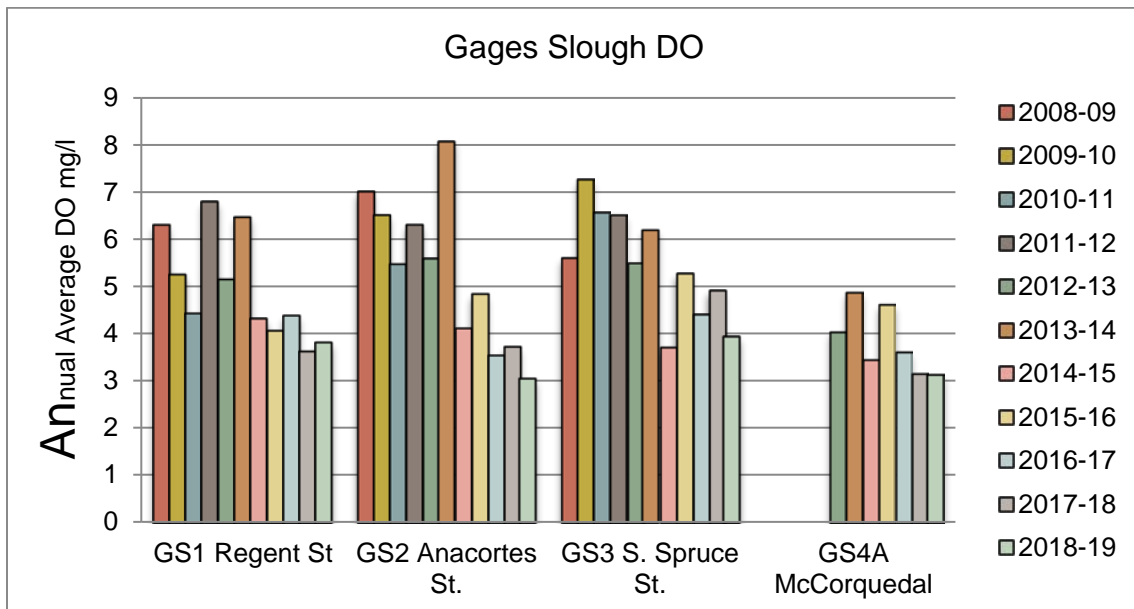
Figure 91. Gages Slough DO: Eleven-year comparison

Dissolved oxygen levels have been decreasing steadily in the ten years of monitoring, and are well below the standard. This is a slow moving stream that dries up completely in summer.

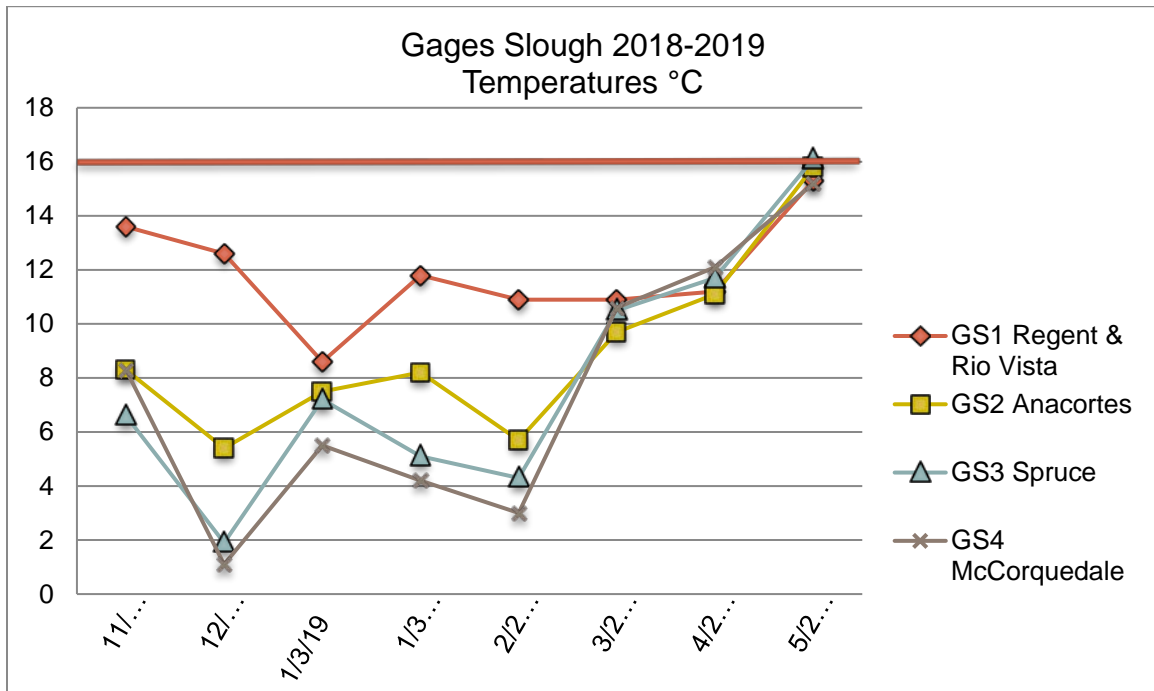
Figure 92. Gages Slough Temperature: 2018-2019

All Gages Slough sites were cooler than 17.5°C throughout the sampling period, with a single exception at Site 3. Sites were not sampled in the warmest months.

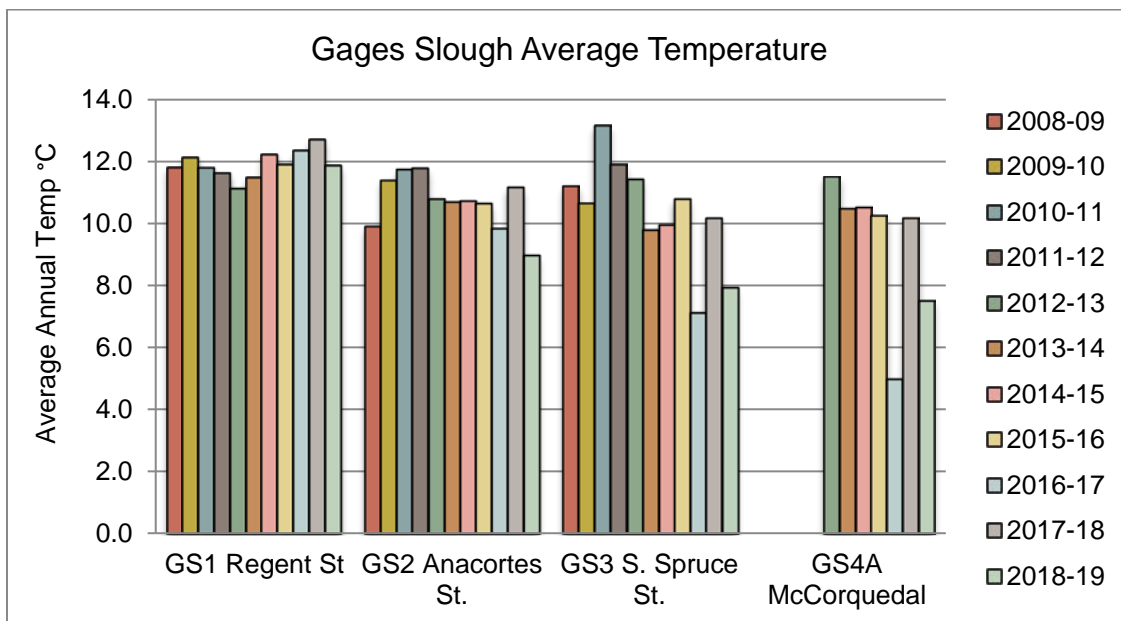
Figure 93. Gages Slough Temperature: Eleven-year comparison

Average temperatures in Gages Slough were cooler than last year. The state standard is not based on average temperature.

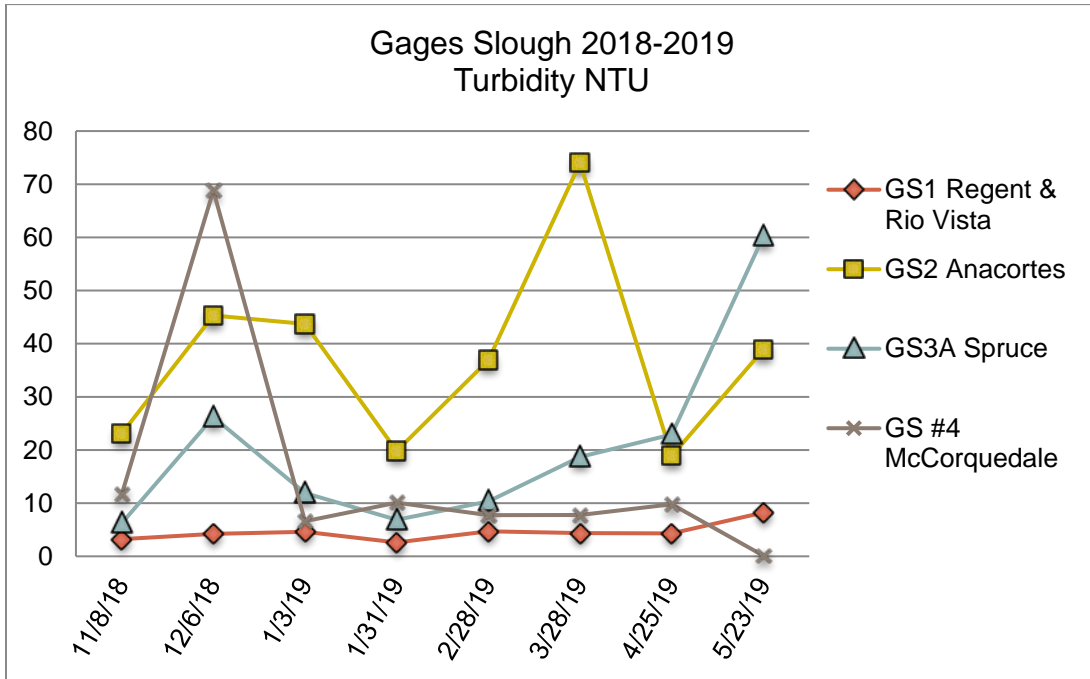
Figure 94. Gages Slough Turbidity: 2018-2019

Site 2 again had the highest turbidity levels.

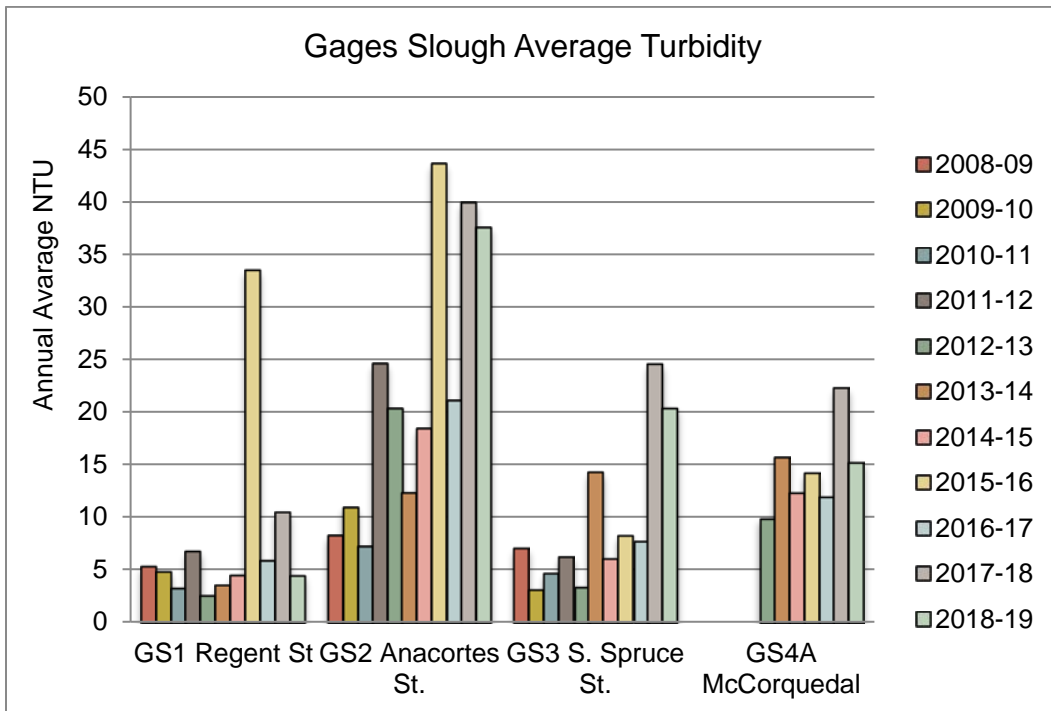
Figure 95. Gages Slough Turbidity: Eleven-year comparison

Sites 2-4 remained high in 2018-2019.

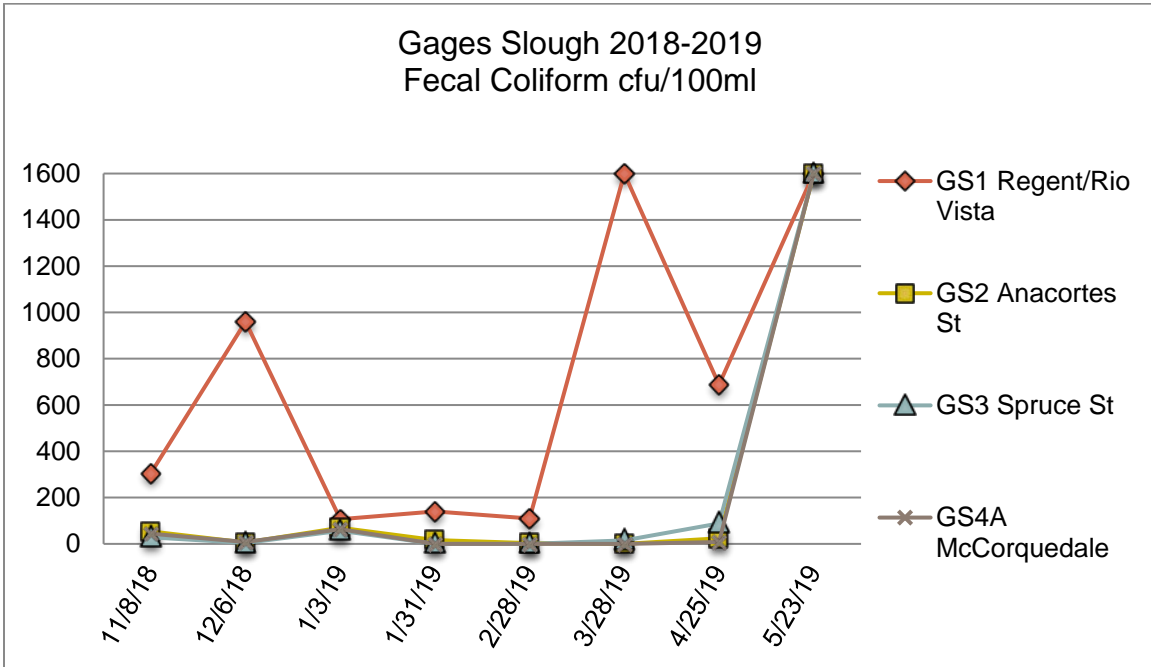
Figure 96. Gages Slough Fecal Coliform: 2018-2019

All sites had more than 10% of the samples >200CFU.100 ml. Note that there were just 8 samples taken this year.

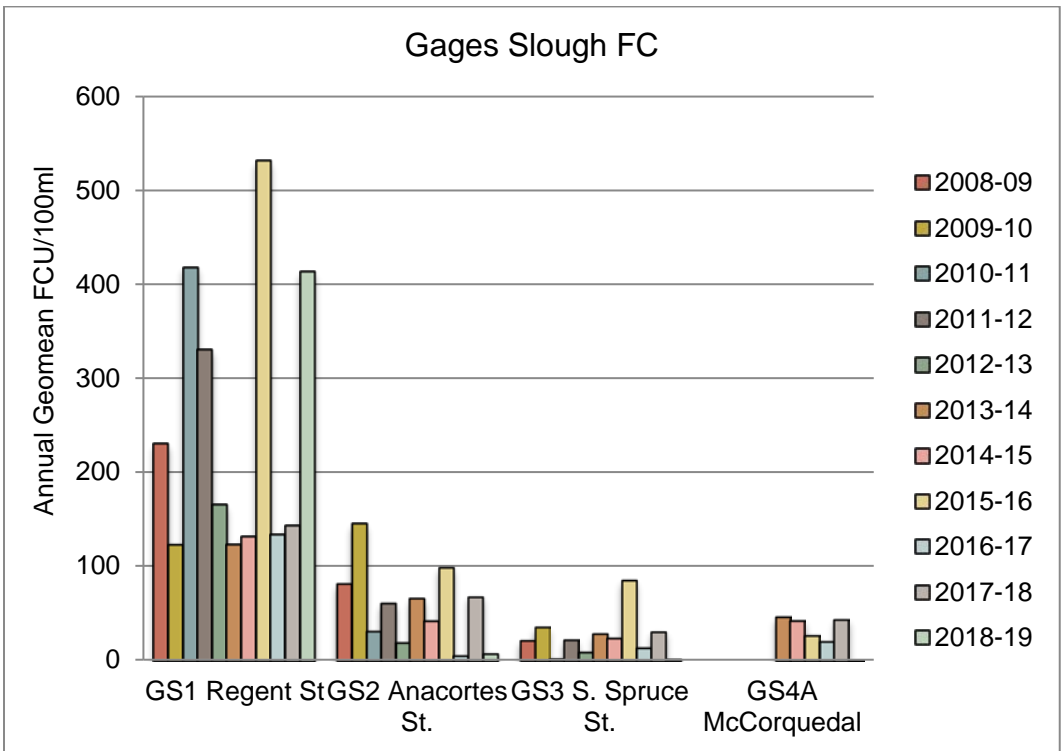
Figure 97. Gages Slough Fecal Coliform: Eleven-year comparison

In spite of very high numbers in May, Sites 2-4 met Part 1 standard with annual geometric mean less than 100CFU 100ml, though the standard requires at least 10 samples.

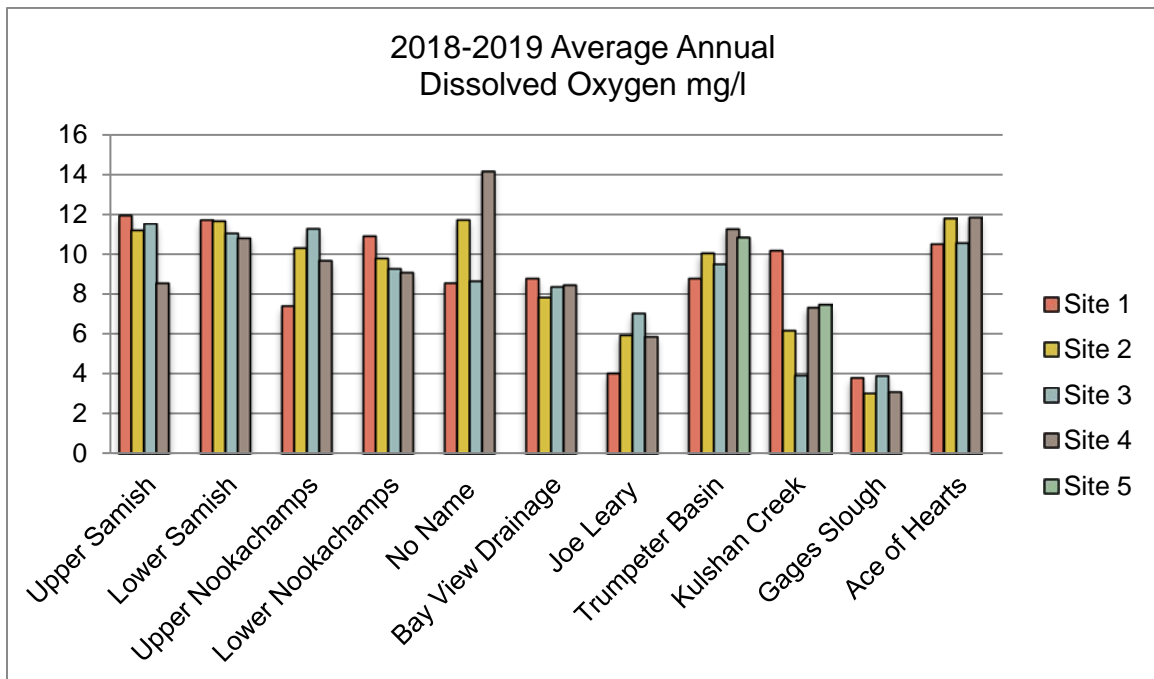
Figure 98. Annual Average Dissolved Oxygen: All sites

For dissolved oxygen, (Figure 98) a number of sites have annual averages below 8mg/l. Considering regulations do not allow even one occurrence of levels below the standard, it is clear that these sites are in need of attention. Upper Nookachamps 1, all Joe Leary sites, Kulshan Creek 2 and all Gages Slough sites have low DO levels.

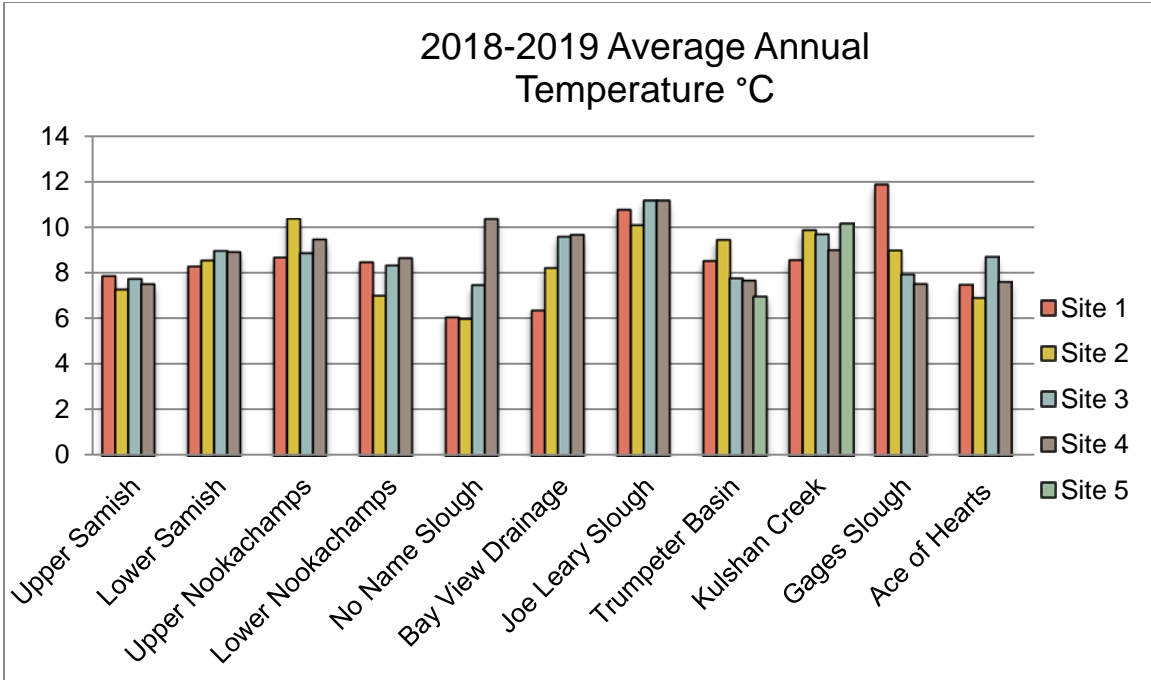
Figure 99. Annual Average Temperature: All sites

Figure 99 (next page) shows average temperature. State standards are not based on annual average temperatures, but on the average 7-day maximum. Most sites were not sampled during the warm summer season.
