# Skagit Stream Team Water Quality Report

*Citizen Monitoring Summary for Samish Bay, Padilla Bay,  
Ace of Hearts, Gages Slough, Trumpeter Basin,  
Kulshan Creek and Nookachamps Creek*

2018 - 2019 Annual Water Quality Report

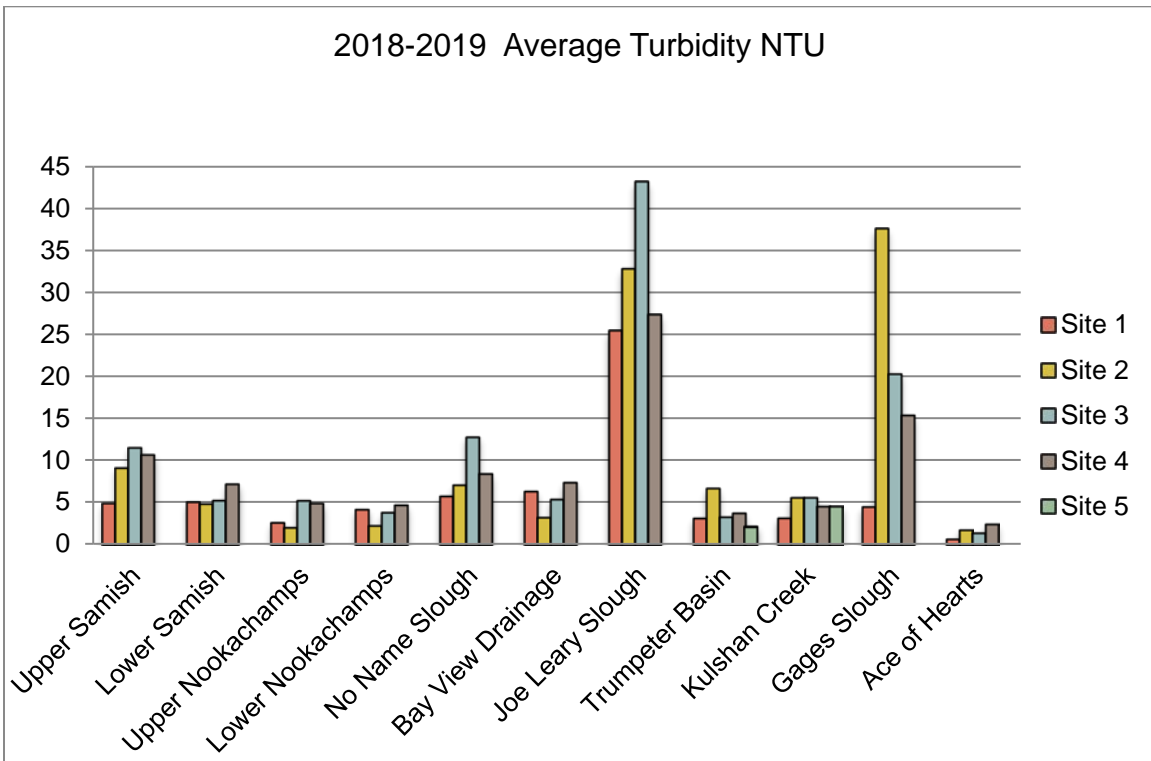
Figure 100. Annual Average Turbidity: All sites

Turbidity is the parameter with the greatest naturally occurring variability. Comparing all streams, Gages Slough Site 2, and Joe Leary Slough stand out. All Joe Leary sites are 2-3 times higher than most other sites. Along much of Joe Leary’s course, it drains cultivated cropland and is periodically dredged to improve drainage.

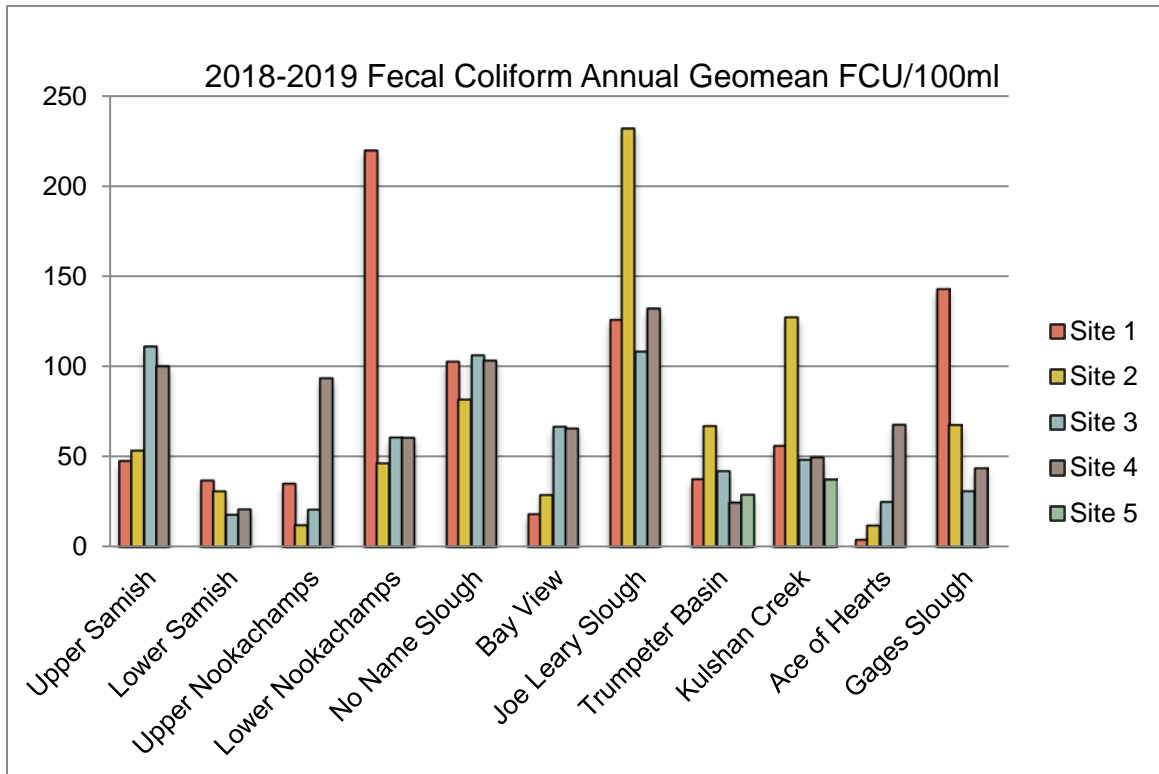
Figure 101. Fecal Coliform Annual Geomean: All sites

Fecal coliform (Figure 101) is the parameter of greatest interest to regulators, health officials, and shellfish growers. In 2015-2016, 18 out of 46 sites did not meet Part I of the standard. In 2016-2017, 13 out of 46 sites averaged above 100CFU/100ml. In 2017-2018 only 9 out of 46 sites did not meet the standard. This year, 2018-2019, 10 out of 46 sites did not meet Part 1. No Name Slough has historically had very high fecal coliform numbers, and hovered close to the standard this year. Like last year, Upper Samish 3, all Joe Leary Slough sites, Kulshan Creek Site 2, and Gages Slough Site 1 all failed to meet Part 1 of the State Standard.

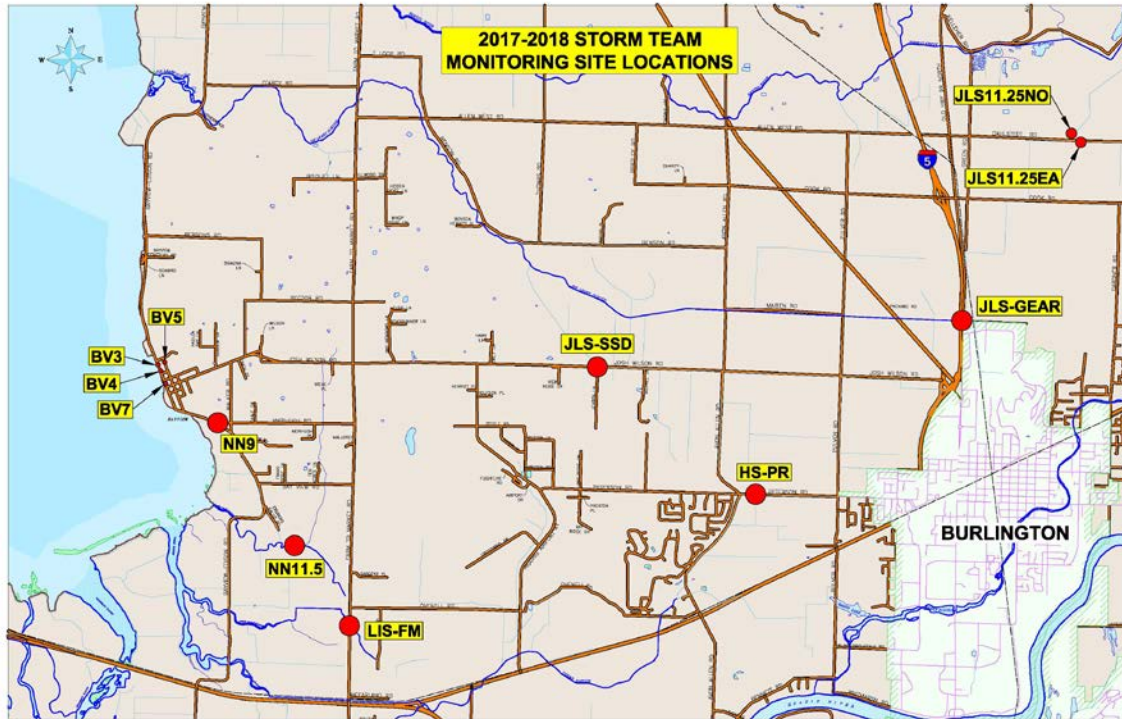
Figure 102. Padilla Bay Storm Team Sampling Sites 2018-2019

2018-2019 the Storm Team completed a third year of sampling in the Padilla Baywatershed. Volunteers sampled 12 sites. Four sites were on Joe Leary Slough, the largest fresh water input to Padilla Bay. Other sites were on No Name Slough, Little Indian Slough, and in the village of Bay View. Volunteers sampled 12 sites during just 4 rain events, the fewest number of events since Storm Team began. Storm team data should be viewed differently from the rest of the stream team data. They do not represent typical conditions. Even a healthy stream can have occasional high fecal coliform levels during rain events. Standards are based on an average of multiple samples taken over time and in a variety of conditions, with at least 10 samples during a year.

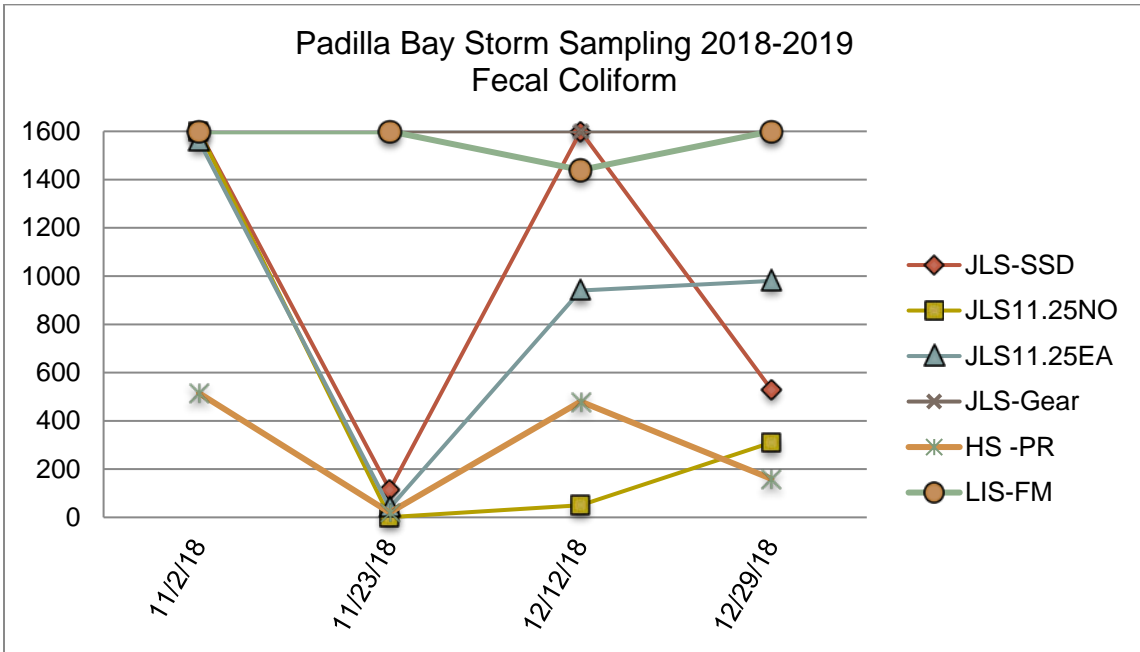
Figure 103. Storm Team: Padilla Bay Fecal Coliform, Joe Leary/Little Indian Slough Sites

Figures 103-105 below show actual fecal coliform counts for all sites. Each graph shows 5 sites.

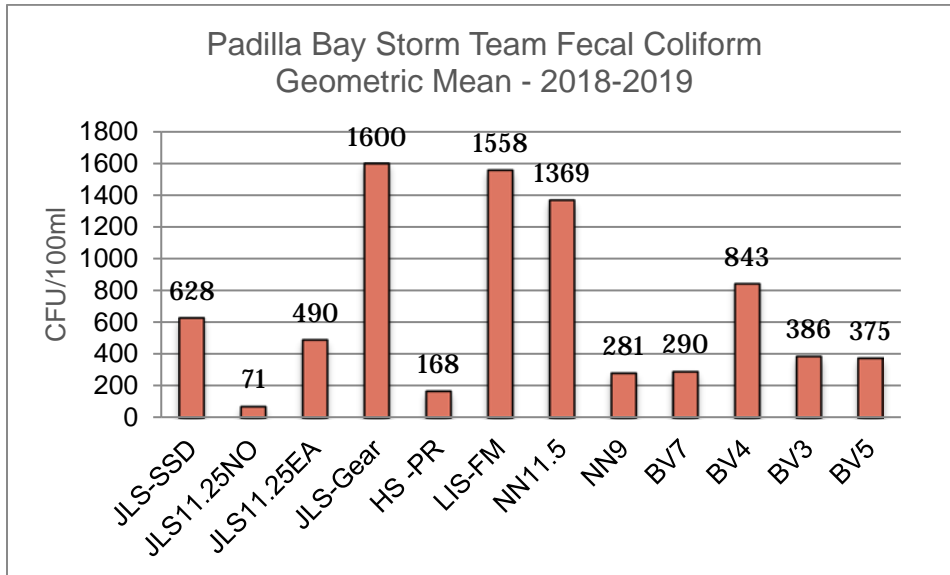
Figure 105. Storm Team: All Sites, Fecal Coliform Annual Geometric Means

Figure 105 (below) shows geometric means for the 2018-2019 sampling season. Only 2 sites were below the state standard of 100cfu/100ml of water. It is important to remember that sampling only occurred during heavy rain events. In Bay View, the B Street culvert (BV 4) continued to have higher counts than nearby Bay View sites. Like last year, two other sites stand out with extremely high counts, Joe Leary Slough at Gear Road and Little Indian Slough at Farm-to-Market Road. State standards require at least 10 samples over the course of a year.

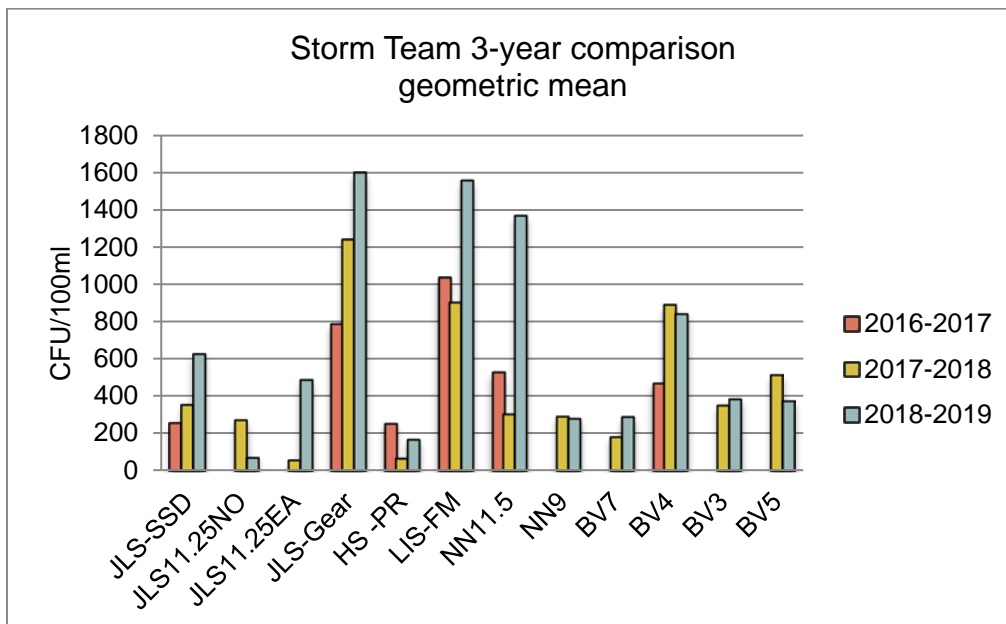
Figure 106. Storm Team: Three-year annual geometric mean comparison

Figure 106 (below) compares sites over the past three years. Again, this year volunteers only sampled during four events. Four sites were much higher in 2018-2019 than in the previous years: two on Joe Leary Slough, the Little Indian Slough site, and No Name slough at Egbers Road.
